MEMO

RE: Draft Field Assessments for Two Peconic Estuary Subwatersheds

SUBWATERSHED BASELINE MAPS

FIELD FORMS AND SKETCHES

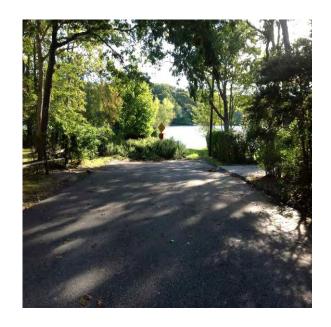
Site ID: NSH-R1

Remove pavement (10-15 feet) at the end of the road, leaving access for existing driveway. Install shallow bioretention with overflows from large storm events directed to existing drain inlets. If needed, could possibly extend another 10 feet past current edge of pavement (there is a guardrail off the edge of pavement).

It appears that this area is used for vehicle access to the pond. Recommend eliminating this or stabilizing access if it is to be allowed to continue.

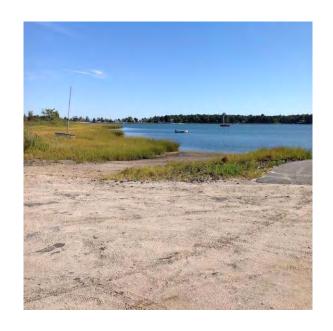
Site ID: NSH-R2

Restoration project. Remove dirt boat ramp (adjacent to the paved boat ramp) and restore natural vegetation. Trustees were onsite and noted that the dirt boat ramp was rarely used. Erosion was observed along side of the existing dirt boat ramp with recently placed rip rap. A vegetated buffer strip could be installed along the seawall. Parking could be removed near the trailhead, restoring with native vegetation (pulling back the trailhead).

The large dirt pile in front of the Sea Scouts building should be removed and/or stabilized.

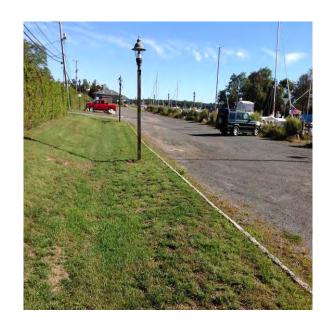
Site ID: NSH-R3

Better utilize existing swale located between dirt parking lot and road. Remove section of curb in parking lot to direct half of parking lot into swale. Overflow to existing drain inlets (outfalls). Could possibly be modified to also take a portion of the roadway runoff.

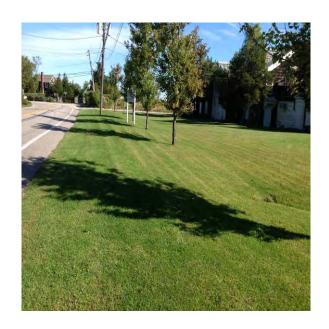
Site ID: NSH-R4

Formalize existing swale to treat a portion of road runoff.

Unknown future use of "club building." Question if existing septic system is failing and the location of the system?

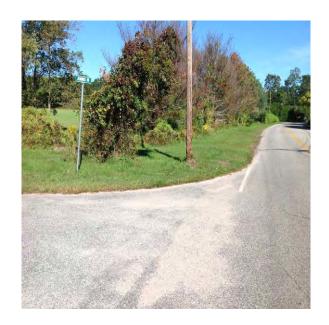
Site ID: NSH-R5

Propose dry swale to replace existing leaching catch basins.

Private property posted adjacent to road. OHW possible constraint. Pole located on corner of Jennings Street. Water line conflict? See mapping from Town and "water meter" observed in field.

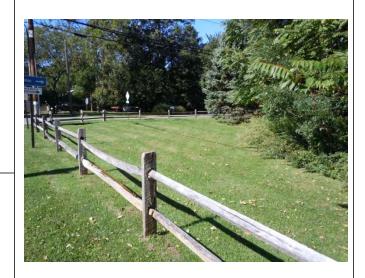
Site ID: NSH-R6

Utilize existing park for bioretention area for road runoff from North Sea/Noyak Rd intersection.

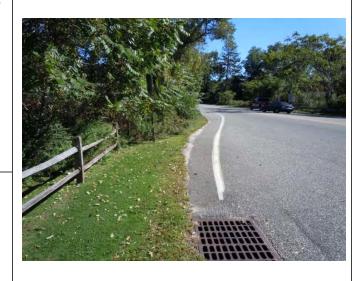
Site ID: NSH-R7

Swale along side of road up to bridge abutments. Existing

inlets on bridge to remain.

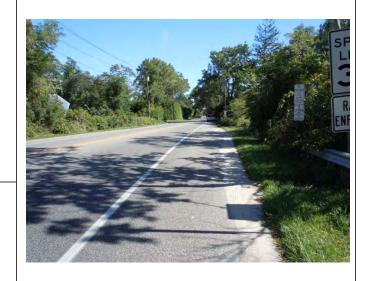
Site ID: NSH-R8

Swale along side of road up to bridge abutments.

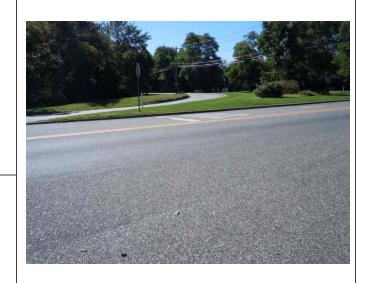
Site ID: NSH-R9

Cut back berm at existing drain inlet and install paved flume to bioretention area in open space adjacent to roadway (southeast corner of intersection).

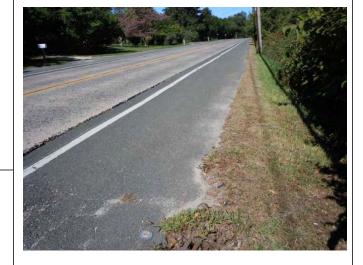
Site ID: NSH-R10

Road is currently super elevated to the east and is in pretty bad condition. Propose Swales when road is resurfaced. Existing drain inlets are stenciled but outfalls were not observed.

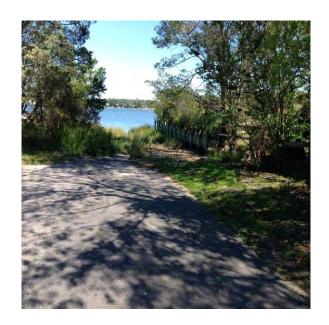
Boat access for mostly sailboats; recommend eliminating or stabilizing. Resident noted flooding problems only during hurricanes and nor'easters.

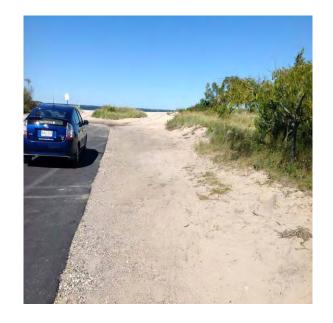
Formalize parking and reduce impervious if possible. Install "beach" bioretention area with split rail fence to prevent damage from vehicles.

Eliminate one or more beach vehicle access points and stabilize those vehicle access areas to remain.

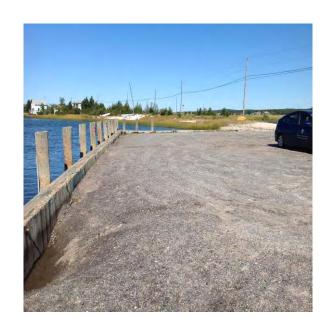
Recommend reconfiguring / formalizing parking lot. Possible vegetated filter strips along sea wall. Formalize kayak launch or eliminate and re-vegetate.

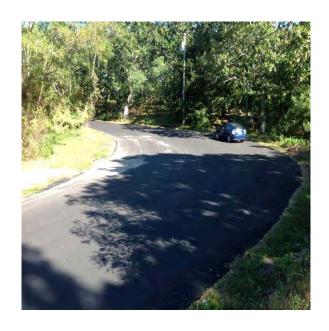
Newly paved road. Very narrow except at low point, possibly to accommodate the leaching structures. Recommend removing excess pavement and installing dry swale.

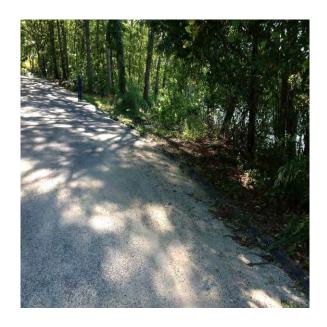
Repair existing eroded slope with stabilized outlet.

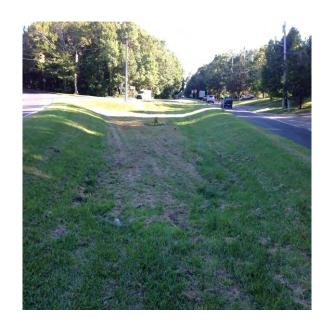
Install sediment forebay for pretreatment in existing infiltration basin.

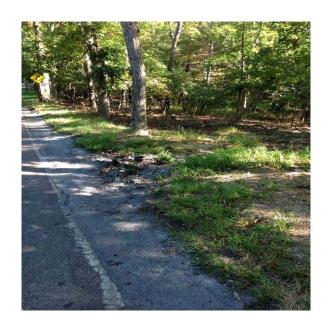
Existing "leak offs" to shallow wooded depression along road. Propose to install paved flumes to pretreatment forebays. If depression is not a regulated wetland, consider creating a stormwater wetland in this area.

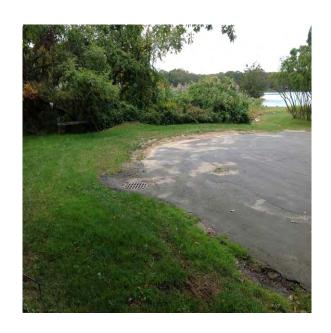
Road end bioretention. Remove existing drain inlet and replace with paved flume into practice. Direct overflows into existing leaching pit.

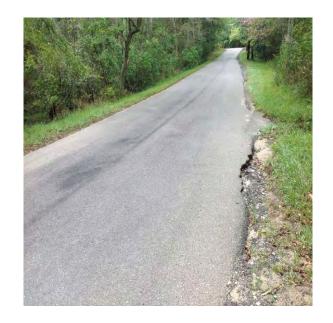
This area experiences frequent flooding. Any retrofit here needs to be paired with other retrofits/education in the drainage area.
