4.0 Goose Creek Subwatershed

4.1 Subwatershed Characteristics

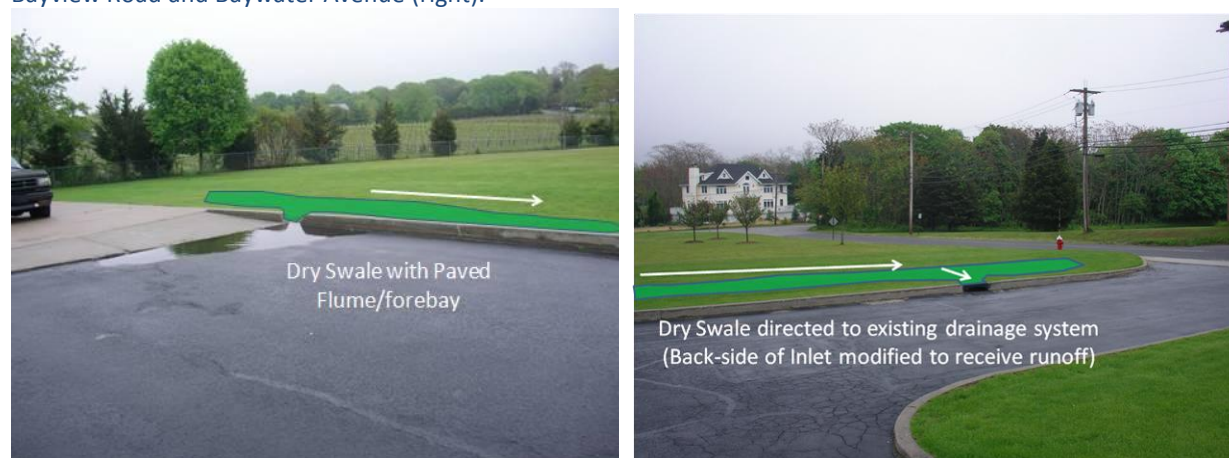
The Southold Firehouse is located just southwest of the intersection of Baywater Avenue and Main Bayview Road in the far southwestern corner of the subwatershed. Currently, stormwater is managed through a series of leaching catchbasins that likely discharge to underground infiltration chambers. The surrounding grounds also contribute high-input runoff from turfgrass. This site was initially identified as a potential hotspot, but this assessment was later dismissed, since it does not appear to be contributing high pollutant input. The recommendation for this site is to construct **dry swales** to treat runoff before discharging into the existing catchbasin/infiltration system.

Figure 4.2. Parking area behind Southold Firehouse with expansive turf areas. Proposed dry swale shown shaded in green, view toward the northeast with vineyards in background (left), and view toward intersection of Main Bayview Road and Baywater Avenue (right).

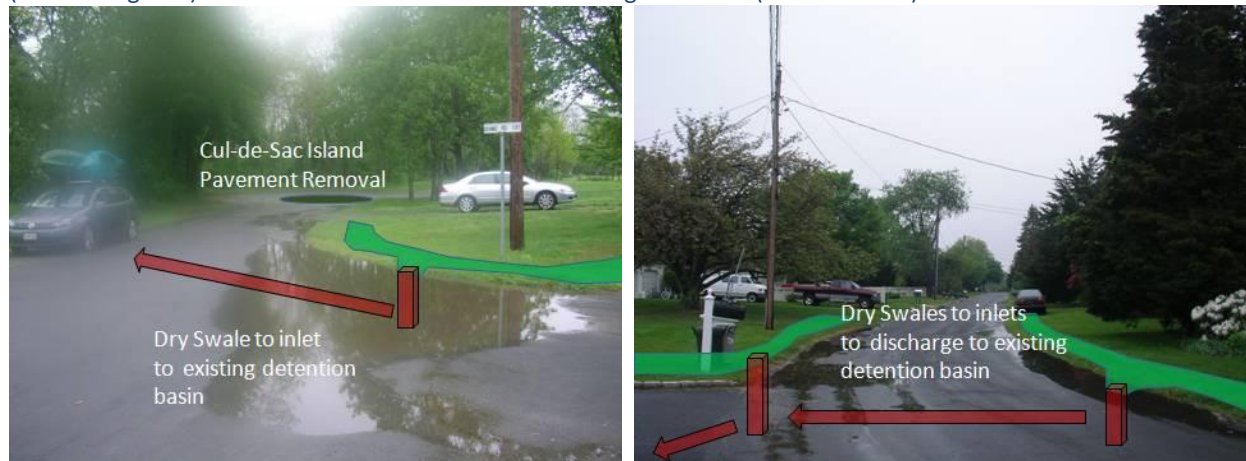
Grange Lane and Grange Lane Extension are located in the far western reaches of the Goose Creek subwatershed. Currently, stormwater collects in the roadway along Grange Lane. In addition, the cul-de-sac pavement is in poor condition with a pair of clogged leaching catchbasins. Stormwater overflows into the adjacent open area, originally designed as a detention pond. The area is now forested, and has evolved into a naturally-recharging detention basin. Unfortunately, there is significant evidence of sedimentation and dumping of debris in this location. Recommended stormwater retrofit BMPs would include installation of a **dry swale** along Grange Lane, overflowing to the existing detention basin.

Figure 4.3. Grange Lane with views toward cul-de-sac (right) and Grange Lane Ext. (left). Proposed dry swales (shaded in green) would be directed to inlets and leaching chambers (shaded in red).

Pavement could also be removed from the cul-de-sac to reduce the amount of impervious surface (and thus, volume of runoff). Non-structural practices such as maintenance of the catchbasins and the existing forested detention pond would also be recommended. Implementation of BMPs at this site has been given a lower priority for this subwatershed due to the presence of the existing recharging detention basin.

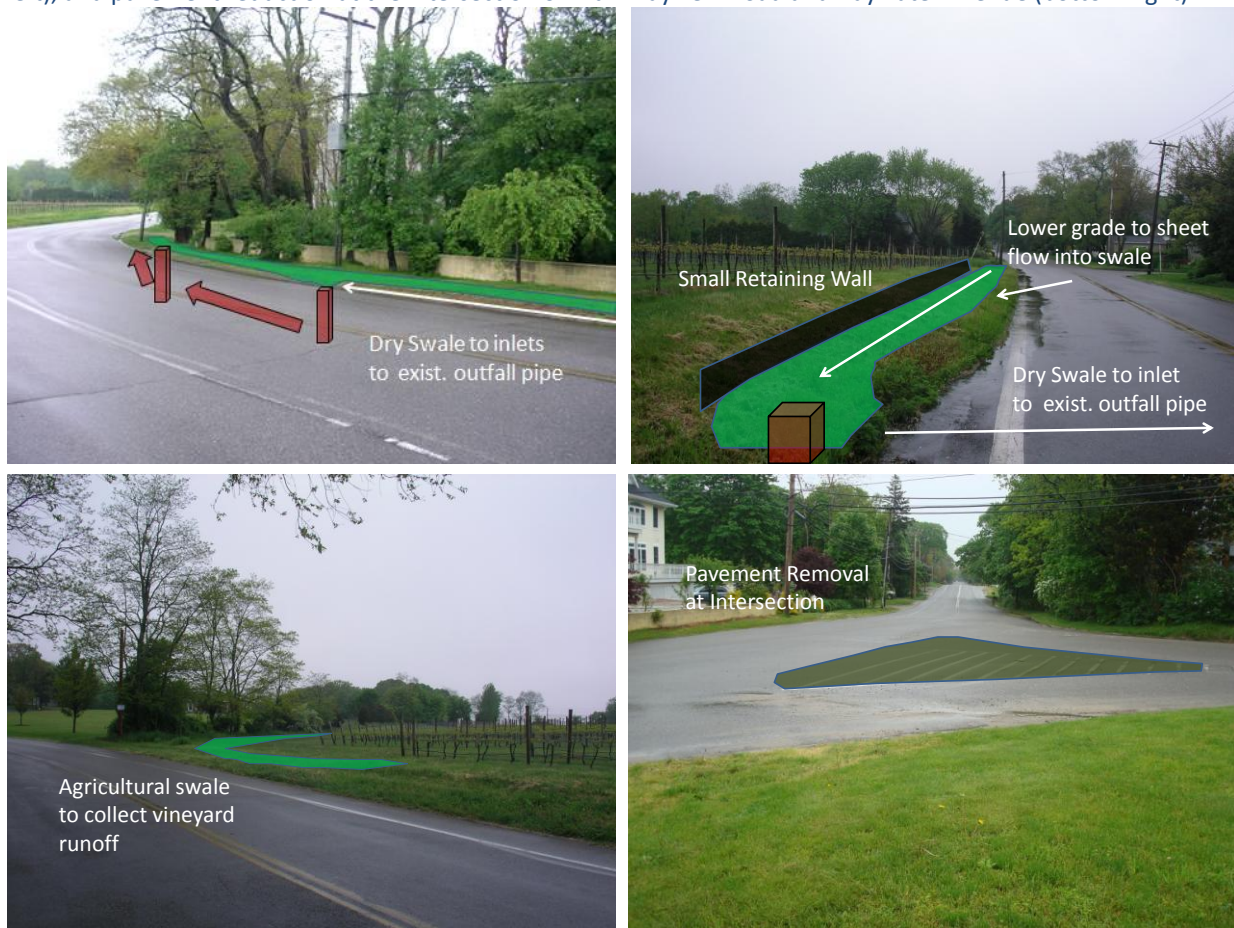
Figure 4.4. Main Bayview Road facing north (top). Proposed dry swales would direct stormwater to the existing outfall pipe at Goose Creek. Proposed BMPs could also include a vegetated swale within the vineyard (bottom left), and pavement reduction at the intersection of Main Bayview Road and Baywater Avenue (bottom right).

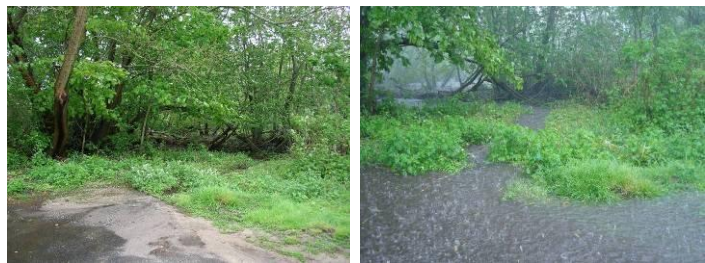
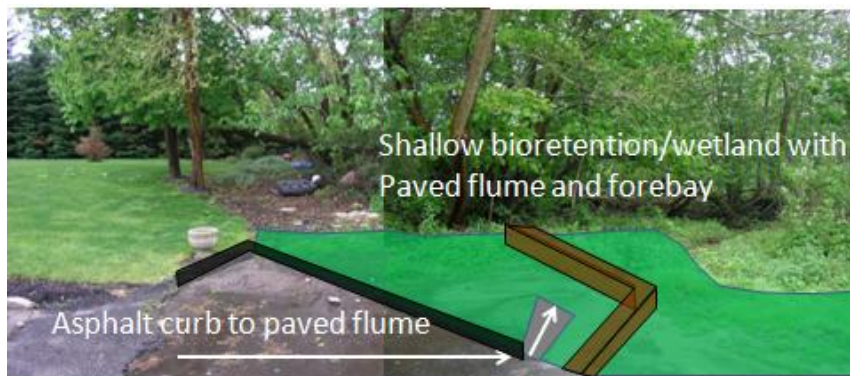
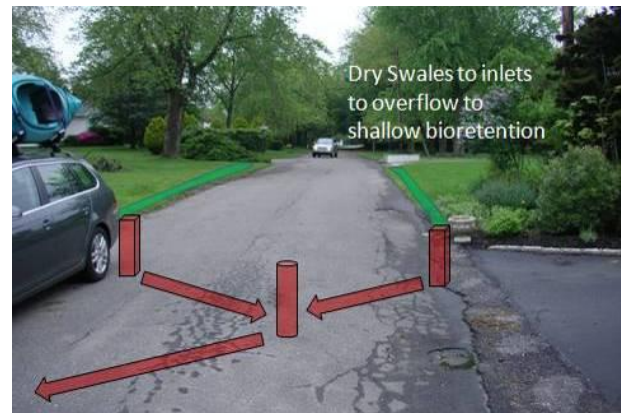
In the northwestern corner of the Goose Creek subwatershed, drainage along Clearview Avenue and Gardiners Lane flows toward the end of Gardiners Lane and discharges directly into an adjacent isolated wetland area as well as an irrigation pond. Upgradient leaching catchbasins were observed to be overwhelmed during a higher intensity storm event that occurred during HW's field investigations. Proposed BMPs for this location would include construction of a shallow **bioretention area/constructed wetland** immediately adjacent to the existing wetland at the end of Gardiners Lane. Site feasibility is dictated by the amount of physical space available for this practice and depth to groundwater.

Figure 4.5. Sedimentation (top left) and stormwater flow during a high intensity storm event (top right) at the end of Gardiners Lane. Proposed pave flume and forebay directed to a shallow bioretention area/constructed wetland at the end of Gardiners Lane. Additional proposed measures include construction of dry swales along Gardiners Lane that would be directed to inlets and leaching chambers within the roadway (right).

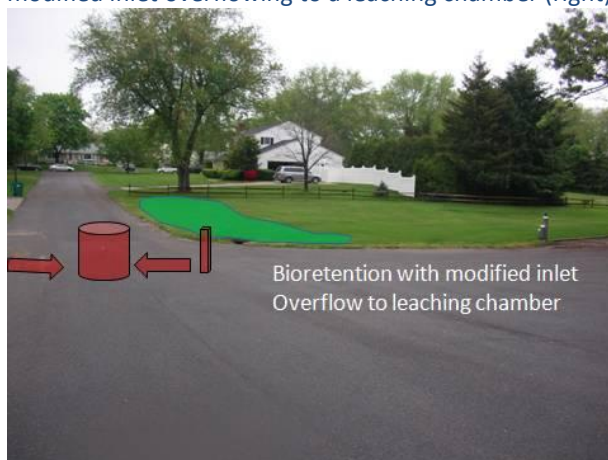
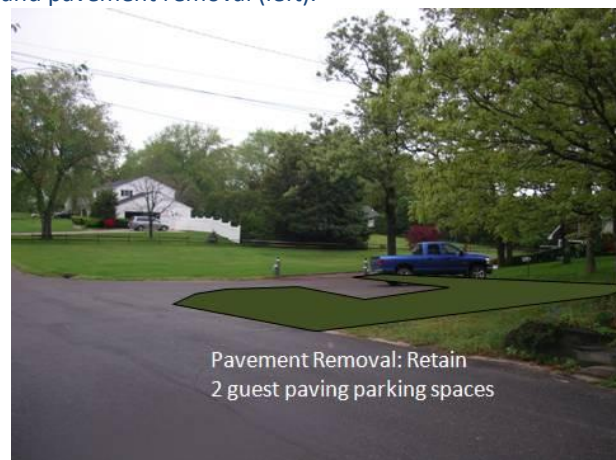
Willow Pond Lane is a 36-foot wide roadway with a wide right-of-way that also encompasses an additional section of pavement that appears to have been a former cul-de-sac, and which is now utilized by the adjacent property owner. Also within the right-of-way at the low point of the road is a large expanse of manicured lawn that extends into the adjacent residential property. The proposed retrofit at this site includes a **reduction of impervious surface** (retaining two guest parking spaces) and revegetation, as well as construction of a **bioretention area** with a modified inlet that would overflow into a **leaching chamber**. The Town may consider reducing the road width in this area to reduce runoff and save the Town money on future road repaving and other maintenance tasks.

Figure 4.6. Willow Pond Lane. Proposed BMPs would involve the construction of a bioretention area with a modified inlet overflowing to a leaching chamber (right) and pavement removal (left).

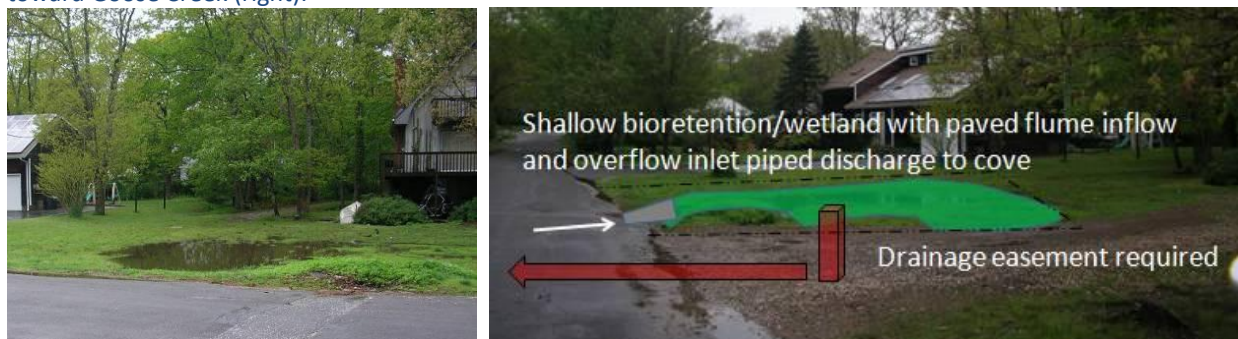
The Goose Neck Estates neighborhood is located north of Main Bayview Road just northeast of the intersection with Corey Creek Lane. Clogged catchbasins along Smith Road South across from the Goose Creek inlet have resulted in ponded drainage in front of house #405. Here, the property owner has excavated a small channel within the ponded area to direct waters to the existing catchbasins. Additional leaching chambers have been added along this road since the field investigations were performed, which likely have reduced some of the ponding issues at the site. To handle remaining pond issues and any bypass of the upgradient leaching chambers, a **shallow bioretention area or constructed wetland** could be constructed in front of #405 with an overflow inlet pipe discharging to the cove. Implementation of this stormwater BMP would require an easement from the property owner.

Figure 4.7. Ponding at #405 Smith Road South (left). Proposed shallow bioretention area with overflow inlet toward Goose Creek (right).

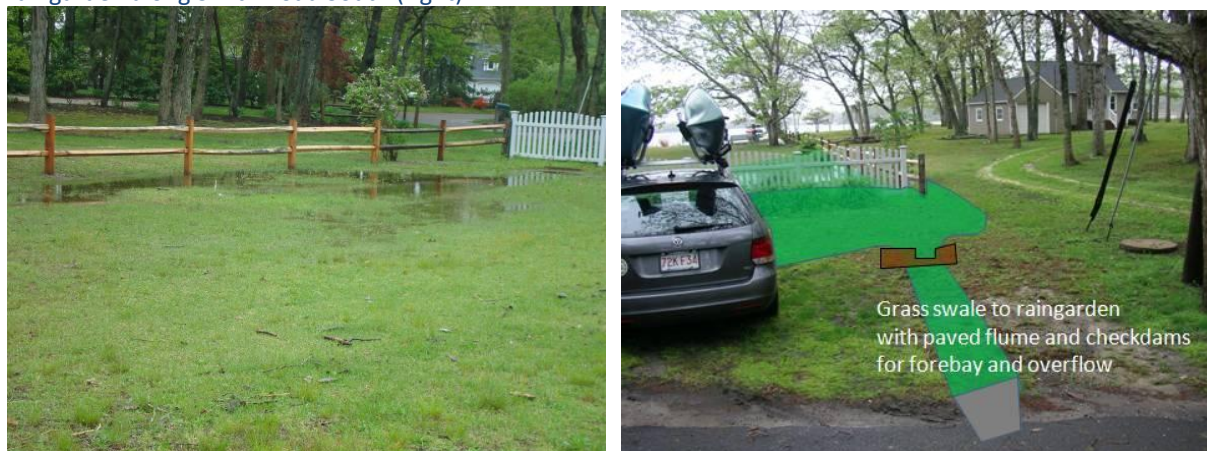
Figure 4.8. Ponding at common area (private beach) within Goose Neck Estates (left). Proposed grass swale and raingarden along Smith Road South (right).

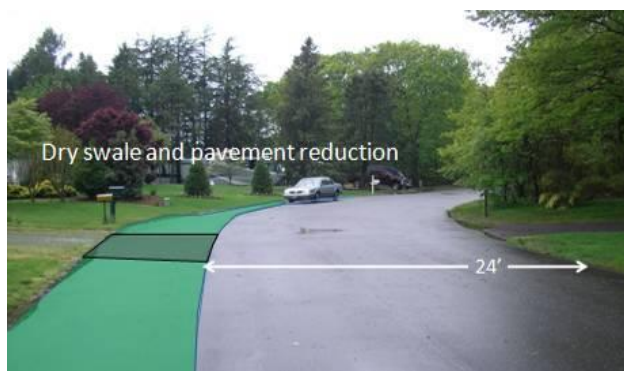
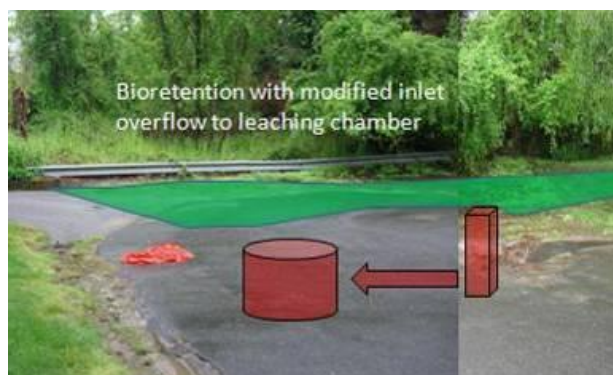
Grissom Lane is located approximately in the center of the Goose Creek subwatershed. Currently, excessive pavement along the roadway contributes to stormwater runoff, which is directed to catchbasins at the Grissom Lane cul-de-sac immediately adjacent and upgradient of a Town-owned right-of-way. Proposed retrofit opportunities include **reduction of pavement** from the existing 32-foot wide roadway and construction of a **dry swale**, as well as construction of a **bioretention area** at the end of the cul-de-sac with a modified inlet overflow to a leaching chamber.

Figure 4.9. Proposed pavement reduction along Grissom Lane, replacing the impervious surface with a dry swale (top) and construction of a bioretention area at the cul-de-sac (bottom).

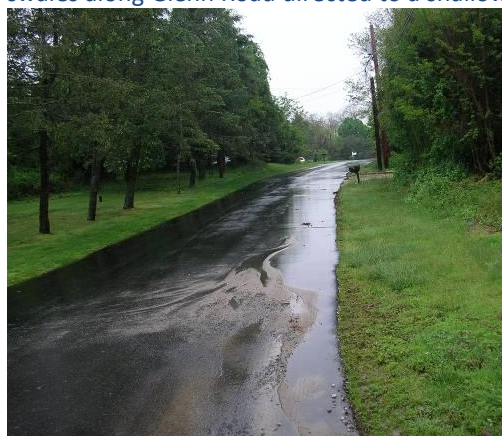
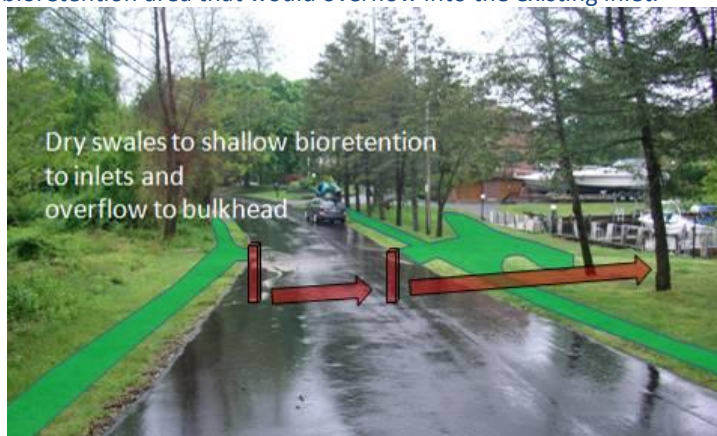
Figure 4.10. Sedimentation along Glenn Road (left). Proposed retrofit (right) would involve construction of dry swales along Glenn Road directed to a shallow bioretention area that would overflow into the existing inlet.

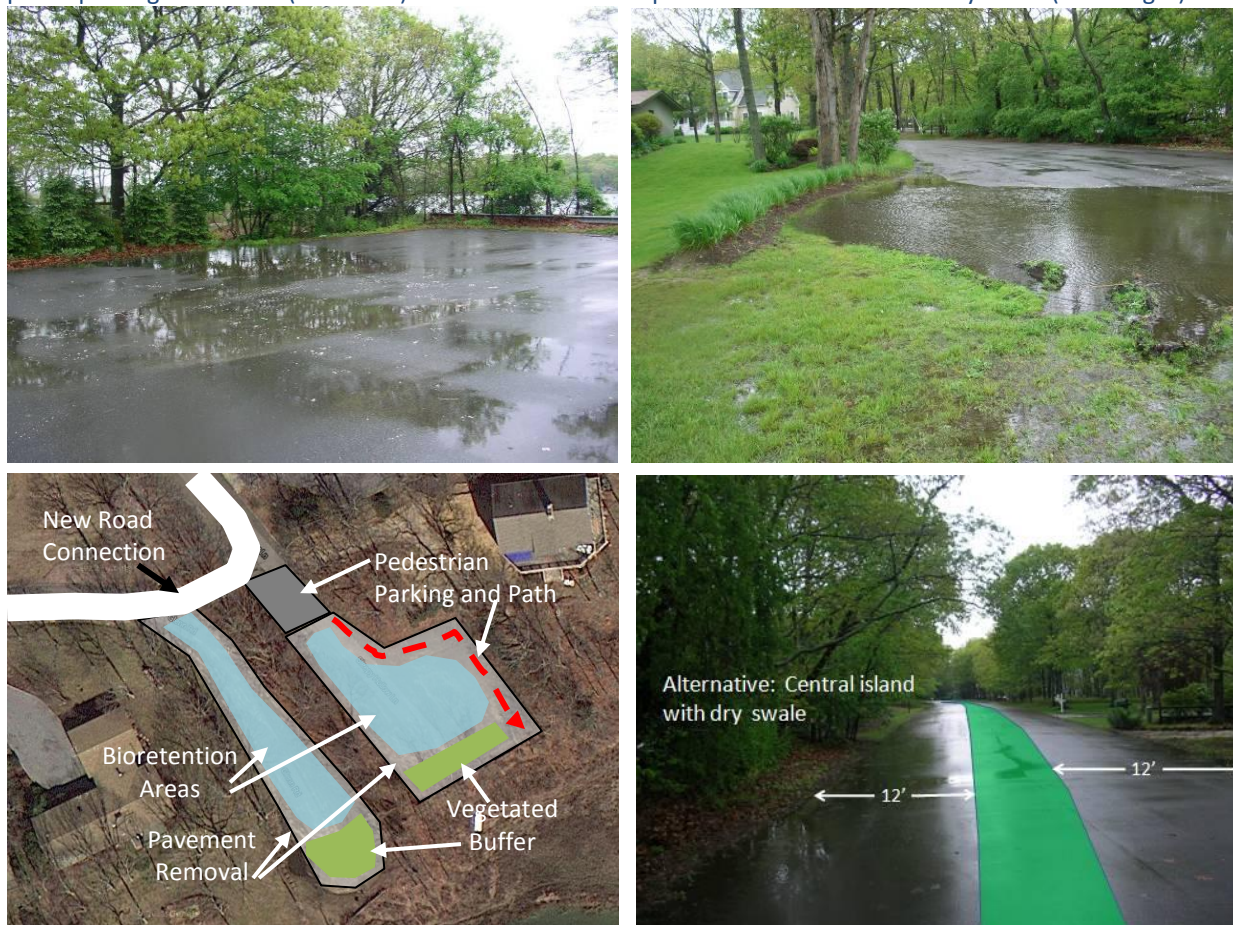
the salt marsh area along Goose Creek, and is parallel to the cul-de-sac for Glenn Road; the two cul-de-sacs are separated by a narrow wooded area. Water currently ponds at the end of Sleepy Hollow Lane, and evidence of overland flow and minor scouring were observed. Water also ponds along the southwestern corner of the Glenn Road cul-de-sac. A small landscaped berm presumably built by the adjacent homeowner does not allow for natural runoff and infiltration away from the paved surface.

Figure 4.11. Ponding at the end of Sleepy Hollow Lane (upper left) and at the end of Glenn Road (upper right). Proposed concept includes connecting the roads, pavement removal, construction of bioretention areas, and public parking and access (lower left). The additional concept for a central island with dry swale (lower right).

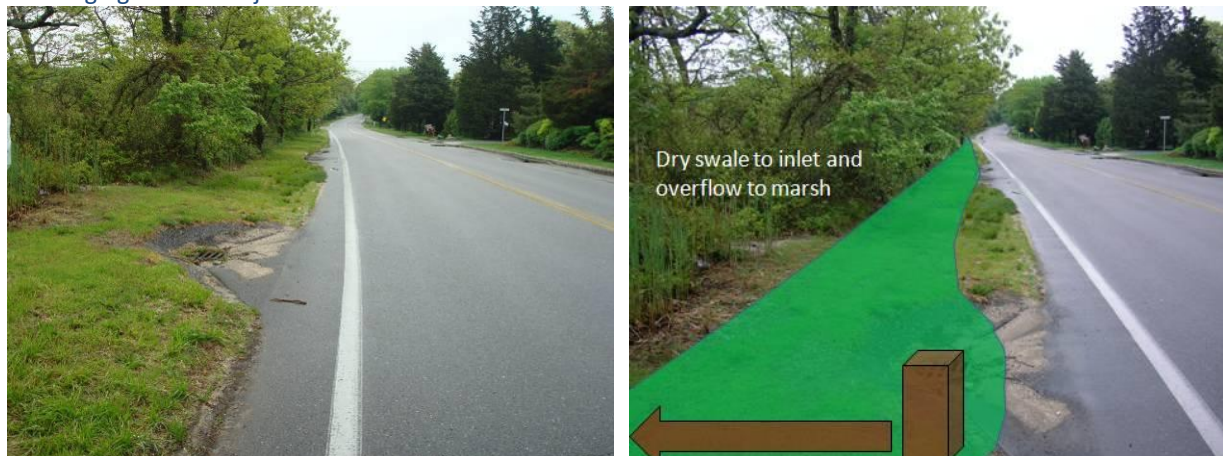
Figure 4.12. Proposed dry swale along Main Bayview Road will allow for improved water quality of stormwater discharging into the adjacent salt marsh.

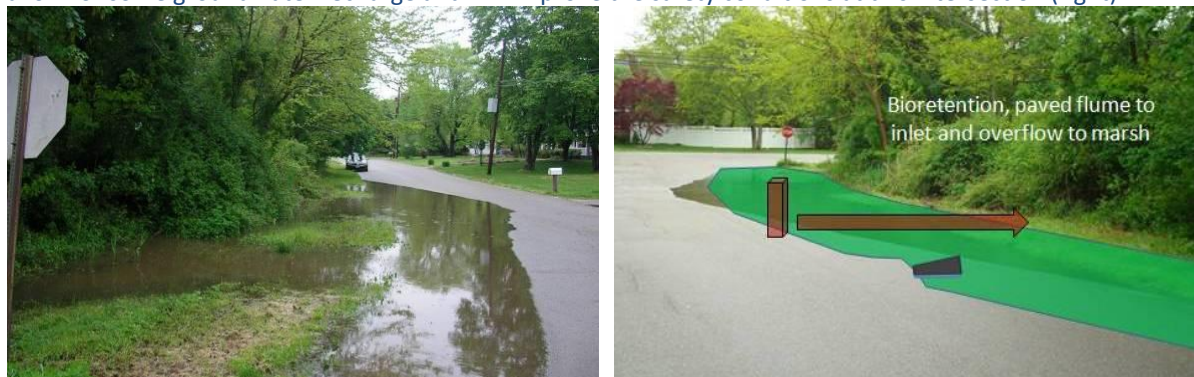
Figure 4.13. Ponding at the corner of Waterview Drive and Main Bayview Road (left). The proposed retrofit will allow for some groundwater recharge and will improve the safety conditions at this intersection (right).

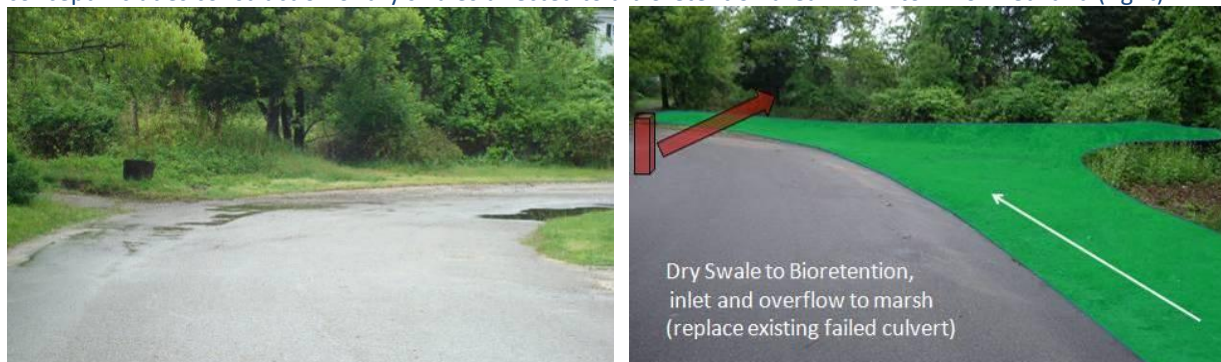
Figure 4.14. Ponding and sedimentation observed at bend in Waterview Drive (left). Proposed stormwater retrofit concept includes construction of dry swales directed to a bioretention area within town-owned land (right).

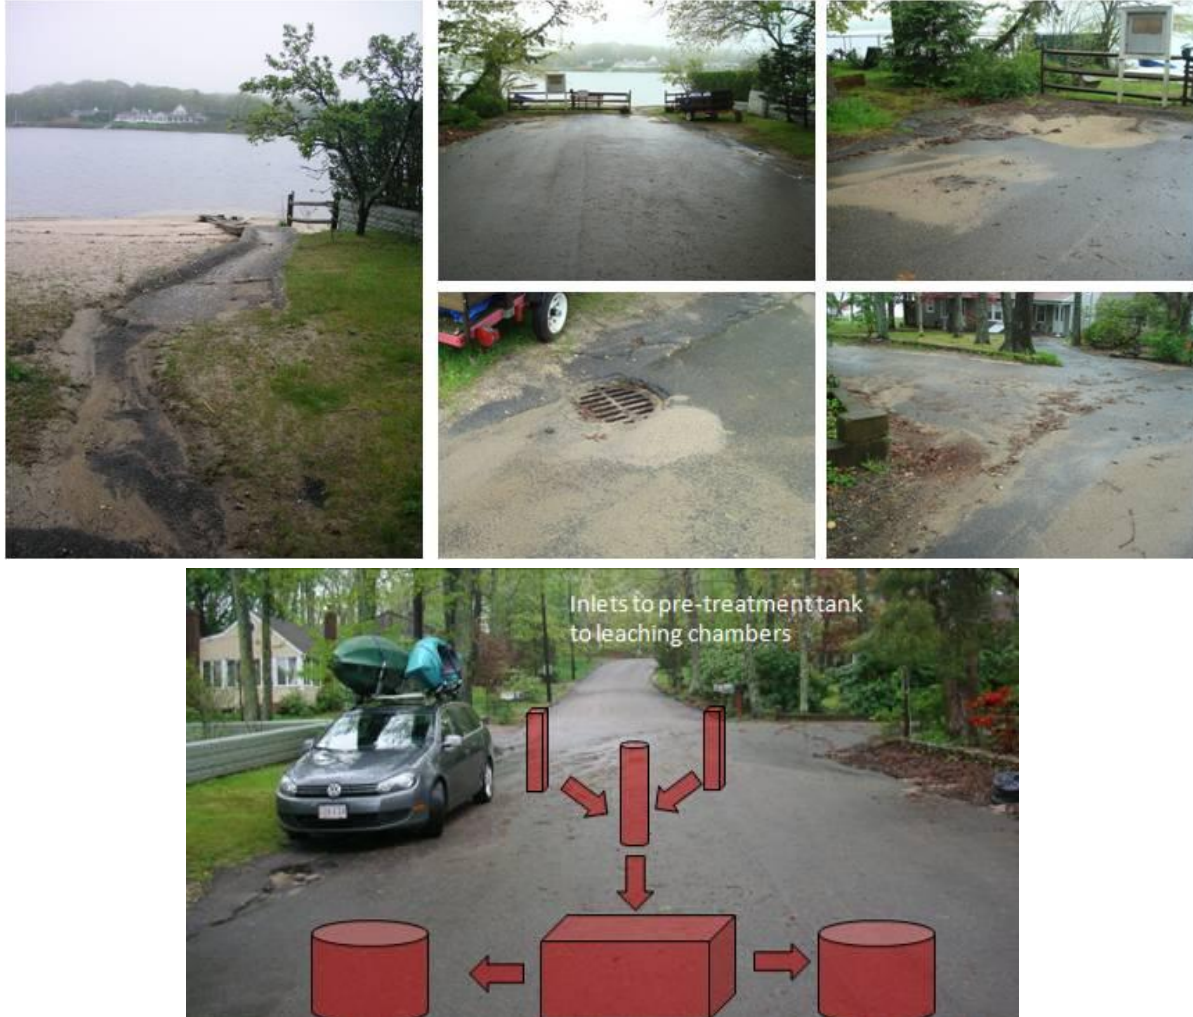
Figure 4.15. Existing conditions along Cedar Avenue where extensive sedimentation has resulted in direct discharge of stormwater into Goose Creek during higher intensity storms (top photos). Proposed retrofit concept would involve more traditional structural measures to accommodate the steep slopes and relatively narrow right-of-way along Cedar Avenue (bottom).

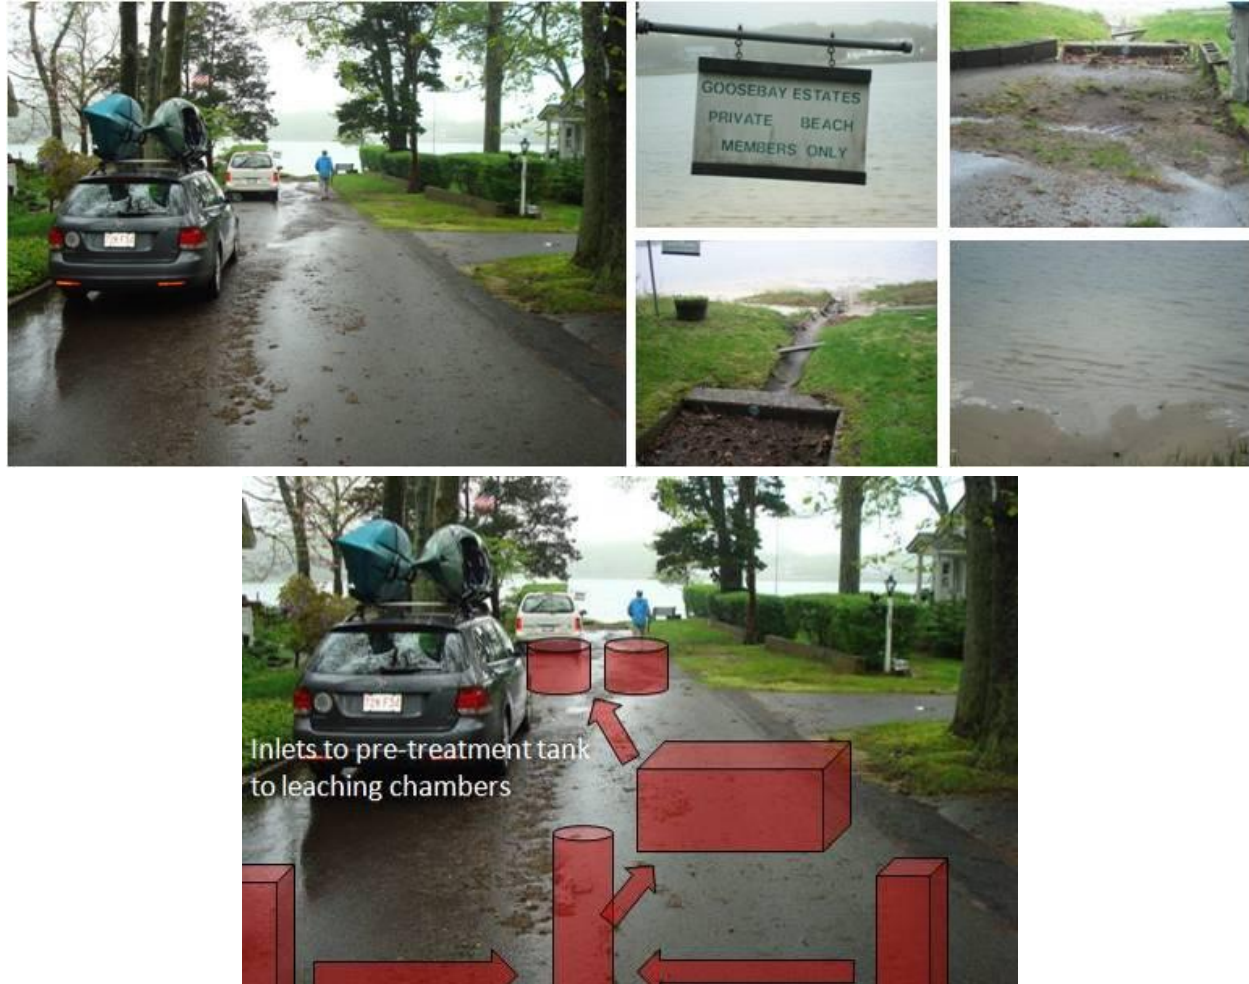
Figure 4.16. Existing conditions at the end of Pine Avenue where stormwater runoff results in an accumulation of sediments that have created a delta within Goose Creek at a private beach (top photos). Proposed stormwater retrofit concept would involve traditional structural measures to address the steep slopes and relatively narrow roadway right-of-way along Pine Avenue (bottom).

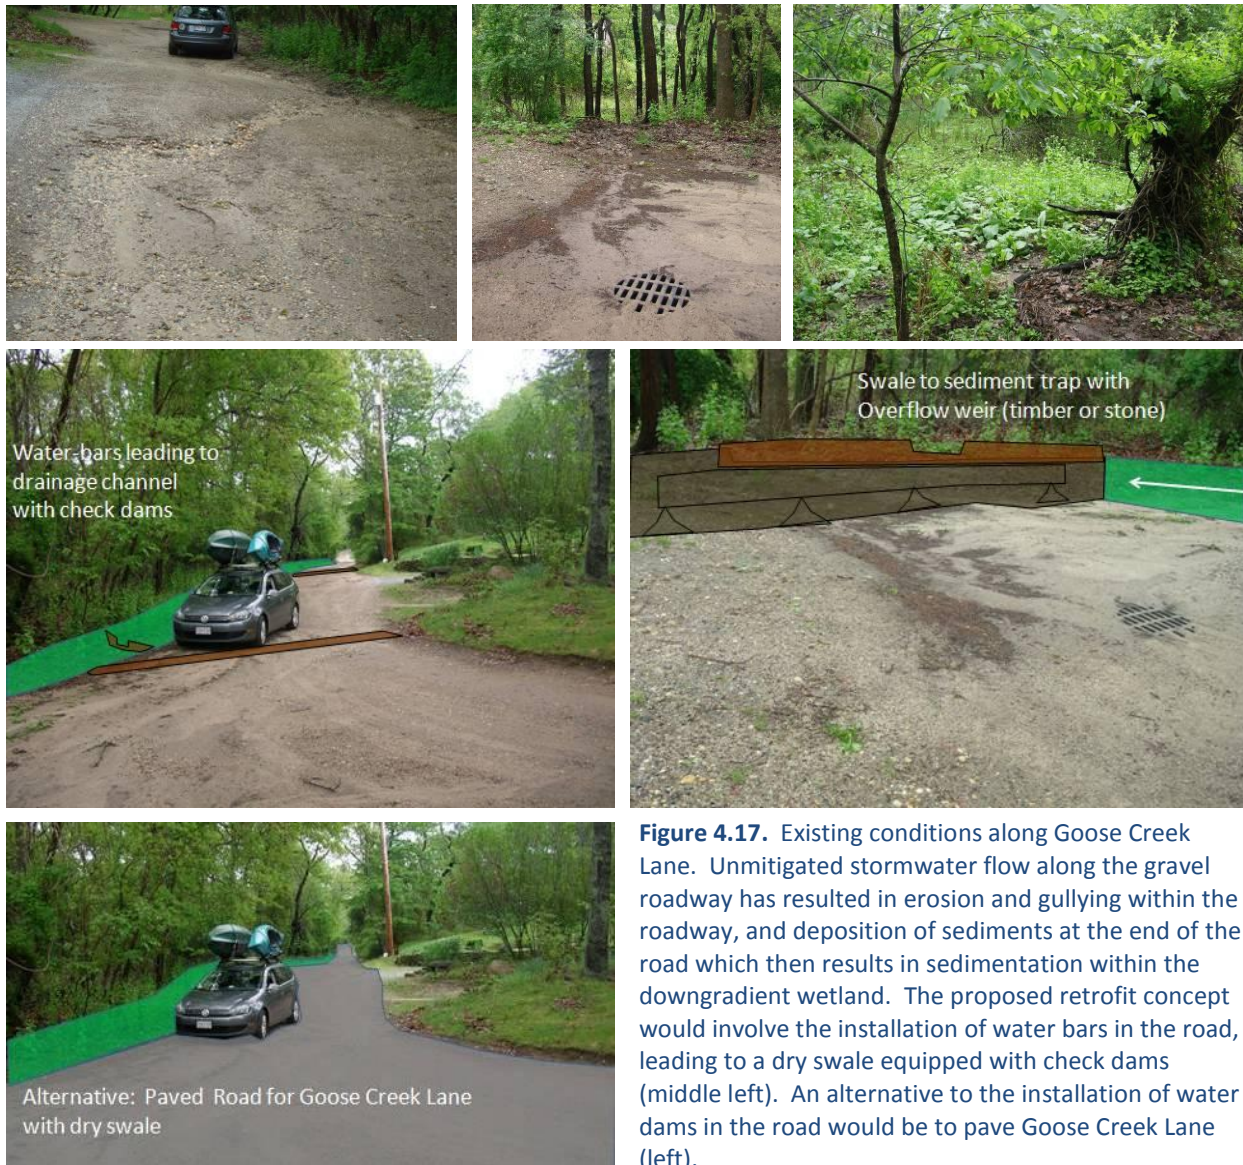
Goose Creek Lane is an unimproved private roadway located in the extreme southeastern portion of the subwatershed. Runoff from the gravel roadways results in erosion, gully, and sediment deposition within roadway. The existing catchbasin at the base of the road is clogged and is frequently overwhelmed, which then results in erosion and sedimentation within the downgradient wetland area. The proposed retrofit concept would involve the installation of **water bars** at intervals along the roadway to direct runoff to a **dry swale with check dams**, designed to slow stormwater velocities. Downgradient of the dry swale, a sediment forebay equipped with an overflow weir would be installed to allow for settling prior to discharge into the downgradient wetland. These BMPs would allow for improved sediment trapping efficiency. Alternatively, the gravel driveway could be permanently stabilized, directing stormwater toward a dry swale leading to a sediment forebay. Because this is a private road, easements would need to be obtained.

Figure 4.17. Existing conditions along Goose Creek Lane. Unmitigated stormwater flow along the gravel roadway has resulted in erosion and gully within the roadway, and deposition of sediments at the end of the road which then results in sedimentation within the downgradient wetland. The proposed retrofit concept would involve the installation of water bars in the road, leading to a dry swale equipped with check dams (middle left). An alternative to the installation of water dams in the road would be to pave Goose Creek Lane (left).

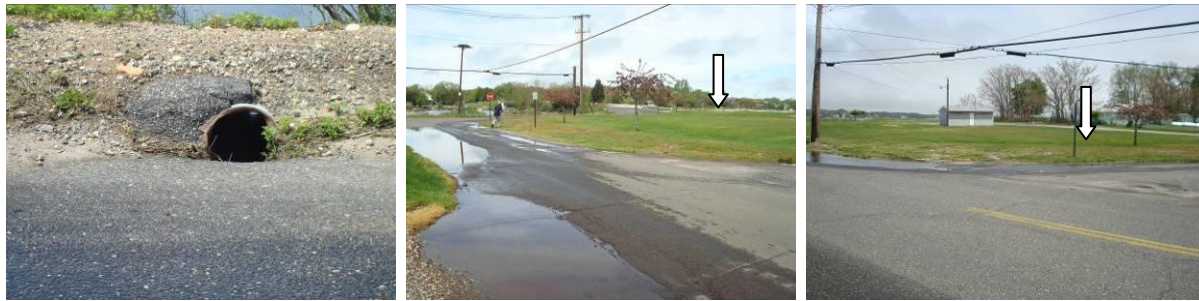
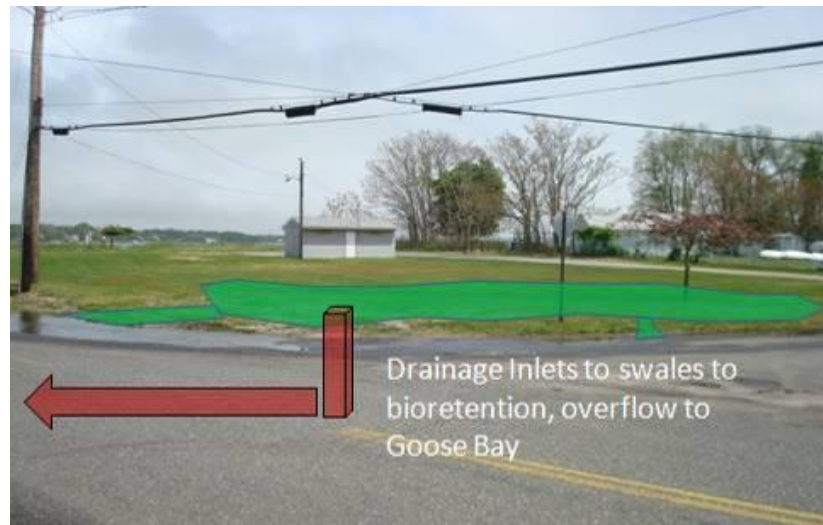
The outfall at North Bayview Road near the public park is located at the extreme northeastern corner of the subwatershed. Here, stormwater discharges directly into Goose Creek at the mouth of the outlet to Peconic Bay, in close proximity to a public beach. An existing grass depression in the adjacent park currently receives some runoff from adjacent impervious surfaces, but stormwater still ponds in the roadway. The proposed retrofit concept for this location would involve enlarging the existing depression within the park to create a **bioretention area** and installation of drainage inlets and swales to convey stormwater to the bioretention area. The bioretention area would then overflow to Goose Creek. Implementation of the proposed BMPs would allow for increased flood storage and improved water quality treatment and groundwater recharge. As this is a public park, there may also be opportunities for public education. Potential design constraints for this site include the specific location of the existing septic system for the bathhouse, which may take up a large portion of the open space here, and the presence of overhead utilities which may pose constraints during construction.

Figure 4.18. Existing conditions along North Bayview Road at the mouth of Goose Creek (top photos). An existing depression within the nearby public park presents an opportunity to repurpose the depression as a bioretention area to improve storage, groundwater recharge, and water quality within the subwatershed (right).

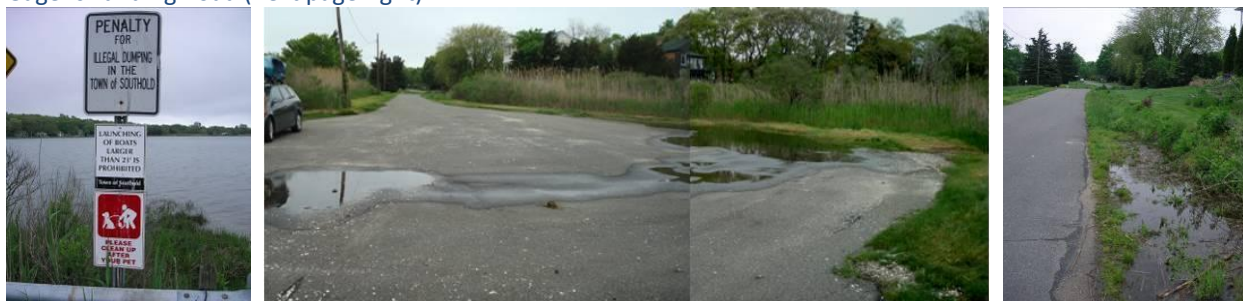
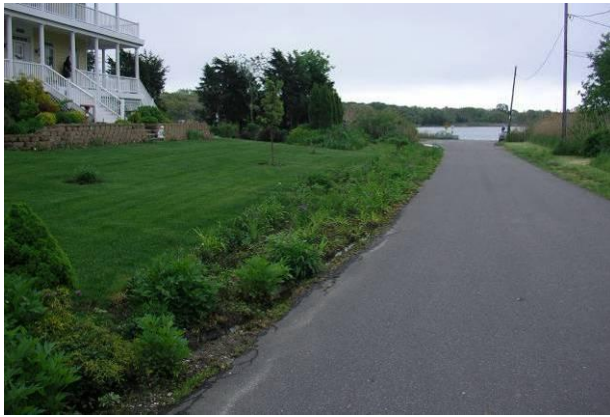
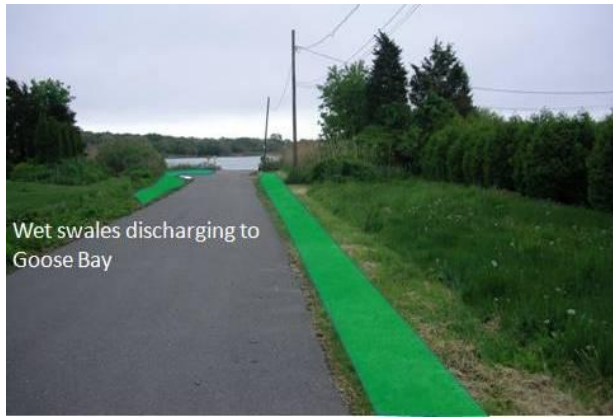
The end of Gagens Landing Road ends in a large cul-de-sac with a public boat ramp in the north-central portion of the subwatershed. Surrounding vegetated areas that are not naturally occurring wetlands are subject to flooding during storm events. While not observed during the field investigation, the Town has stated that a retrofit has been installed at this site by excavating the road shoulders to a depth of three feet and backfilling with gravel, covered with sand, but that it currently needs maintenance. The field team did observe the linear wet swale “garden” created by the property owner at 2520 Clearview Ave at the edge of the property. The recommended retrofit upgrades to improve water quality in this area would be to extend this **wet swale** along both sides of the roadway, allowing for some pretreatment of stormwater prior to discharging into Goose Creek.

Figure 4.19. Ponding and sedimentation along Gagens Landing Road near public boat ramp (below center). The existing “wet swale” garden created by the adjacent property owner (next page left) suggests an easily implemented stormwater retrofit by extending this wet swale practice along both sides of the lower reaches of Gagens Landing Road (next page right).

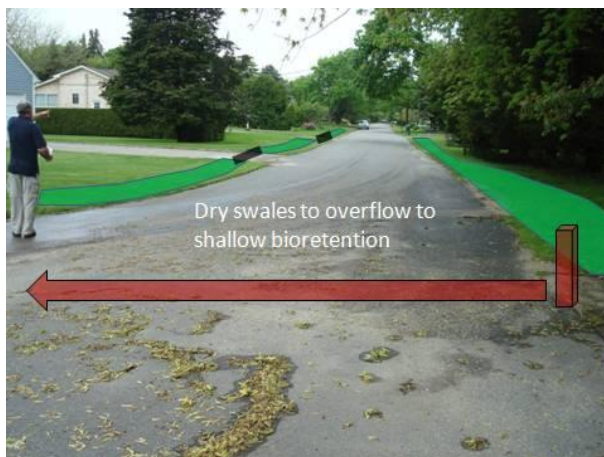
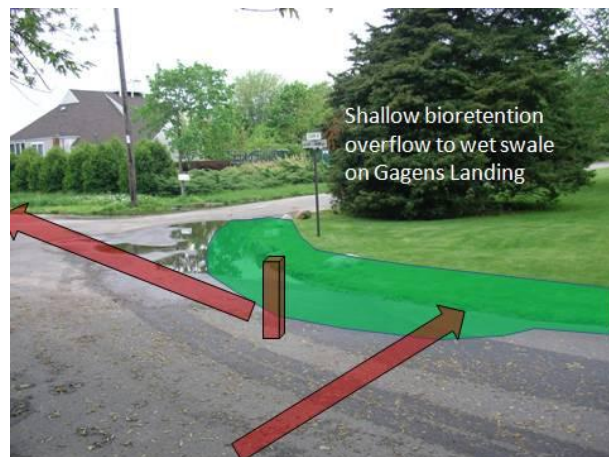
Just upgradient of the Gagens Landing Road at the intersection with Clearview Avenue, stormwater ponds within the roadway. No existing stormwater infrastructure was observed in this location. The proposed retrofit concept would include installation of **dry swales** along both the eastern and western sides of the roadway, with culverts beneath existing driveways. An overflow structure would convey stormwater to a **bioretention area**, which would then overflow to the proposed retrofit **wet swales** described above (see GC-R19). Construction of the bioretention area may require an easement from the property owner at the northwest corner of this intersection, and a traffic calming “bump out” into the roadway. The proposed practices would allow for some temporary storage and water quality improvements.

Figure 4.20. Sedimentation and ponding at the intersection with Gagens Landing Road and Clearview Avenue. Proposed stormwater retrofit would involve the installation of dry swales directed to a shallow bioretention area to allow for temporary storage and water quality treatment.

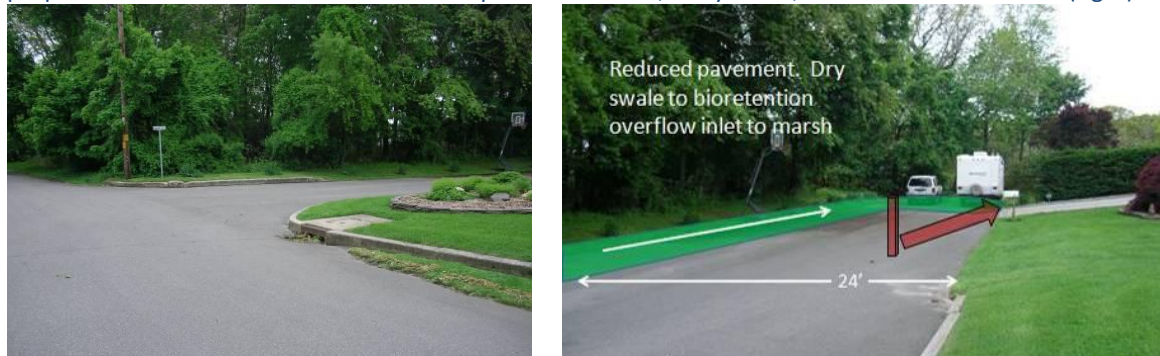
Landing Path is a short roadway “spur” located two streets west of Gagens Landing Road within the same north-centrally located neighborhood (“Southwood”) within the subwatershed. Similar to other dead end roadways or cul-de-sacs observed within the Goose Creek subwatershed, the existing road is wider than necessary for the residential neighborhood. Stormwater flows along this section of the road have resulted in an accumulation of sediment and debris within the roadway and in the adjacent lawn area (Figure 4.21, top left). In addition, it is located immediately adjacent to a nature sanctuary owned

Figure 4.21. Existing conditions along Landing Path, which is located just west of a nature sanctuary (left). The proposed retrofit includes a reduction of impervious surface, a dry swale, and a bioretention area (right).

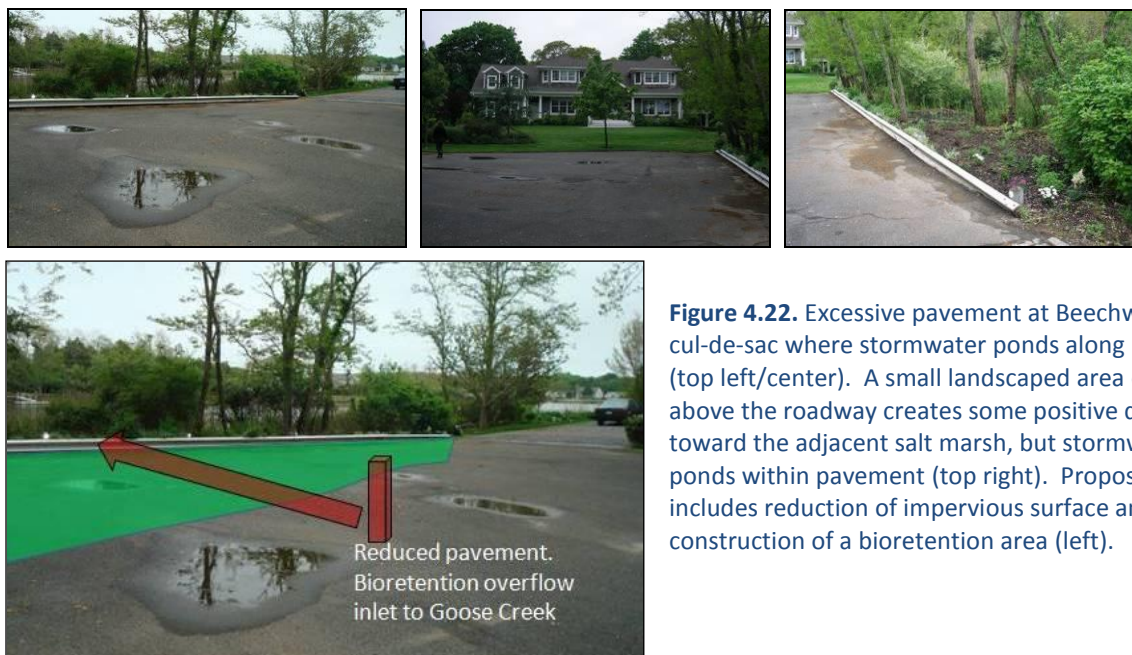
The Beechwood cul-de-sac, as with several others observed within Goose Creek, has more pavement than necessary. An adjacent homeowner has planted an area at the end of the cul-de-sac such that it is elevated above roadway to create positive drainage toward salt marsh; however, stormwater ponds within the roadway prior to reaching that area. The proposed concept for this site would be to **remove excessive pavement** and construct a **bioretention area** equipped with an overflow inlet to Goose Creek. This proposed practice would allow for water quality treatment and increased groundwater recharge, and would also increase vegetative buffering to the salt marsh.

Figure 4.22. Excessive pavement at Beechwood Lane cul-de-sac where stormwater ponds along pavement (top left/center). A small landscaped area elevated above the roadway creates some positive drainage toward the adjacent salt marsh, but stormwater still ponds within pavement (top right). Proposed retrofit includes reduction of impervious surface and construction of a bioretention area (left).

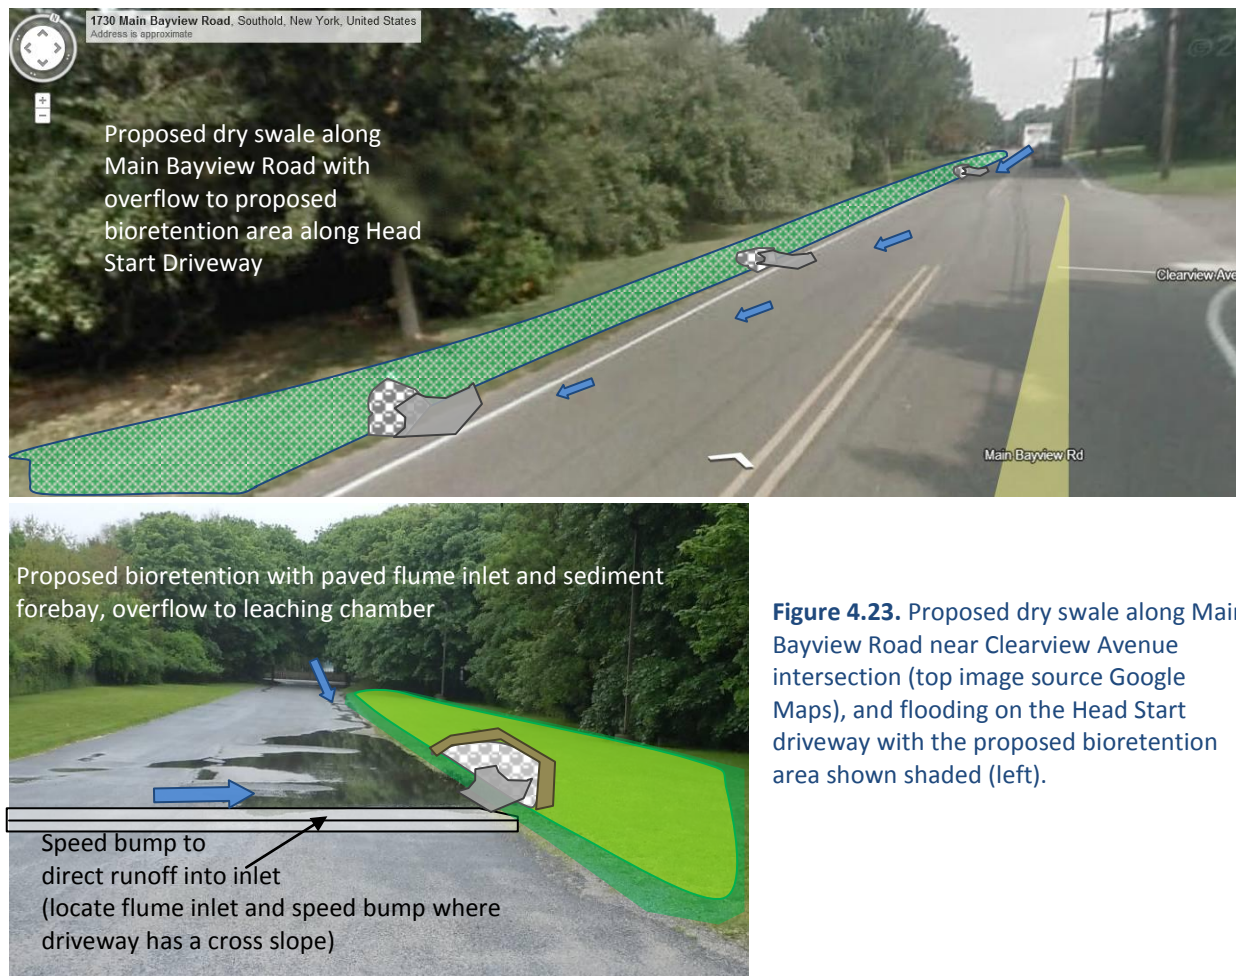
the parking area at leaching catchbasins. However, a portion of the driveway does not have stormwater infrastructure and ponding was observed. Much of the stormwater flowing on the driveway comes from Main Bayview Road, which does not have infrastructure in place along the west side of the road to capture runoff up gradient of the Head Start driveway. An area of open space in the right-of-way along the western side of Main Bayview Road is ideal for construction of a **dry swale** to provide water quality treatment of roadway runoff (GC-23A). Additionally, there is ample space along the south side of the Head Start driveway for a **bioretention area** (GC-23B) that could provide treatment for the driveway as well as the overflow from the proposed dry swale along Main Bayview Road. The combination of the dry swale along Main Bayview Road and the bioretention along the driveway will greatly improve water quality treatment, groundwater recharge, and alleviate existing flooding issues. The Town would need to work with Head Start and potentially obtain easements to treat some Town runoff from Main Bayview on Head Start property.

Figure 4.23. Proposed dry swale along Main Bayview Road near Clearview Avenue intersection (top image source Google Maps), and flooding on the Head Start driveway with the proposed bioretention area shown shaded (left).

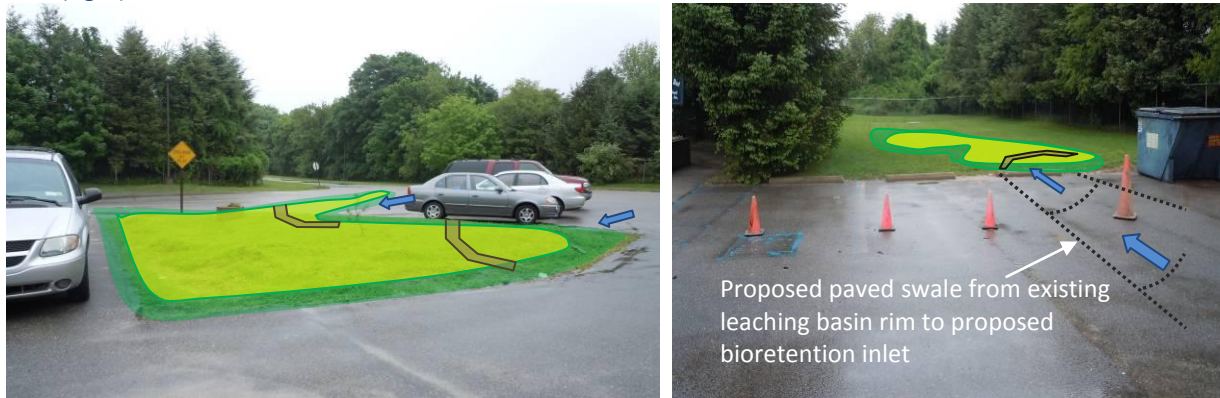
Two additional **bioretention areas** are proposed for treatment of runoff from the parking area. One (GC-23C) is proposed in an existing parking island located in the upper portion of the parking lot, and the second (GC-23D) is proposed in open space to the northwest of the parking area. In addition to installation of the second bioretention area, the existing leaching basins closest to the practice should be abandoned and the pavement between the abandoned basins and the bioretention inlet should be replaced with a shallow paved swale with sufficient pitch to drain runoff from the parking surface to the bioretention area. The bioretention areas will provide greater water quality treatment than that provided by the existing leaching catchbasins in addition to groundwater recharge.

Figure 4.24. Proposed bioretention area at upper parking area (left), and proposed bioretention area lower parking area (right).
