4.0 Goose Creek Subwatershed

4.1 Subwatershed Characteristics

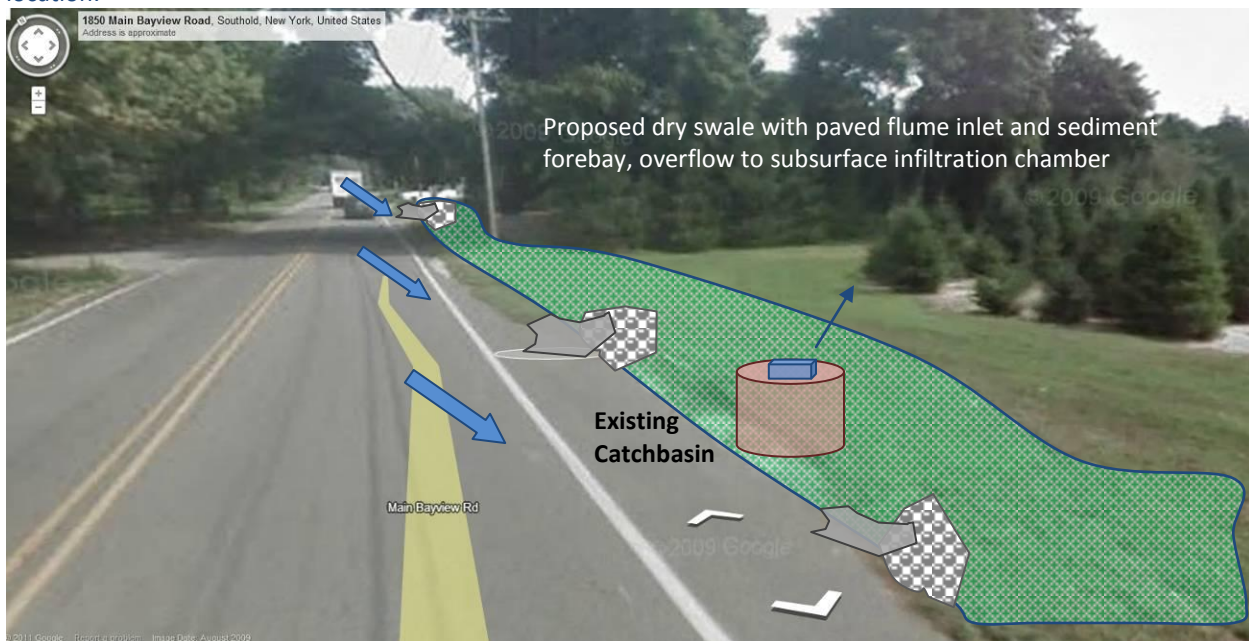
Figure 4.25. Proposed dry swale with paved flume inlet and sediment forebay with overflow to a subsurface infiltration chamber. The proposed retrofit concept would provide for improved water quality treatment in this location.

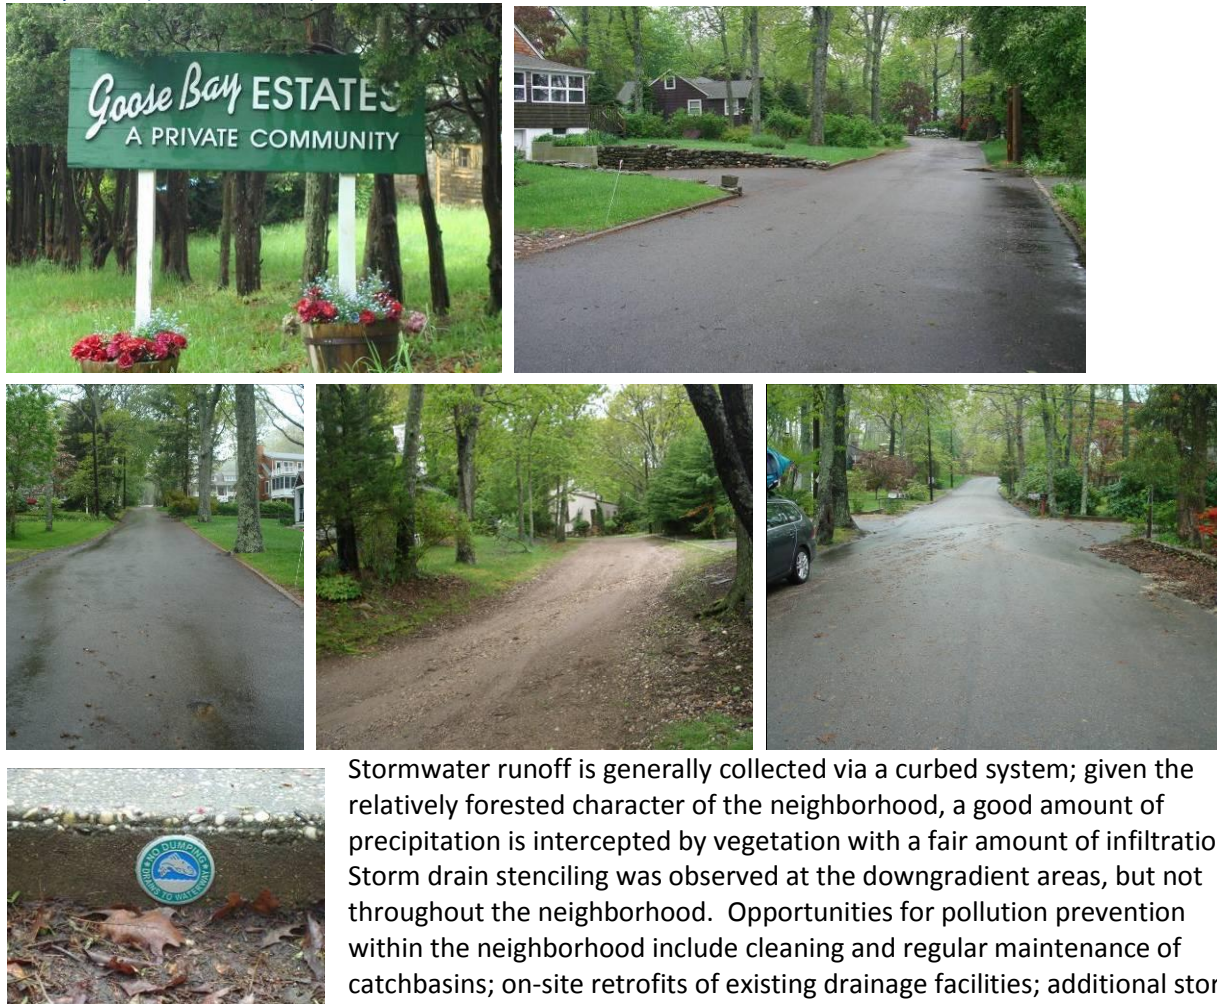
"Goose Bay Estates" is an older neighborhood located in the southeastern section of the subwatershed. Single-family detached dwellings estimated to be constructed between the 1920s and 1940s. Approximately 10% of the homes are newly remodeled or reconstructed. Paved roads within the neighborhood are generally in good condition with some cracked surfaces observed. One roadway, Goose Creek Lane, is unimproved. The overall size of the neighborhood is approximately 26 acres, of which approximately 60% of the neighborhood is forested. Lots range in size from $\frac{1}{8}$ to $\frac{1}{3}$ of an acre, with typical lot sizes being $\frac{1}{4}$ acre. Since lots are smaller, average impervious cover is approximately 40%, typically with low-maintenance lawn areas (40%) and 15% landscaped beds. Less than 10% of the lawns have permanent irrigation with higher management requirements. The neighborhood was clean at the time of observation without visible pet waste, trash, or illegal dumping.

Figure 4.26. Typical roadways within “Goose Bay Estates” (top). Most roads within the neighborhood are in good condition with some cracked pavement observed along roadway edges. One roadway, Goose Creek Lane, is unimproved (bottom center).

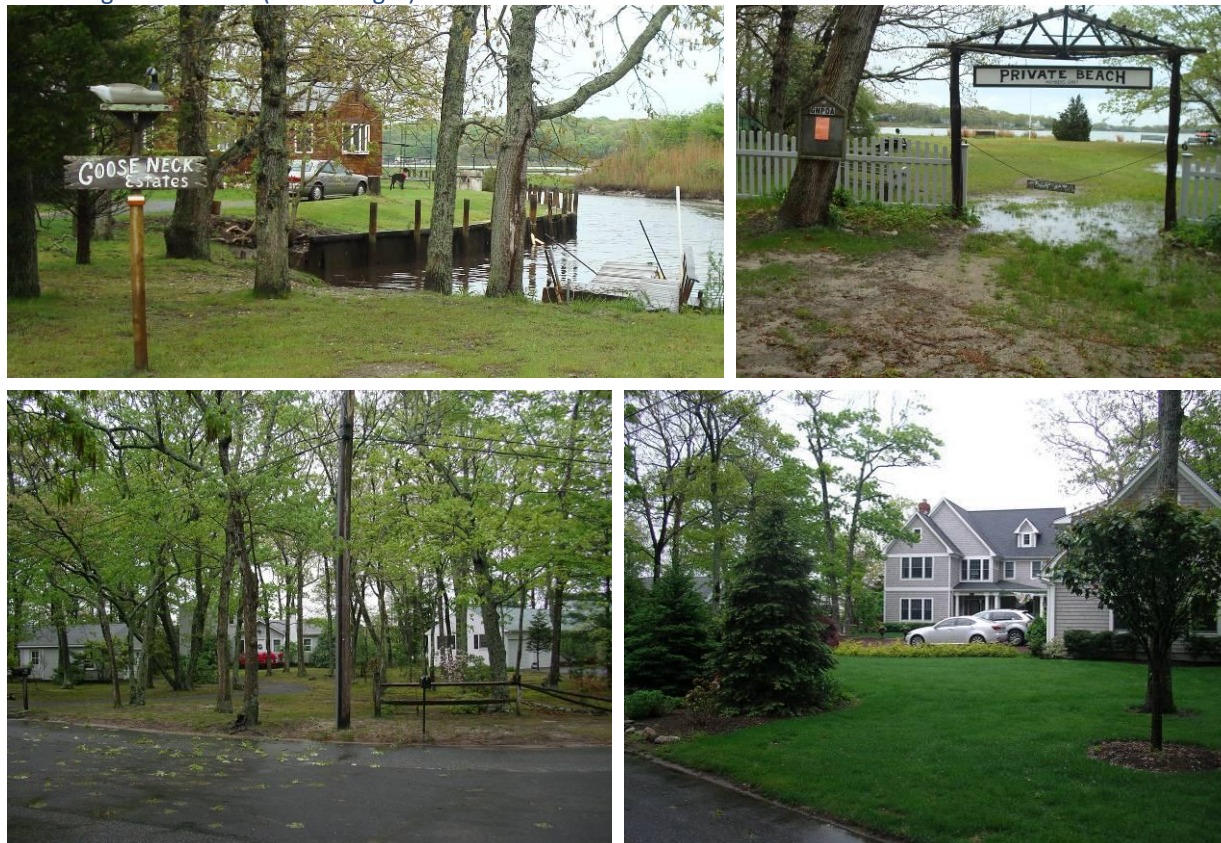
Figure 4.27. Common areas within “Goose Neck Estates” (top). Typical interior lot (bottom left) and typical lot bordering Goose Creek (bottom right).

The stormwater system consists primarily of individual leaching catchbasins. Many of the leaching catchbasins are clogged due to high accumulations of sediment and organic matter. As a result, runoff is bypassing upgradient basins in the neighborhood study area and entering catchbasins down gradient that directly discharge to the creek.

Opportunities for pollution prevention within the neighborhood include homeowner education on fertilizer use with emphasis on reduction or elimination. Many of the existing catchbasins would benefit greatly from more frequent cleaning and maintenance, while clogged leaching catchbasins should be replaced with systems that can trap sediments/organics and provide pretreatment prior to discharge. The homeowners association is encouraged to work with the Town to address storm drain maintenance and repair. On-lot retrofit practices to disconnect roof runoff (e.g., rain gardens, rain barrels) appear to be feasible on most lots, and retrofits of common spaces such as the private beach and marina also appear feasible (see Site GC-R8B). Providing plantings of native vegetation along the shoreline would increase vegetative buffering along the shoreline while also discouraging waterfowl from gathering in common areas, potentially reducing bacteria within stormwater runoff.

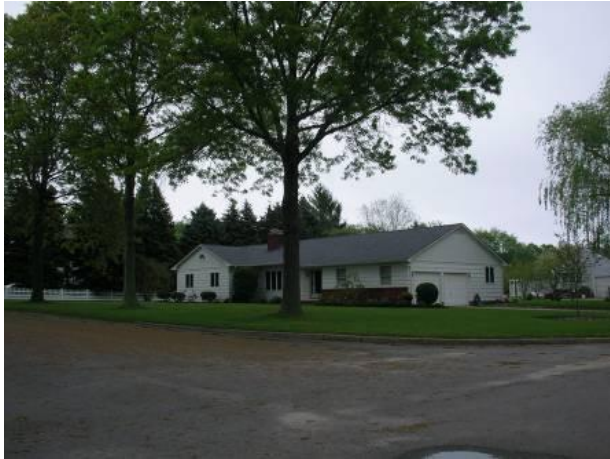
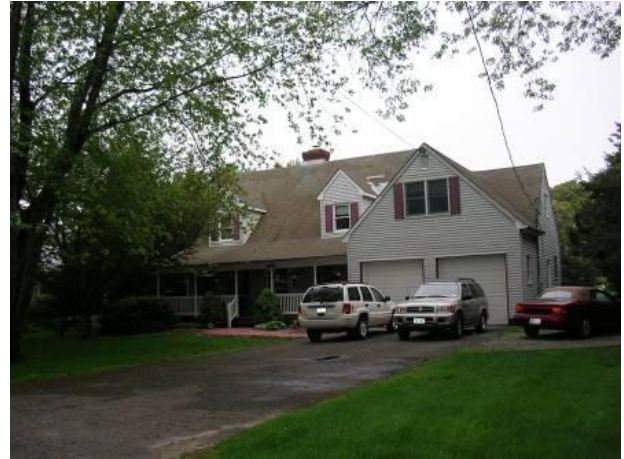
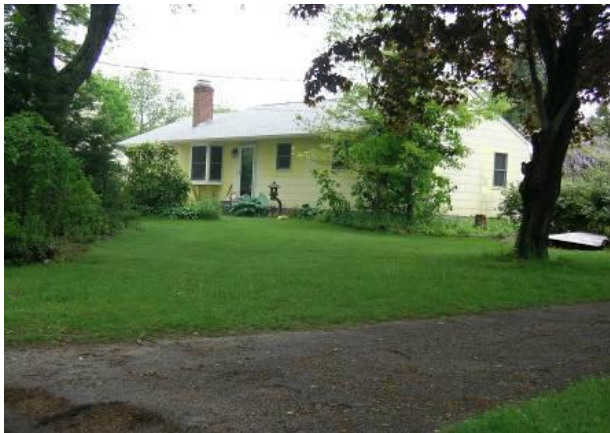
Figure 4.28. Typical lots within the Gagens Landing Road/Oak Lawn Avenue Extension neighborhood.

The stormwater management system in this neighborhood consists of leaching catchbasins. Many of the leaching catchbasins are clogged due to accumulations of sediment and organic matter. As a result, runoff either ponds on the roads or in some places, bypasses the clogged basins and directly discharges to the creek. Opportunities for pollution prevention include street sweeping and increased maintenance and repair of the existing leaching catchbasins. Storm drains that directly discharge to the creek should be stenciled to identify this direct connection. Moderate feasibility exists for on-site retrofit practices to disconnect downspouts.
