Accabonac Harbor Subwatershed Management Plan

June 2013

Horsley Witten Group, Inc. 90 Route 6A, Sandwich, MA 02563 508.833.6600 www.horsleywitten.com

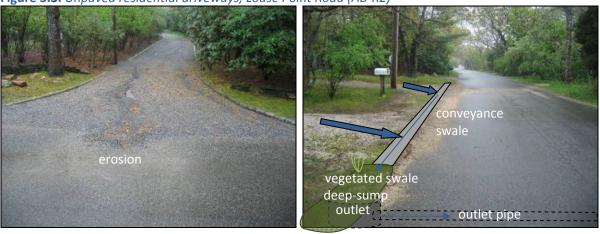
Figure 3.3. Unpaved residential driveways, Louse Point Road (AB-R2)

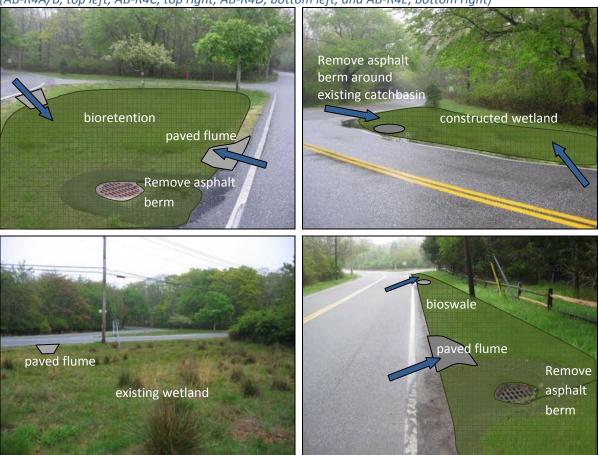
Several treatment practices are proposed at this location. The most feasible and practicable retrofit (retrofit A) is a **traffic island bioretention** retrofit at the intersections of Old Stone Hwy and Neck Path. There is currently an existing depression that temporarily collects some road runoff, and a drain inlet that manages another portion of road runoff. An engineered soil mix could replace the existing soil in the depression to enhance pollutant removals at this location. The existing drain inlet could serve as the overflow structure for this system if the asphalt berm that surrounds it is removed.

Figure 3.6. Proposed retrofits for the sites at the Junction of Old Stone Hwy, Accabonac Rd & Neck Path (AB-R4A/B, top left; AB-R4C, top right; AB-R4D, bottom left, and AB-R4E, bottom right)

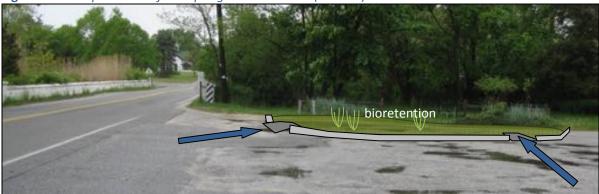
Figure 3.14. Proposed retrofit at Springs General Store (AB-R8D)

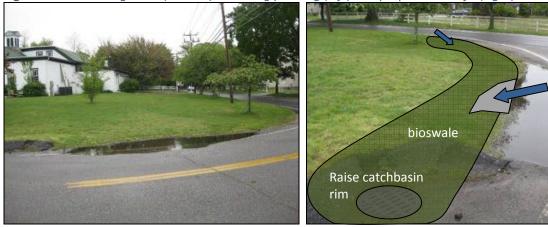
Runoff from the western end of Old Stone Hwy and a portion of Fireplace Road is currently captured in a leaching catchbasin structure near the Ashawagh Hall property. A **bioswale system** is proposed that could be installed in the ROW along Fireplace Road. The rim of the existing leaching structure could be raised and converted to an overflow for the bioswale system. The Ashawagh Hall would be a good location for educational signage explaining any nearby retrofit systems.

Figure 3.15. Ashawagh Hall (AB-R8E) – Existing ponding (left) and proposed retrofit (right)

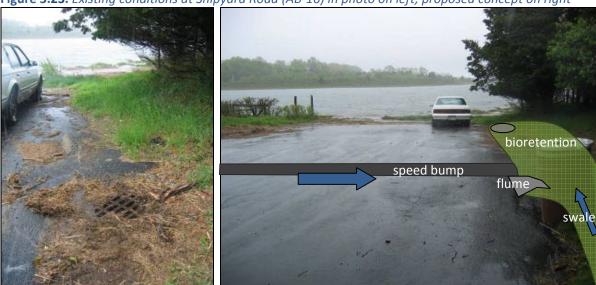
Shipyard Road drains to a boat ramp at the northern end of the street. There is an existing catchbasin on the southeast side of the road near the boat ramp that manages a portion of the road runoff. The remainder bypasses the structure and discharges directly into Accabonac Harbor. A speed bump could be installed near the boat ramp to direct runoff to the southeast side of the road and into a proposed **bioretention area**. The roadway and shoulder are wide enough to provide ample space for construction with some **pavement removal**. A **vegetated swale** along the southeastern side of Shipyard Lane may also be necessary to direct runoff to the treatment area.

Figure 3.23. Existing conditions at Shipyard Road (AB-16) in photo on left; proposed concept on right

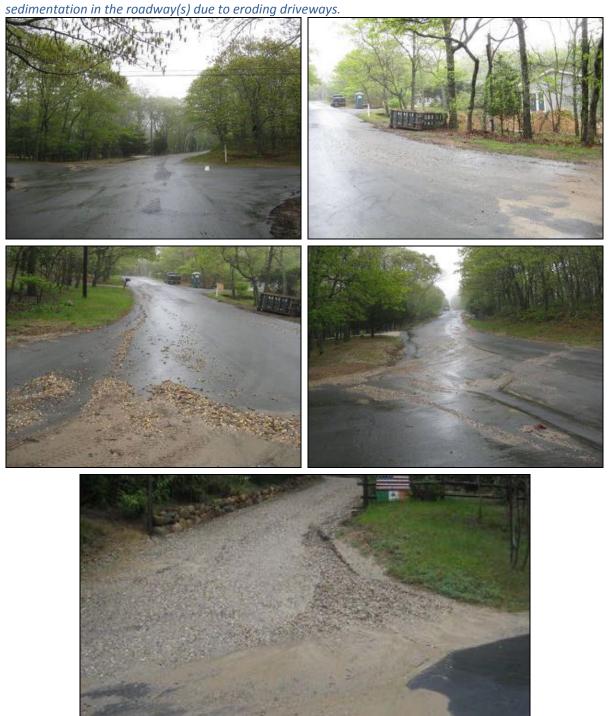
Pollution prevention within the neighborhood should include better maintenance of the leaf litter on the road via street cleaning. A reduction in pavement along the roads and at intersections would decrease impervious surface and make room for swales and bioretention areas that could help treat stormwater runoff. Examples of applicable retrofit sites in the neighborhood include AB-R15A, AB-R15B, and AB-R15C. Additionally, raingardens could be constructed in yards to help collect stormwater from downspouts and increase infiltration. Covering stockpiled materials during remodeling or landscaping projects would help reduce sediment and trash accumulation. Sediment traps at the end of unpaved driveways will also help reduce erosion. No obvious septic system issues were observed.

Figure 3.29. Typical roadways and lots within the Barnes Landing Neighborhood. Notice the

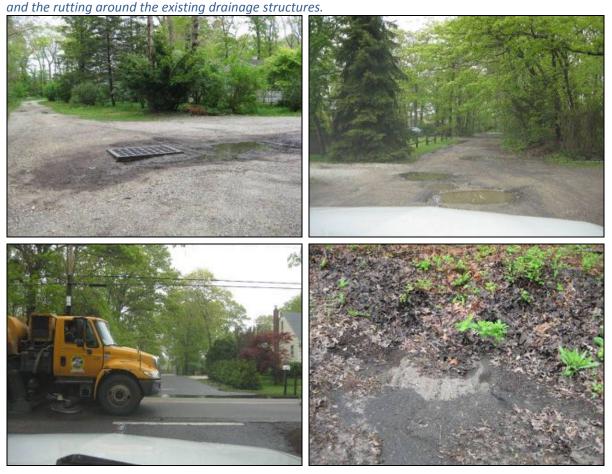
Figure 3.32. Typical roadways and lots within the Gardiner Ave Neighborhood. Notice the unpaved roads

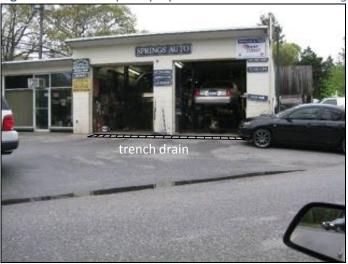
Figure 3.34. Auto Repair - proposed trench drain and existing drainage structures
