# Dering Harbor Subwatershed Management Plan

June 2013

### Horsley Witten Group, Inc.

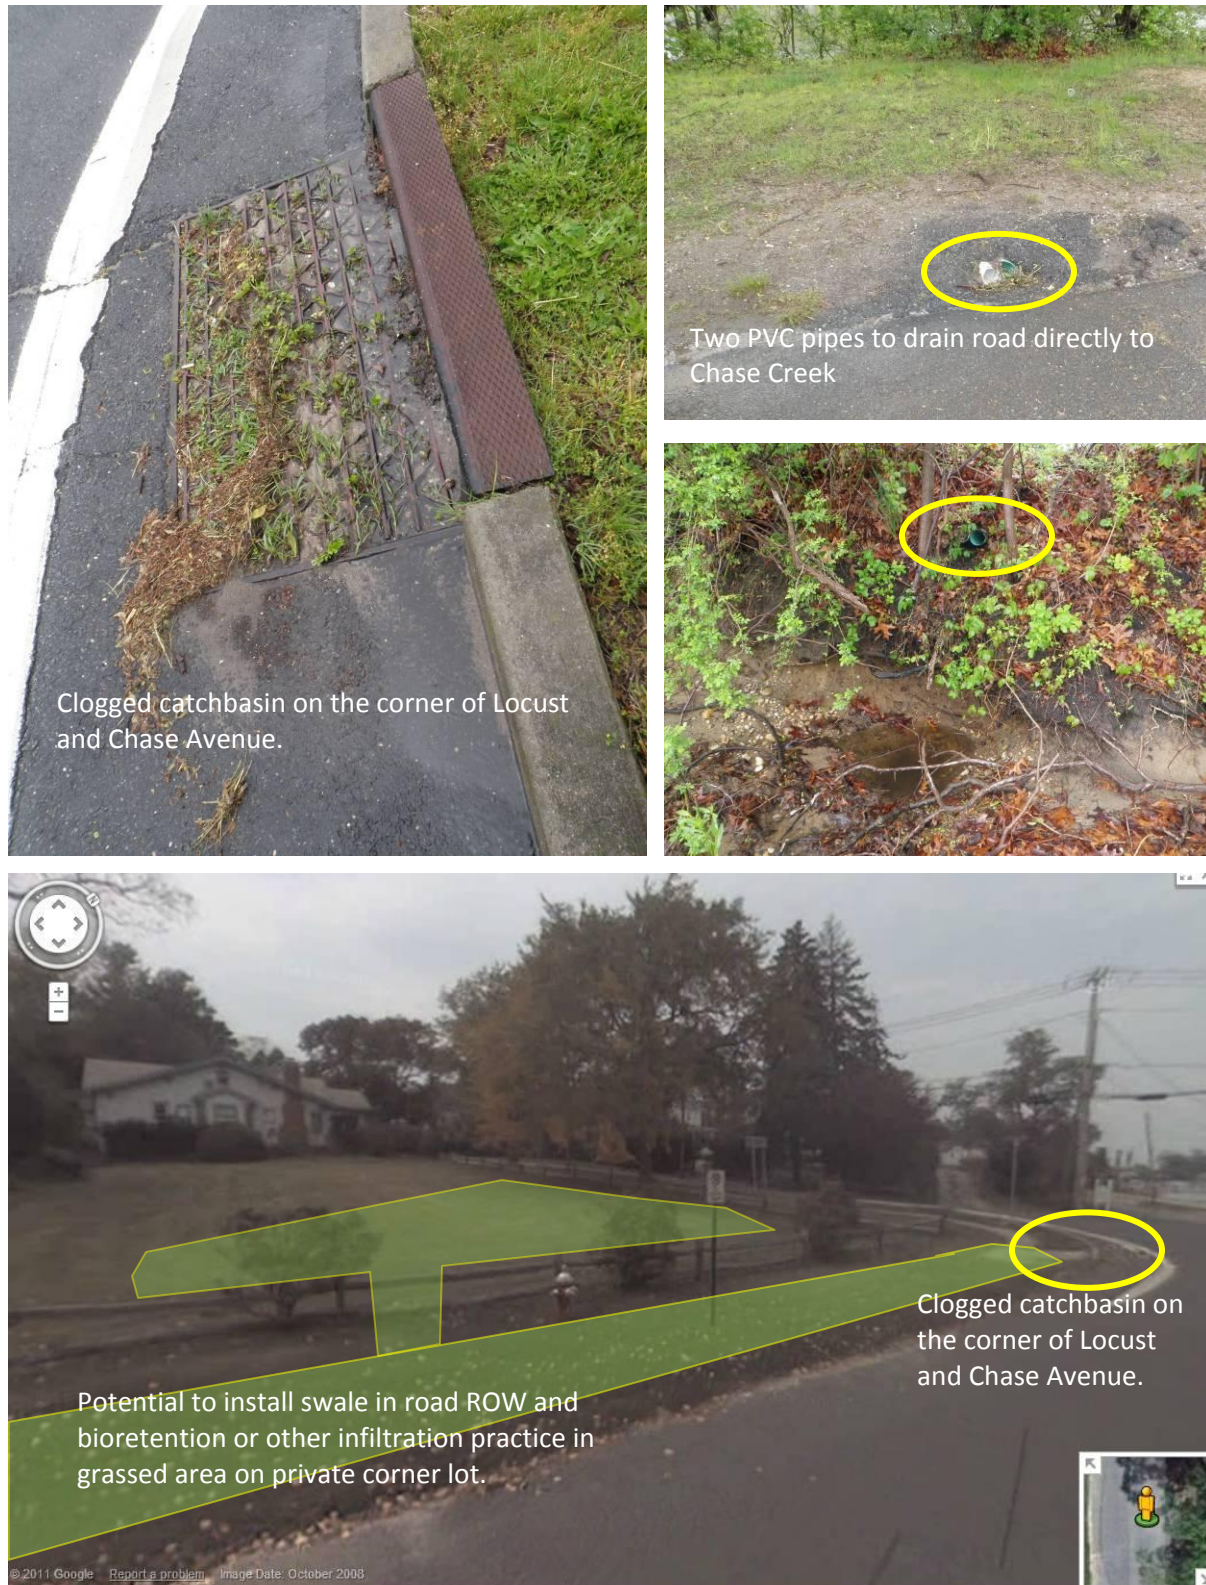
The catchbasins at this intersection show signs of sedimentation/clogging and are in need of maintenance. A temporary fix to flooding at the street corner was to install two PVC pipes in the asphalt berm with a direct discharge to Chase Creek (Figure 3-5). There is a large grassed private lot on the corner where a **bioretention** or other infiltration practice could be installed prior to discharge to the existing catchbasin. A **swale** to collect additional road drainage and take overflow from the bioretention can be fit into the road ROW. This would provide water quality treatment and help reduce catchbasin clogging. Depending on the separation distance to groundwater and soils conditions, additional infiltration could be attained here. The PVC pipes should be replaced with a **deep sump catchbasin**. Additional investigation at this site could refine the concept design and perhaps identify a potential **parcel for the Town to purchase or obtain a drainage easement**. This retrofit was ranked as low priority at this point, partly due to the ownership issue.

**Figure 3-5.** Provide water quality treatment and reduce maintenance burden at corner of Locust/Chase Avenues

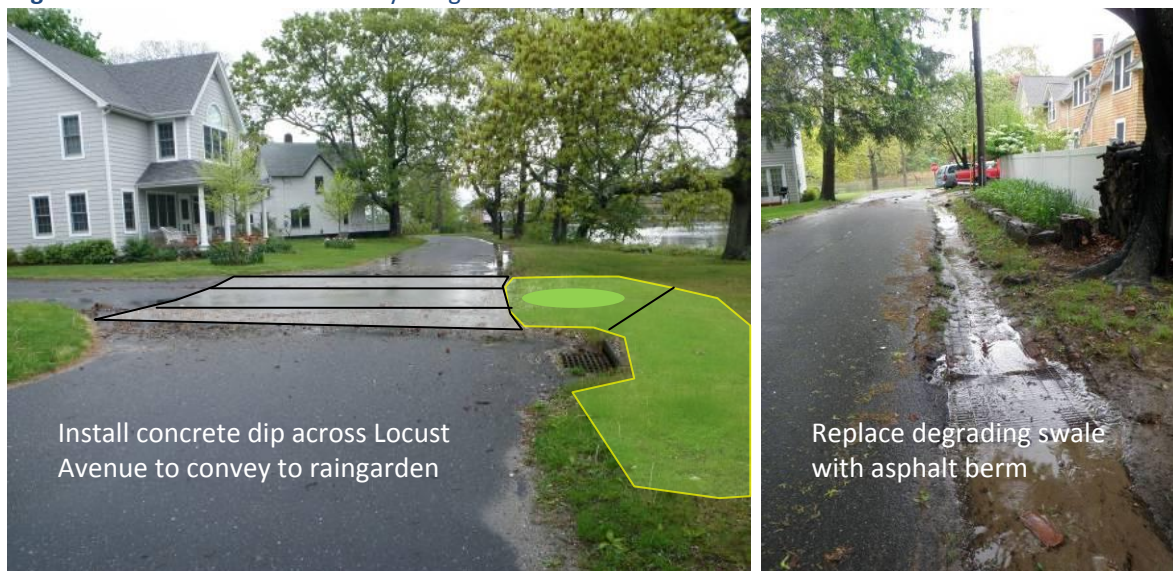
Existing runoff down Meadow Lane is deteriorating the edge of the road and flooding leaching catchbasins along Locust Avenue. Organic debris and sediment were visible on the road surface and likely contribute to clogging of the catchbasins (Figure 3-6). The proposed retrofits for this area include replacing the existing degraded swale on the south side of Meadow Lane with an asphalt berm to direct flows to a **concrete dip** across Locust Avenue. Sheet flow from the dip will be directed into a **raingarden** in the grassed area at the bottom of the street, which can then overflow into the existing leaching catchbasin. The raingarden should include a sediment forebay area that can be easily maintained, and should incorporate native plants to enhance the existing riparian buffer, while not restricting residential uses and views. This community-based retrofit can be enhanced with a residential disconnection program to install raingardens and rainbarrels in this neighborhood to help reduce the volume of runoff sheet flowing across Locust Avenue.

**Figure 3-6.** Location for community raingarden at bottom of Meadow Lane

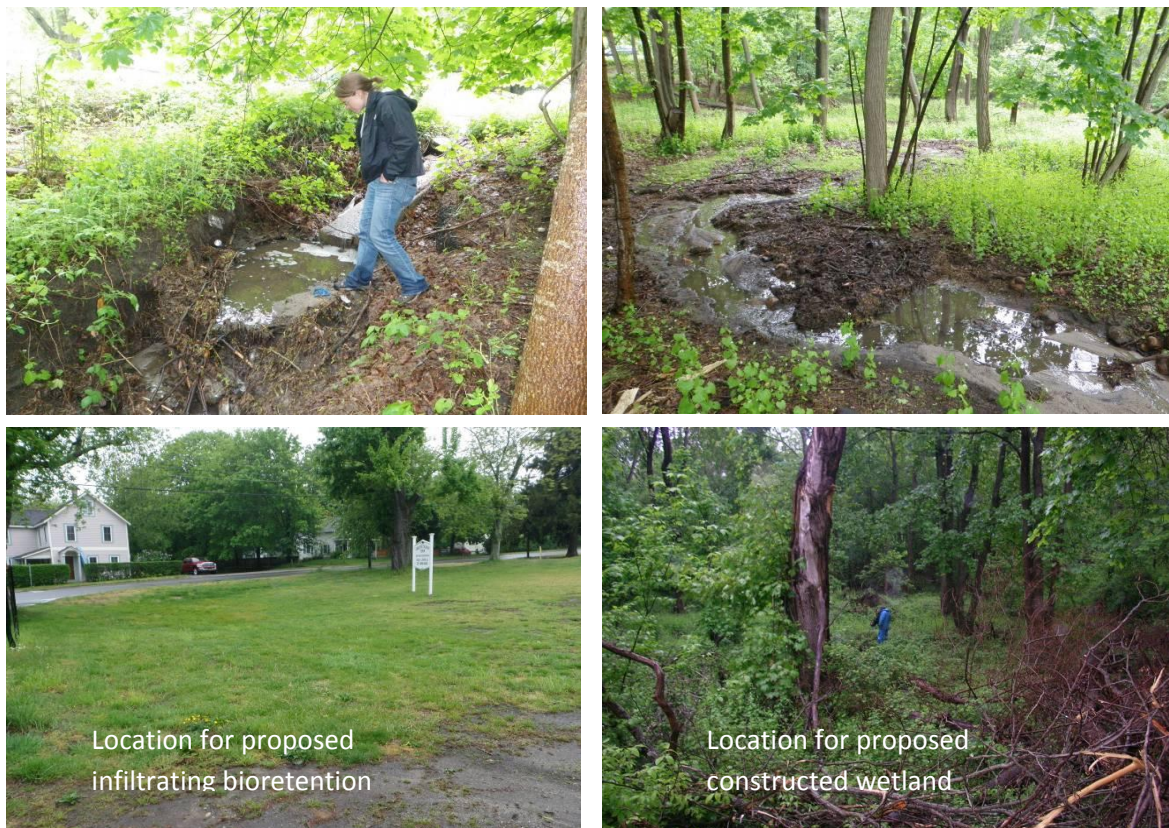
Over 90 acres (including roads, Goat Hill Public golf course, residential area, and a small commercial strip) drain to five catchbasins at the New York Avenue/West Neck Road intersection and the Capital One Bank entrance. The four catchbasins at the intersection drain to the catchbasin at the bank, which then discharges through a culvert under West Neck Road directly into a wetland complex upstream of Ice Pond Park and Chase Creek. No stormwater treatment practices were observed in the drainage area. A distinct flow path from the outfall location to the wetland was visible, and a significant amount of sediment deposition in the area was observed (Figure 3-9). There are two proposed retrofits to treat runoff coming to this site. The first is to install a linear **dry swale** and **infiltrating bioretention** in the corner of the golf course property. A **new drain inlet** could be installed to the west of the existing catchbasin to convey flows into the swale and then into the bioretention. Alternatively, a flow splitter could be installed in the existing catch basin to divert a portion of flow from roadway into a bioretention facility. Overflows can tie back into the existing catchbasin. In addition, more water retention could be provided within the golf course itself, incorporating water treatment and storage features into the design of the golf holes. This would also serve as excellent public education in the Town's largest public land mass in the watershed.

**Figure 3-9.** Outfall from West Neck Road and sediment deposition (top). Two locations for proposed retrofits (bottom).

There are two proposed retrofits to treat runoff coming to this site. The first (DH-R10A) is to install a linear **dry swale** and **infiltrating bioretention** in the corner of the golf course property. A **new drain inlet** could be installed to the west of the existing catchbasin to convey flows into the swale and then into the bioretention. Alternatively, a flow splitter could be installed in the existing catch basin to divert a portion of flow from roadway into a bioretention facility. Overflows can tie back into the existing catchbasin. In addition, more water retention could be provided within the golf course itself, incorporating water treatment and storage features into the design of the golf holes. This would also serve as excellent public education in the Town's largest public land mass in the watershed.

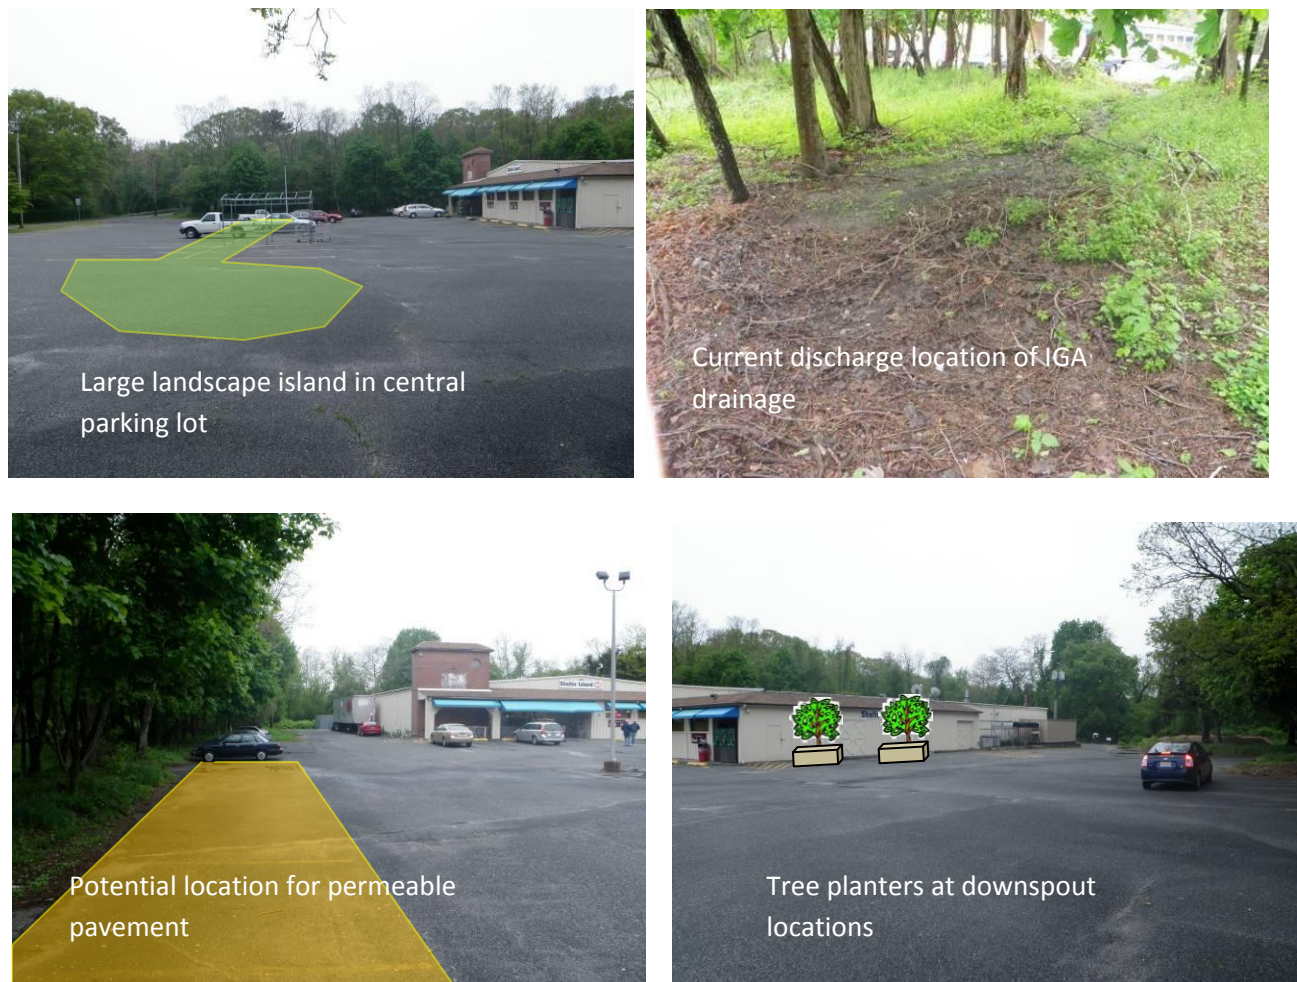
The roof and parking lot at a local grocery store currently drain untreated to the adjacent forested parcel/potential wetland area. The parking lot gets a lot of use during the summer, and has been recently repaved. The drive aisle widths seem wider than they need to be, and the lot lacks landscaping and canopy cover. The proposed concept for this site is to add a **landscaped island bioretention cell** in the central portion of the lot where a few trees can be planted either as a retrofit or as part of any future repaving at this site. The lot should then be **re-striped and aisle widths minimized** where possible, with no reduction in parking spaces. Alternative opportunities exist at this site as well, including **pavement removal** and/or use of **permeable pavement**, as well as the installation of **stormwater planter boxes** where the building downspouts exist to provide some volume reduction and improve aesthetics. Due to the high use of this area, this is a good location for public education to demonstrate that even sites that do not directly discharge into Dering Harbor play a role in overall water quality and watershed health.

**Figure 3-10.** There are many opportunities to provide stormwater management at the IGA.

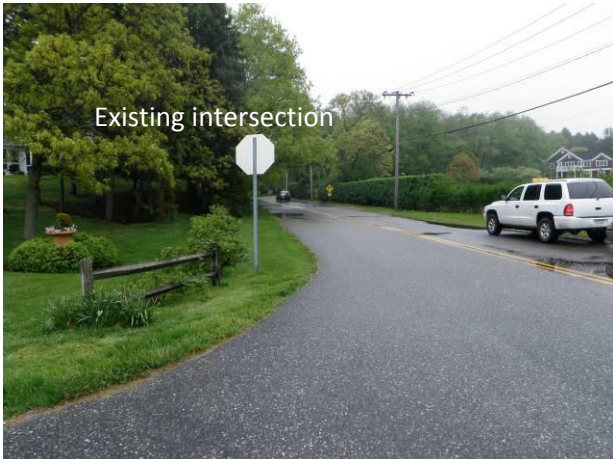
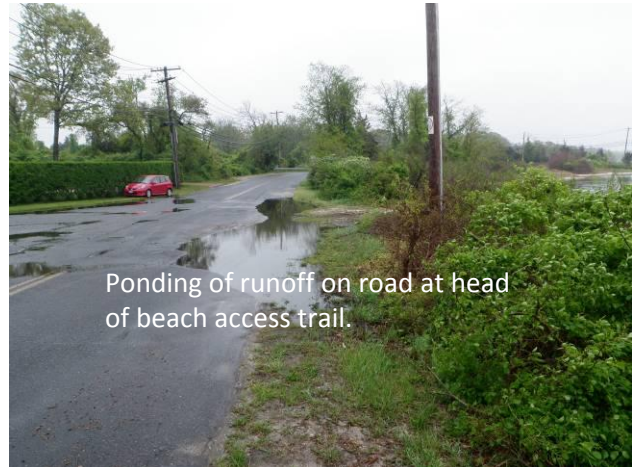
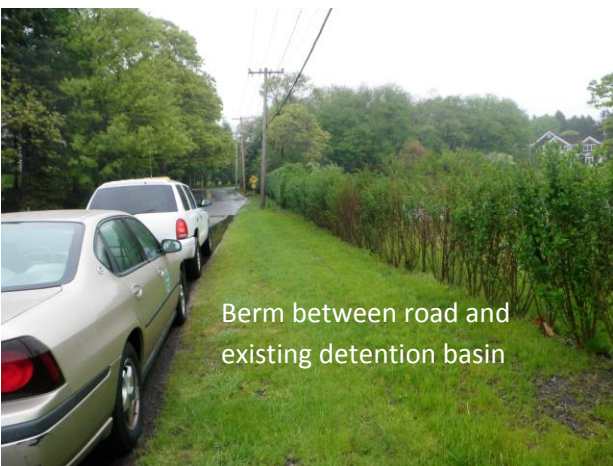
**Figure 3-11.** Intersection of Cobbetts Lane and Winthrop Road.

There is an existing, privately owned wet pond at the intersection of Cobbetts Lane and Winthrop Road that reportedly accepted road drainage until the property owner recently installed a landscaped berm

that caused road drainage to bypass the facility and pond at the intersection instead (Figure 3-11). This has also led to the increased erosion of the beach access trail at this location. The retrofit concept for this site is to install infiltrating dry swales along Cobbetts Lane where possible to avoid trees and utilities to treat and manage runoff from 1.5 acres of impervious cover.

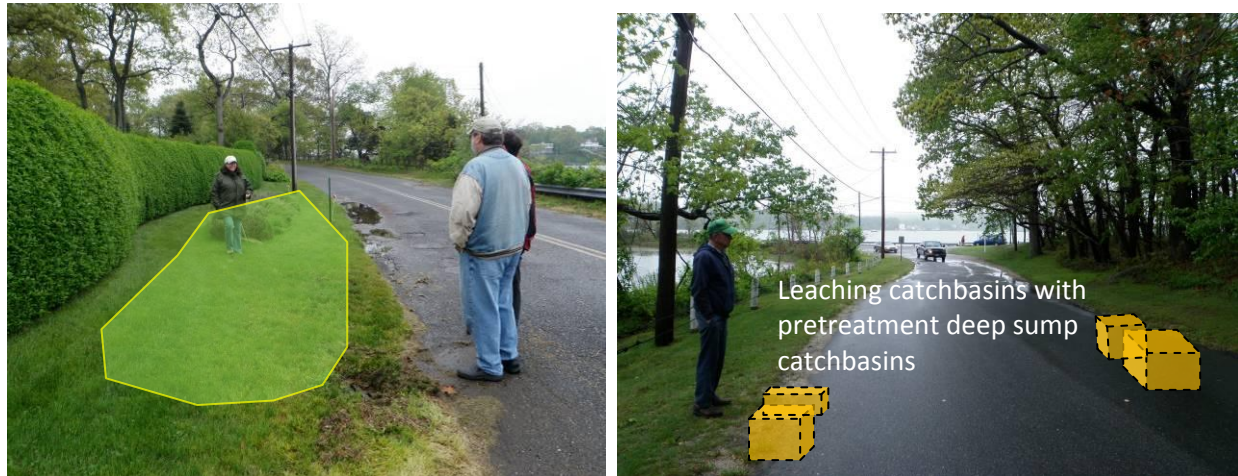
Just south of Third Bridge, the Town installed an underground infiltration chamber; however, the structure has become clogged with grass and debris. Soil maps (see Appendix A) indicate C and D soils in this area (poor infiltration capacity). Ponding occurs at the corner of Locust and Shore Roads, particularly at high tide. A hand-dug channel to pond/wetland area was dug to encourage drainage. Retrofit concepts for this site include providing pretreatment prior to the underground leaching field using a **shallow biofilter** (vegetated swale/raingarden) upgradient of the existing practice, depending on depth of chambers (Figure 3-12). This retrofit should be viewed as a demonstration practice on how to provide pretreatment for these types of infiltration practices. In addition, the concept for this site includes the installation of **two leaching catchbasins** with **deep sump catchbasins** to provide pretreatment along Locust Road to reduce overall volume of road drainage at bottom of hill; however, infiltration capacity of soils in this area should be further investigated. **Pavement removal** at the intersection would help reduce impervious cover (and thus volume of runoff) and realign the

**Figure 3-12.** Location of existing underground leaching field and proposed leaching catchbasins.

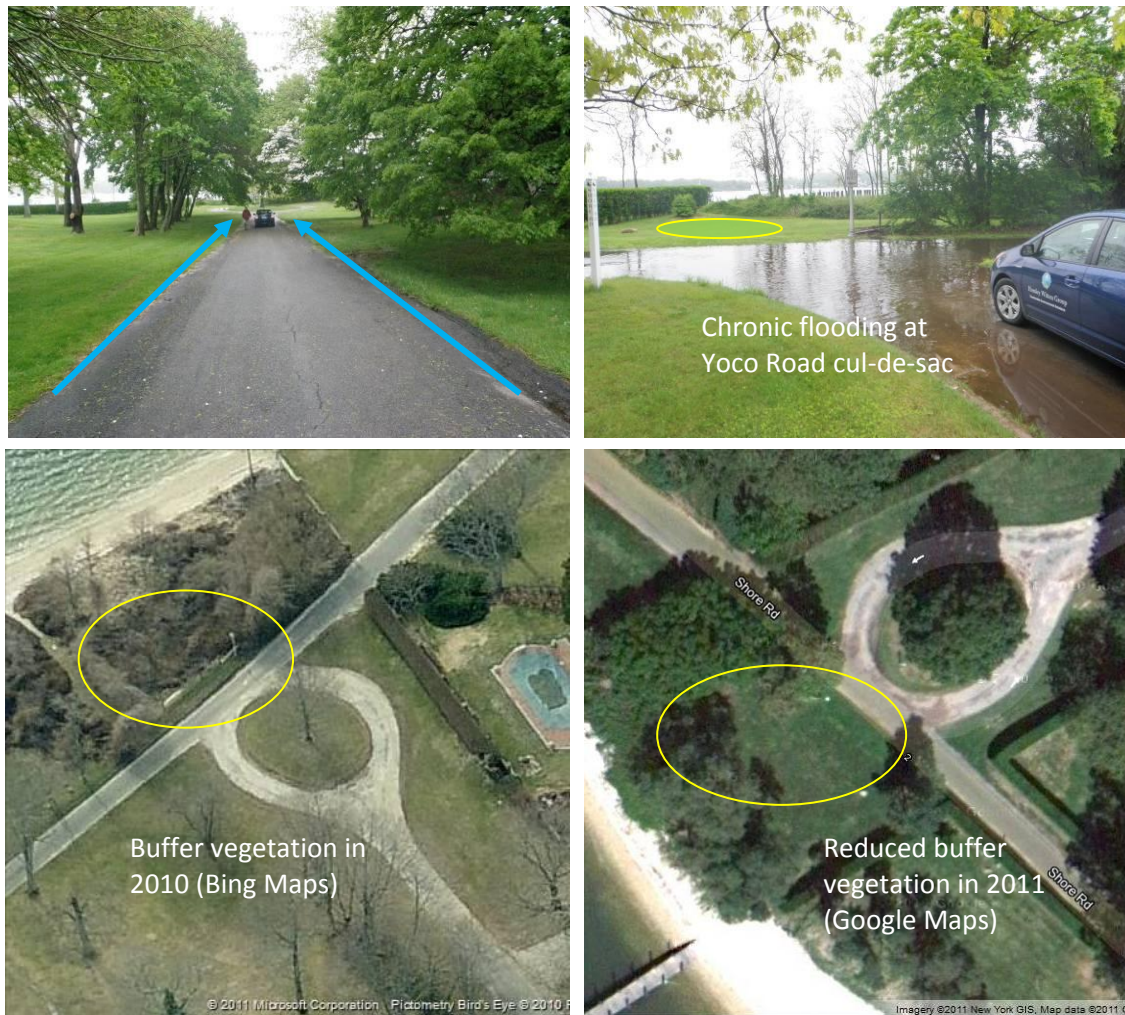
Runoff flows down the open-sectioned Yoco Road and ponds at the cul-de-sac/Shore Road intersection. Flooding is reportedly a chronic issue at this location. The only stormwater infrastructure observed in the area is uphill at the intersection of Yoco and Locust. There appears to be sufficient room in the grassed areas around Yoco Road to excavate **raingardens** that may help provide some temporary storage; however, soils do not appear conducive to infiltration in this area based on the soils mapping. It is assumed that the drainage area to this site does not include areas east of Locust Road, which are presumed to be captured in the leaching catchbasin at the intersection. If it is determined that additional drainage area does contribute, swales along either side of the road may need to be installed in addition to the raingardens. From a comparison of 2010 and 2011 aerial photos, the vegetated buffer area between the beach and the cul-de-sac appears to have been cleared and replaced with lawn (Figure 3-13). Retrofits opportunities at this site should look to re-establish some of the protective plants in this area.

**Figure 3-13.** Yoco Road looking towards the flooded cul-de-sac area (top); removal of buffer vegetation between 2010 and 2011 (aerials by Bing and Google Maps, respectively) (bottom).

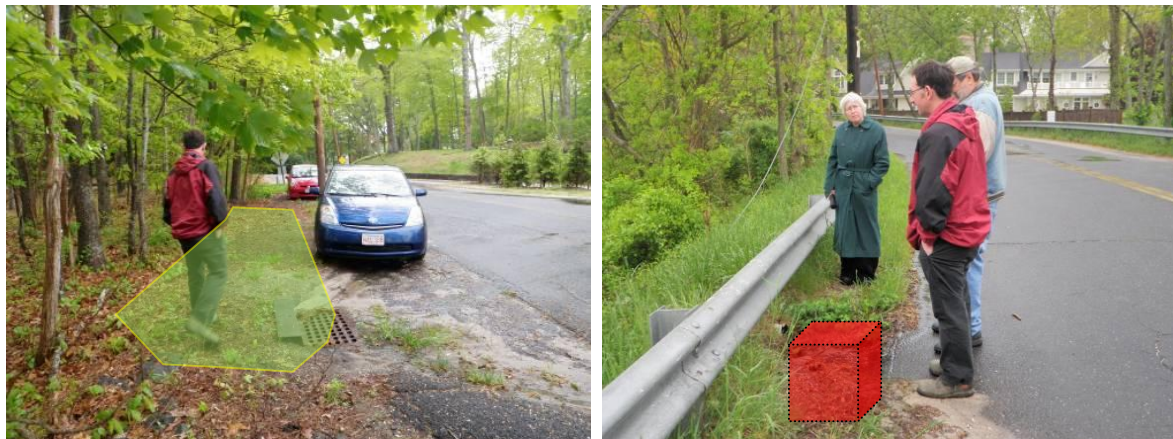
Road runoff enters an existing catchbasin and leaching pit that is partially clogged and causes water to be conveyed further down the road to a paved flume with a direct pipe discharge into Gardiners Creek. Residents report sediment plumes at this location. According to mapping information, soils are questionable for infiltration (HSG C soils). The concept for this site is the installation of a **dry swale** in road ROW uphill from existing catchbasin to provide pretreatment and replacement of the paved flume on the causeway with a **deep sump catchbasin** (Figure 3-14). There does not appear to be enough room for the swale to meet full water quality volume criteria, but this retrofit will alleviate erosion from the clogged leaching pit to the banks of Gardiners Creek and reduce direct discharge of runoff through the paved flume. Further investigation on distance to groundwater would be required to pursue this retrofit, as well as a commitment to frequent maintenance due to the swale not meeting the full water quality volume.

**Figure 3-14.** Location for proposed pretreatment swale and deep sump catchbasin.

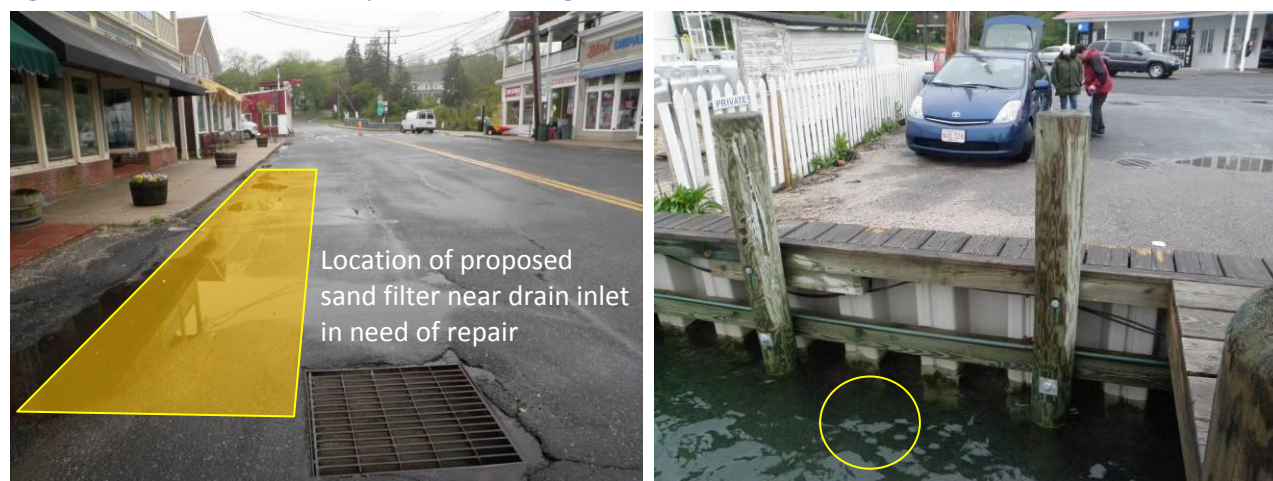
There are a number of catchbasins along Bridge Street that discharge to outfalls near the docks across from the gas station. An existing underground oil/grit separator was installed in the parking area near the docks across from the gas station. While it appears that this retrofit is likely undersized for the area draining to it, if maintained, it will provide some level of water quality treatment. The catchbasin in front of the liquor store takes drainage from the gas station and a portion of Bridge Street. It is completely clogged and in need of structural repair. Given the high potential for pollutants (oil, sediment, washwater, dumpster leachate, etc.), installation of a **sand filter** and **reconstruction of the existing catchbasin** are recommended (Figure 3-17). A sand filter was chosen because it has a level of pollutant removal but does not impact parking in this constrained area since vehicles can park on top of the structure. In addition, the outfall pipe by the dock bulkhead should be investigated to determine if a **tidal gate** needs to be added to prevent inflow.

**Figure 3-17.** Catchbasin for replacement during installation of a sand filter; outfall at bulkhead

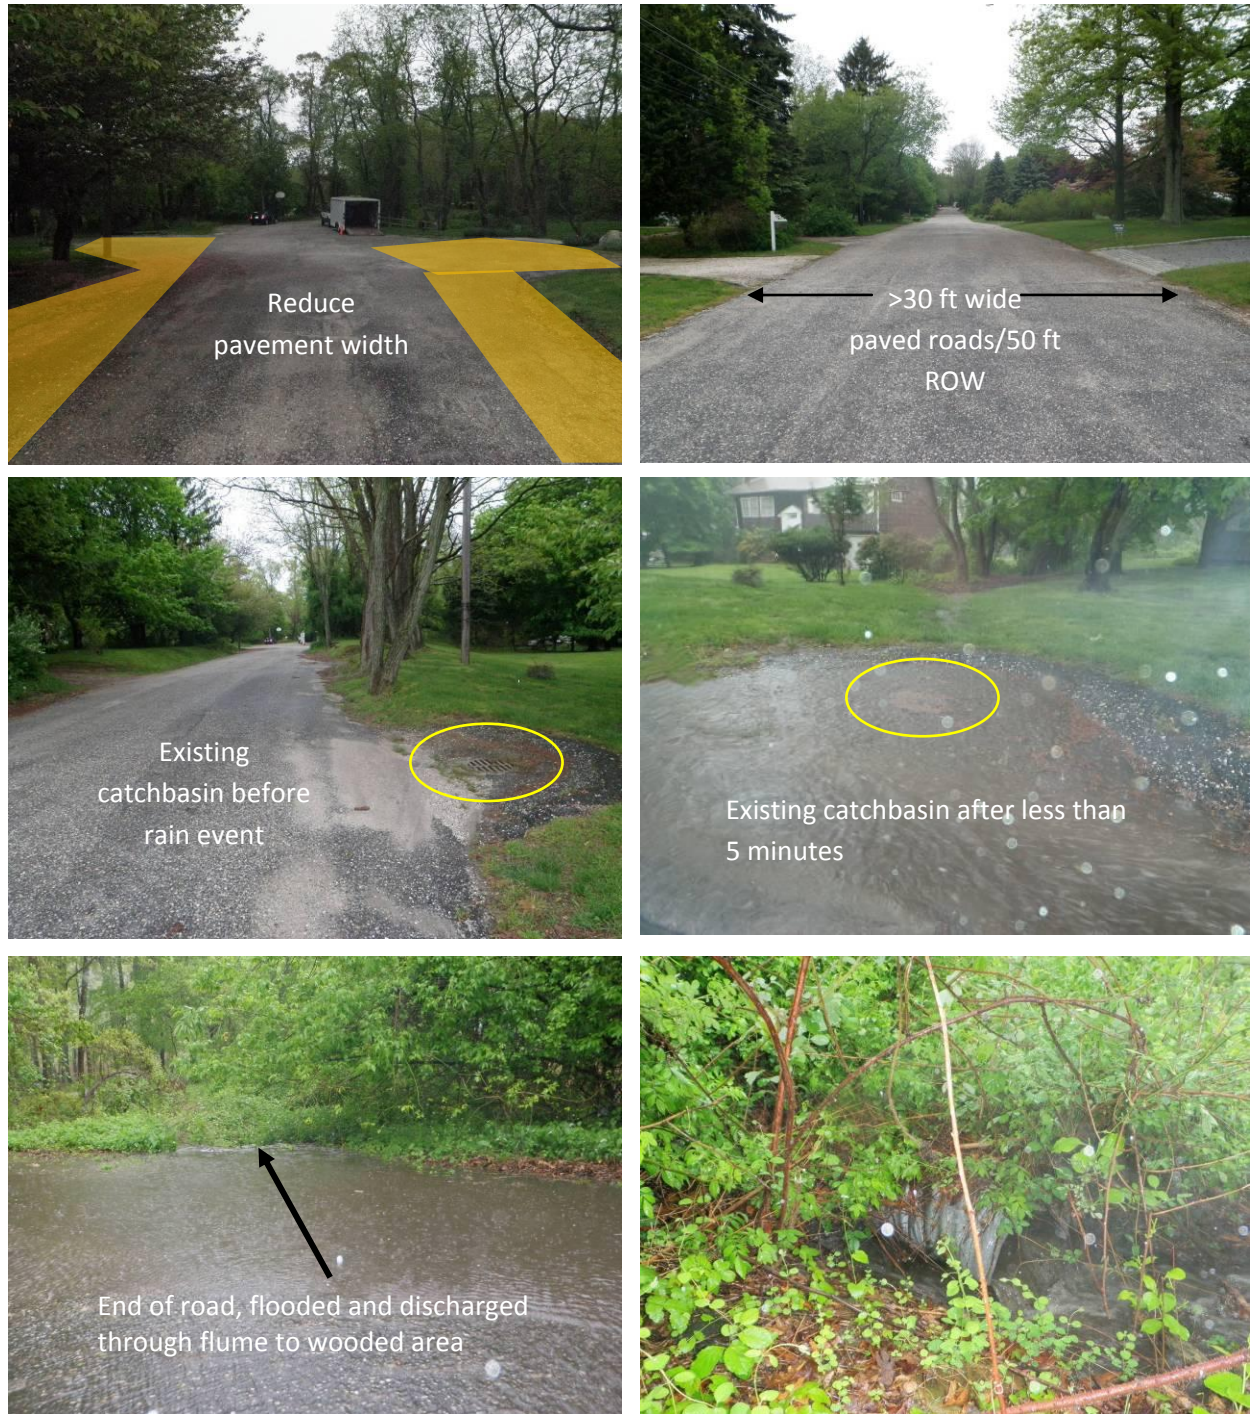
This road services 18 single family residences and has a paved width greater than 30 ft, with wider areas towards the end of the street. Runoff from the road and surrounding area drains north on either side of the road and discharges through a paved flume and a corrugated metal pipe into a wooded area to the west of the two driveways at the end of the road. The neighborhood backs up to Ice Pond Park, and the drainage flows into a headwater wetland to Chase Creek. There appears to be one catchbasin along the road which was flooded at the time of observation; therefore, we were unable to determine if this is a leaching structure or if it is tied into the discharge pipe at the end of the road.

Figure 3-18 shows the large volume of water quickly generated during a short rainfall event that flooded the catchbasin and discharged into the wooded area during the site visit. **Pavement reduction** and pretreatment prior to discharge is recommended. Depending on the location of wetland and drainage easement boundary, a **constructed wetland with forebay** could be installed to provide energy dissipation and water quality treatment. Another alternative for this site is to provide pretreatment prior to the existing catchbasin in the form of a bioswale that also serves as a road narrowing device (aka “**green streets**”).

**Figure 3-18.** Sylvan Road before and during a rain event.

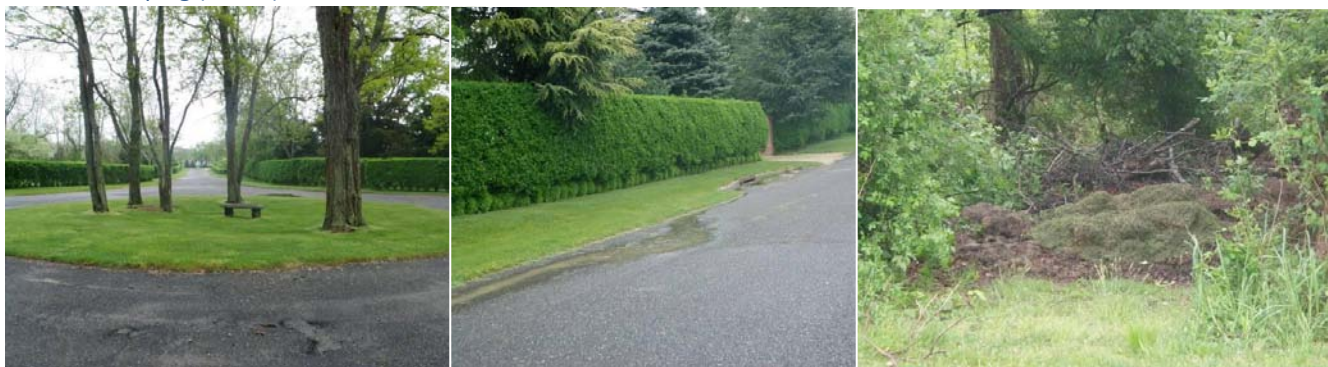
Bonnie Lane is a newer neighborhood of 13 single-family detached dwellings that appear to be approximately ten to fifteen years of age. Located off Manhasset Road, the neighborhood has two main streets, Bonnie Lane and Locust Woods Drive. Two of the homes are accessed from Bonnie Lane; the remaining eleven homes are located on Locust Woods Drive, a dead-end street that has grass/landscaped cul-de-sacs at the north and south ends. Both streets are relatively wide (28 ft of pavement) with an overall right-of-way width of approximately 50 ft and open-section road draining to a catch basin at the low point in the road. Standing water was observed in some of the drain inlets, most likely due to sediment accumulation. No outfalls were observed, and the catchbasin is assumed to be leaching. There are no sidewalks present, and the road surface shows some signs of deterioration. The neighborhood is approximately 23 acres, and lots are typically an acre in size. On average, each lot is comprised of 15% impervious cover, 70% grass cover, and 15% landscaped area/trees. Almost all the driveways are impervious. No permanent irrigation was observed; however, a majority (80%) of the lawns appears to have high management requirements. Some sediment accumulation was observed originating from one of the driveways where the homeowner had excavated a trench to drain their

property. Additionally, grass clippings and yard waste dumping were observed in a wooded area next to the northern cul-de-sac. No pet waste or trash was seen.

**Figure 3.23.** Bonnie Lane grass cul-de-sac (left), sediment-laden runoff to leaching pit (right) and grass and yard waste dumping (below).

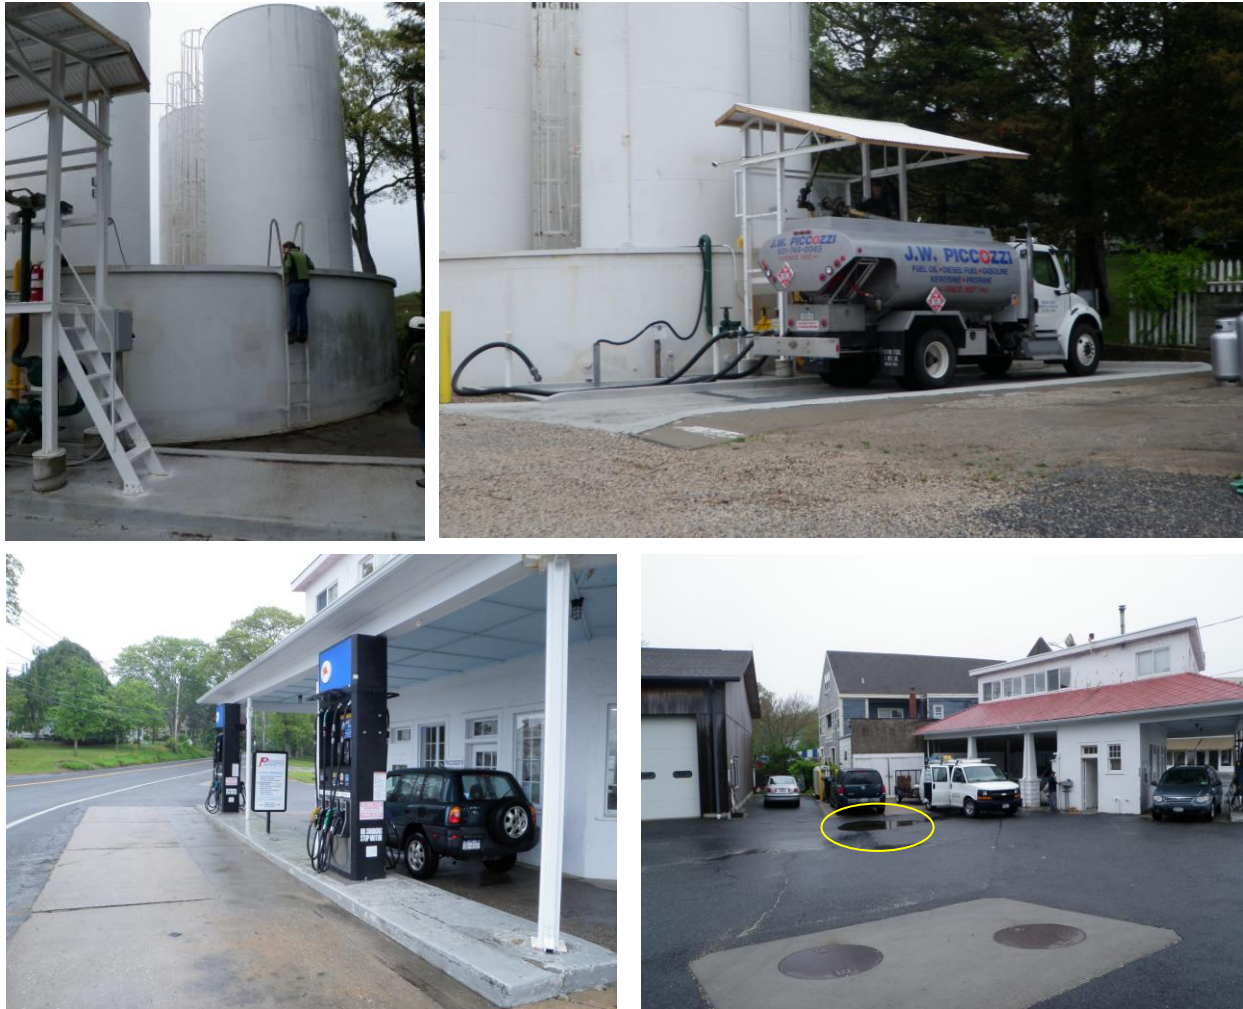
The gas station on the corner of Bridge Street, directly adjacent to Dering Harbor, is used for fueling, fuel storage, and bike rental/repair. Across the street from the gas station is a SPDES-permitted propane and home heating oil storage facility. Runoff from the gas station flows north to a series of baffled tanks and through the bulkhead to Dering Harbor, and south to catchbasins in the adjacent commercial parking lot. Catchbasin cleaning in the commercial parking lot is recommended. Also, gas station fueling areas should be covered, and catch basin frames should be stenciled. Retrofit DH-R27 describes improvements to the northern section of Bridge Street, including a perimeter sand filter and tide gate valves on the outlet pipe to Dering Harbor.

**Figure 3.24.** Good examples of existing pollution prevention techniques employed include the spill containment for storage tanks and bermed refueling area with separate drain (top); lack of pollution prevention at uncovered fueling island and leaching catchbasin in the rear of the gas station should be addressed (bottom).

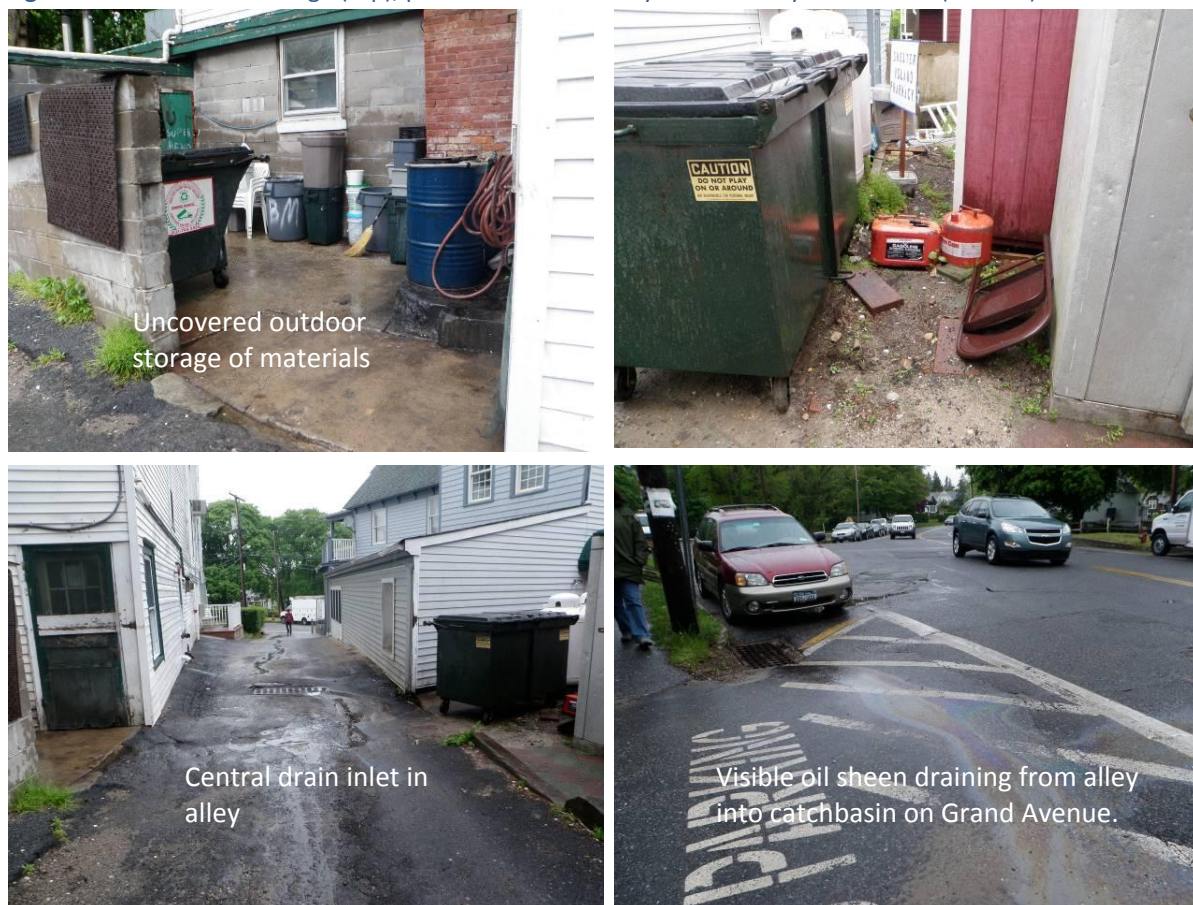
In the alley off Grand Avenue behind the Shelter Island Heights Pharmacy and the Chequit Inn, runoff from downspouts, dumpsters, gas storage, paint dumping, and grease traps discharges directly to a catchbasin in the center of the alley and continue to Grand Avenue. Improvement recommendations include redirecting downspouts away from the storage areas. Storage areas should be covered or spill containment areas built to eliminate polluted runoff from entering the catchbasins. Retrofit DH-R4 described additional opportunities for pollutant prevention from runoff originating from this area.

**Figure 3.23.** Pollutant storage (top), polluted runoff to alley and roadway catchbasins (bottom).
