# Suffolk County Peconic Estuary Program Conceptual Habitat Restoration Designs

## Lake Montauk Alewife Access and Habitat Enhancement Montauk, Town of East Hampton

July 2019

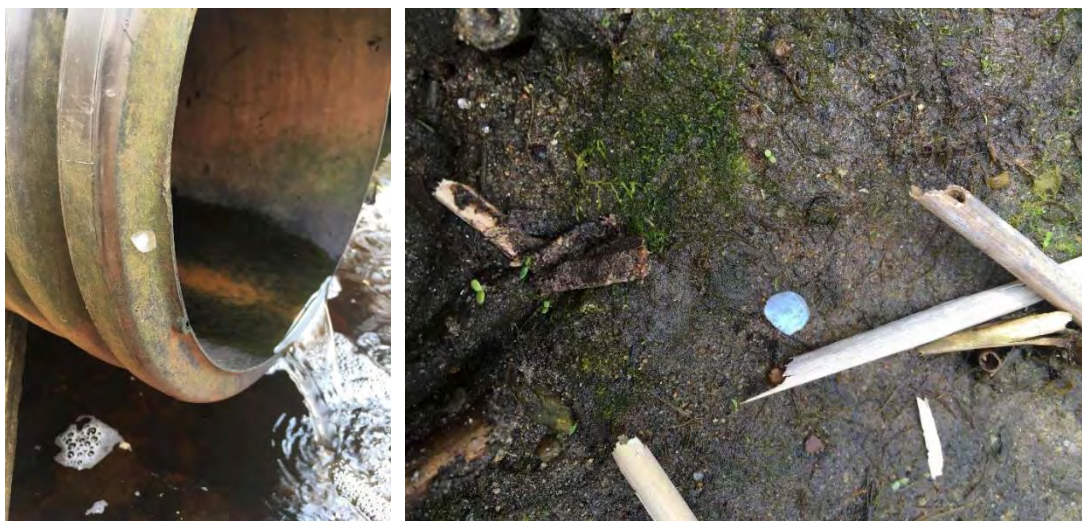
Figure  
7a  
(Left):

Field investigation of the Stepping Stones Pond culverts to assess potential evidence of diadromous fish passage was conducted during the 2018 alewife spawning run (May 7, 2018). Evidence of alewife migration was observed at the downstream side of the Stepping Stone culverts under Old West Lake Drive. Three (3) alewife scales were observed attached to the culvert pipe and the stream bed (Figure 7). No scales were observed on, in, or adjacent to the upstream side of the culvert. Accordingly, it is not known if these alewives successfully crossed through the culvert. This observation corroborates earlier observations in 2018 by Kate Rossi-Snook (Concerned Citizens of Montauk) on or about April 24, 2018. According to Enrico Nardone (Seatuck Environmental Association), these 2018 observations are the first known documentation of a remnant alewife spawning migration at Stepping Stones Pond.

Alewife scale on Downstream Culvert Pipe at Stepping Stone Pond

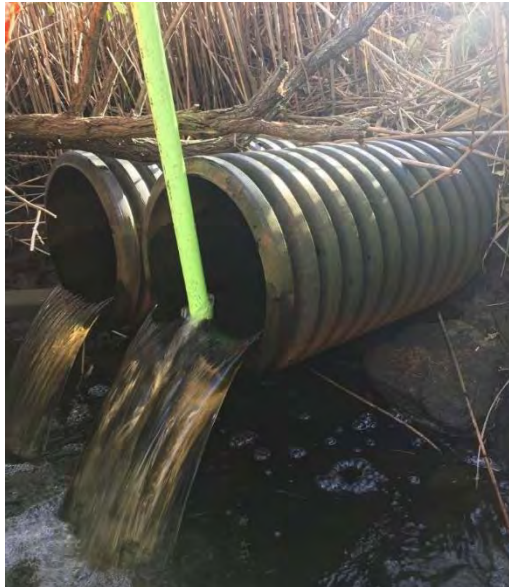
The downstream and upstream ends of the culverts are perched approximately 1 foot above the bed of the channel (Figure 8). While high tides backwater the downstream end of the culvert, the invert elevation of the upstream end of the culvert prevents salt water from entering Stepping Stones Pond under existing sea level conditions. Extreme high tides likely flow over the road and into Stepping Stones Pond, but typical tidal fluctuations currently do not impact the pond.

Figure 8: Downstream end of culverts at Stepping Stone Pond. Culverts perched approximately 1' above bed of channel.

The upstream invert of the pipes is elevation 2.6 feet and the downstream invert is elevation 0.6 feet, resulting in a relatively steep 3.6% slope over approximately 54 feet of culvert length (Table 3). The corrugated culvert is smooth on the inside, with no roughness elements to slow and deepen flow. At low tide, fish are unable to move upstream into Stepping Stones Pond due to two primary reasons:

2) the water velocity is high and water depth low through the culverts, and high velocity and low depth of flow presents a barrier to upstream movement of fish. An alewife scale has been observed on the downstream end of the culvert, suggesting the fish are attempting to access the habitat in Stepping Stone pond, but the current configuration precludes passage.

We are proposing the replacement of the twin 1-foot culverts with a 3- or 4-sided concrete box culvert with a natural substrate bed (Appendix A). As shown on the conceptual drawings, the culvert would be capable of holding a pool-riffle sequence, with a riffle constructed specifically to prevent tidal inflow to the pond without flooding Old West Lake Drive. Approximately 7-8 riffle-pool combinations would be constructed to accommodate the 3.5 feet of elevation difference between the pond and Lake Montauk. Each riffle-pool would be approximately 0.5 feet high and 15 feet long, with an overall slope of 3%. Our design of the slope, substrate, and channel configuration allows migratory fish, such as alewives and American eel, to move upstream and downstream. Alewives are capable of jumping modest-sized steps and generally have high passage rates on channels that have slopes of 3% or less. The pools in the new channel will provide resting areas for the fish as they gain strength to continue to move upstream. These smaller pools could become the transitional zone for fish moving from saltwater to freshwater. This kind of channel construction is also conducive to American eel passage. Eel are able to swim close to the bottom of stream channels where water velocities are greatly reduced, especially with the roughened surface that the gravel and cobbles provide.

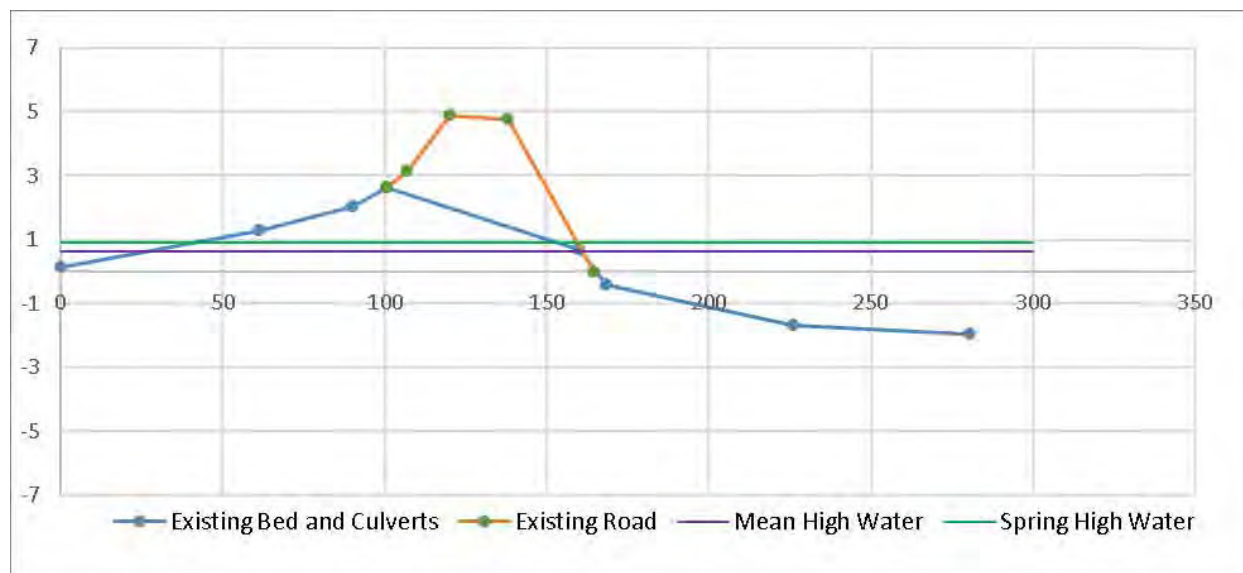
In addition, alewives and other migratory fish need a transitional estuary zone where they can acclimate to the more fresh water ecosystems they are migrating into. The outlet of Stepping Stones Pond does not provide much opportunity for this acclimation process, which would be limited to the channel between the culverts and Lake Montauk and the mixing of the fresh water as this channel enters the saltier Lake Montauk.

Figure 9: Cross section of Stepping Stone outflow culvert and channel. MHW and SHW are based on vegetation survey.

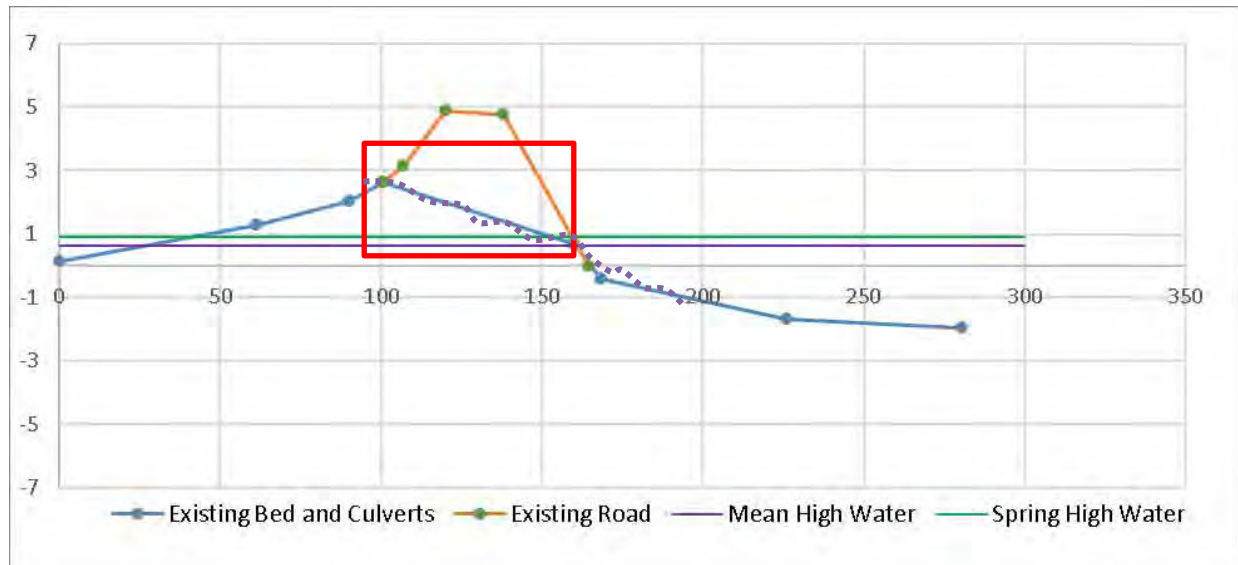
Figure 10: Stepping Stones Pond crossing, with proposed box culvert shown in red, with proposed bed in dashed purple. Dimensions and locations are approximate and would be determined in the design phase of the project.

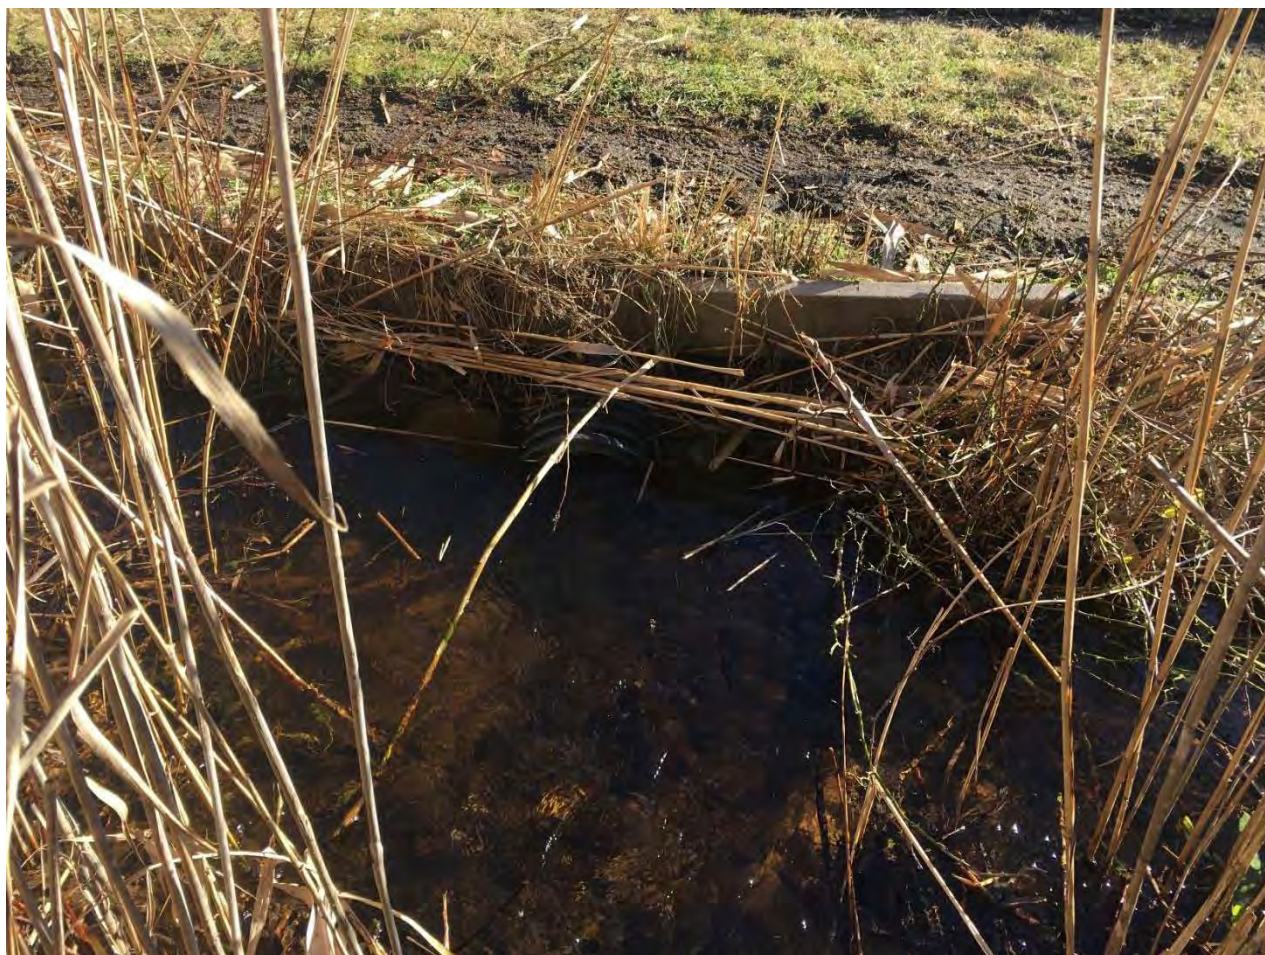
The culvert was also assessed during the 2018 alewife spawning run (May 7, 2018). No typical evidence of alewife (*Alosa pseudoharengus*) spawning migration, such as live or dead fish, or loose scales on the stream bank or bed, were observed at the culverts at Little Reed Pond or Big Reed Pond or the nearby stream and wetlands. Hundreds of American eel (*Anguilla rostrata*) elvers were observed at the downstream end of the Big Reed Pond double culverts apparently feeding on zooplankton in the culvert outflow.

While fish are able to move through this culvert, the *Phragmites* plant material obscuring the upstream entrance and channel and the narrow culvert are likely decreasing the success rate of fish trying to move upstream into Big Reed Pond. Higher passage success rates are found in culverts with more space for fish to turn around where water velocities are low within the culvert. With this partial barrier replaced, alewives should be capable of reaching spawning areas in Big Reed Pond. While the channel was difficult to identify during our survey downstream of the dam, fish are likely able to move through the vegetation by following the active flow signatures. Alewives and American eel will also be able to move through the culvert under East Lake Drive as this was not determined to be a fish passage barrier. The culvert is wide, the slope is within the ability of fish passage, and portions of the channel bottom are natural gravel and cobbles.

Figure 13: The downstream end of the culvert at Big Reed Pond.

The existing 1-foot HDPE culvert is undersized and presents at least a partial barrier to fish passage. To improve fish passage, the culvert should be replaced with a 2-foot diameter corrugated metal pipe arch culvert (design drawings, Appendix A). As shown on the drawings, this style of culvert has a broadened, flat bottom, requiring less excavation while providing the same space for water above the bed of the channel. During installation, the bottom of the culvert will be partially filled with natural channel substrate, creating a nature-like channel bed through the culvert that is more conducive to fish passage.

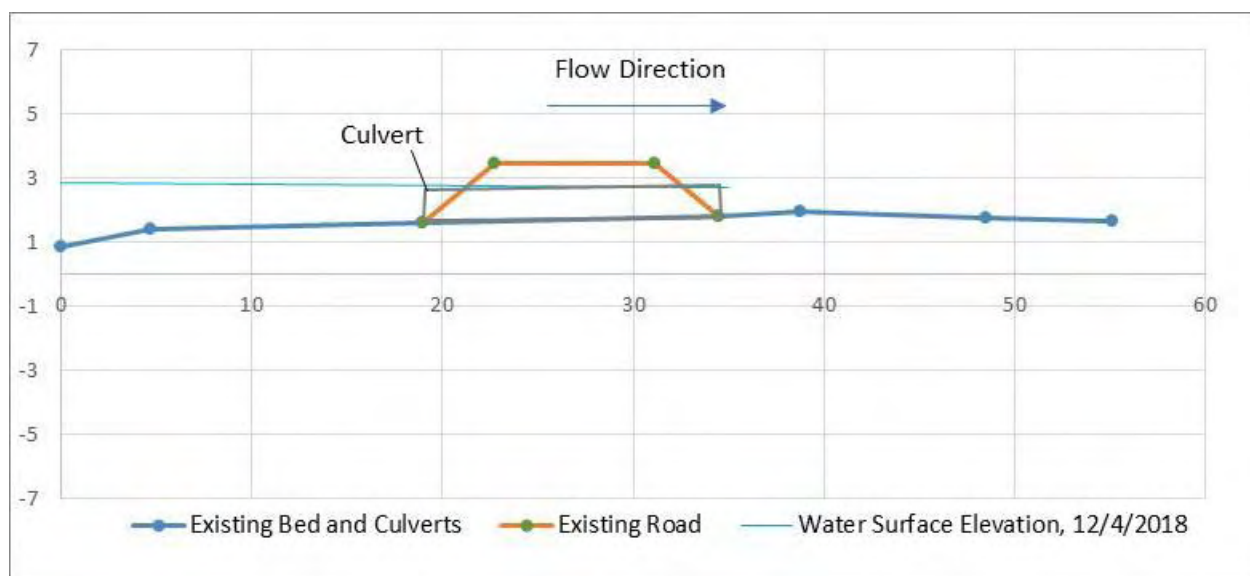
Figure 14: Longitudinal profile of Big Reed Pond outflow culvert and channel. Water flow is from left to right.

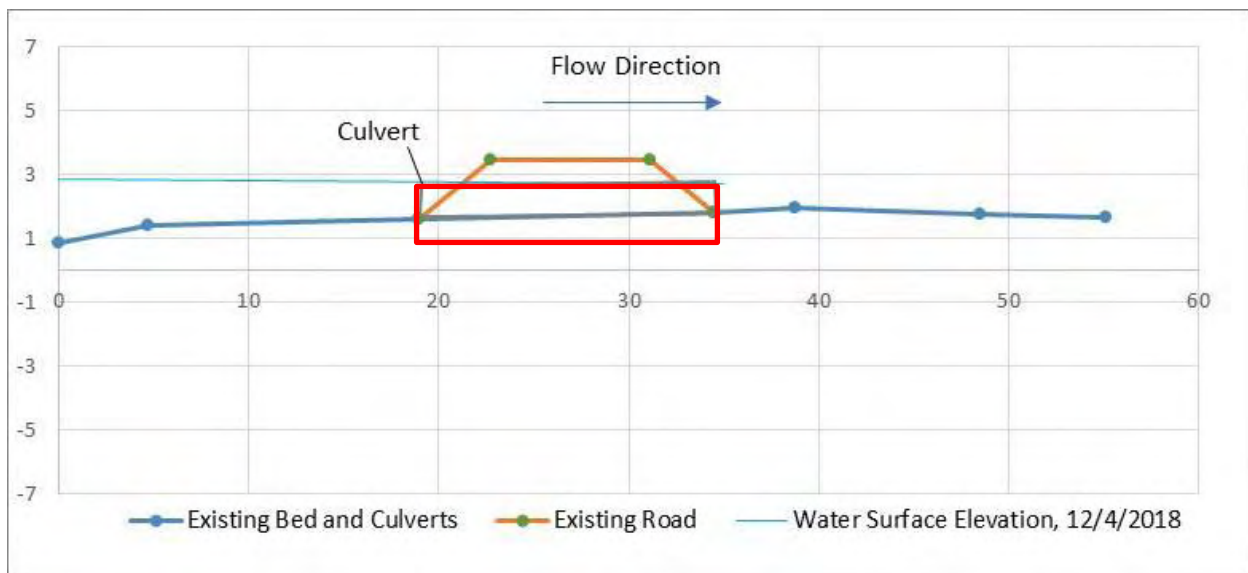
Figure 16: Cross section of Big Reed outflow, with proposed 2-foot culvert shown in red. Location and dimensions are approximate and would be determined in design phase.
