Suffolk County Peconic Estuary Program

Conceptual Habitat Restoration Designs

Diadromous Fish Passage Restoration at Forge Dam Road (Riverhead), Ligonee Brook (Sag Harbor), and Moore's Drain (Greenport)

Date: February 15, 2013
Last Revised: June 10, 2013

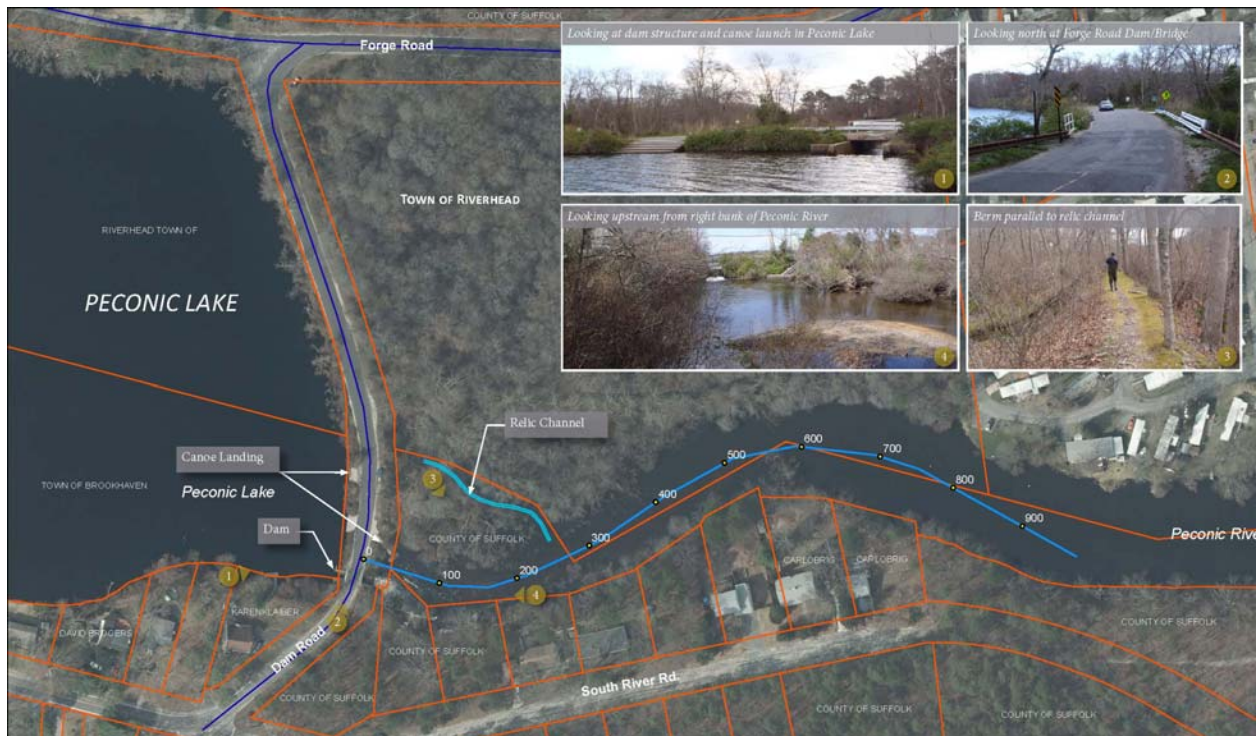
Figure 7: Forge Road Dam Existing Conditions Exhibit. Suffolk County owns all three parcels on the south bank between Dam Road and the first house.

Forge Road Dam is approximately 4.3 miles from the mouth of the Peconic River in Flanders Bay (Figure 7). The Town of Riverhead owns the northern half of Peconic Lake and the floodplain north of the River downstream of the dam. Peconic Lake is the impoundment on the upstream side of the Forge Road Dam. Below the dam, the south bank of the river is characterized by a wooded bluff and residential property, while the land to the north of the river is an undeveloped forested wetland owned by the Town of Riverhead. The forested wetlands site shows evidence of historic ditching and possible agricultural use (i.e. cranberry production), with a vegetated earthen berm parallel to the Peconic River. A relic channel is present on the north side of the berm, with active flow assumed to be subsurface seepage under the Peconic Lake earthen dam.

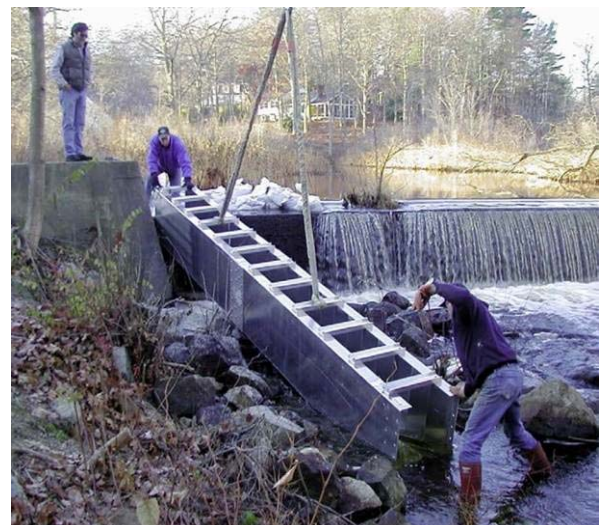
Figure 9: Installation of an Alaska Steeppass structure

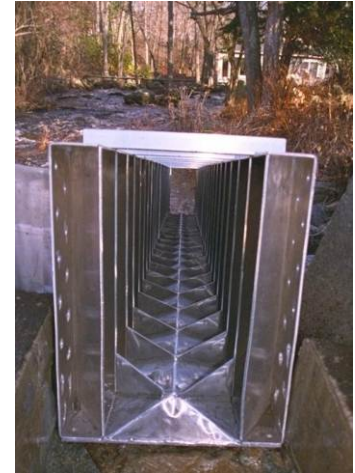
Figure 10: Looking downstream at an Alaskan steeppass fish ladder installed on the Parker River (photo from NOAA library)

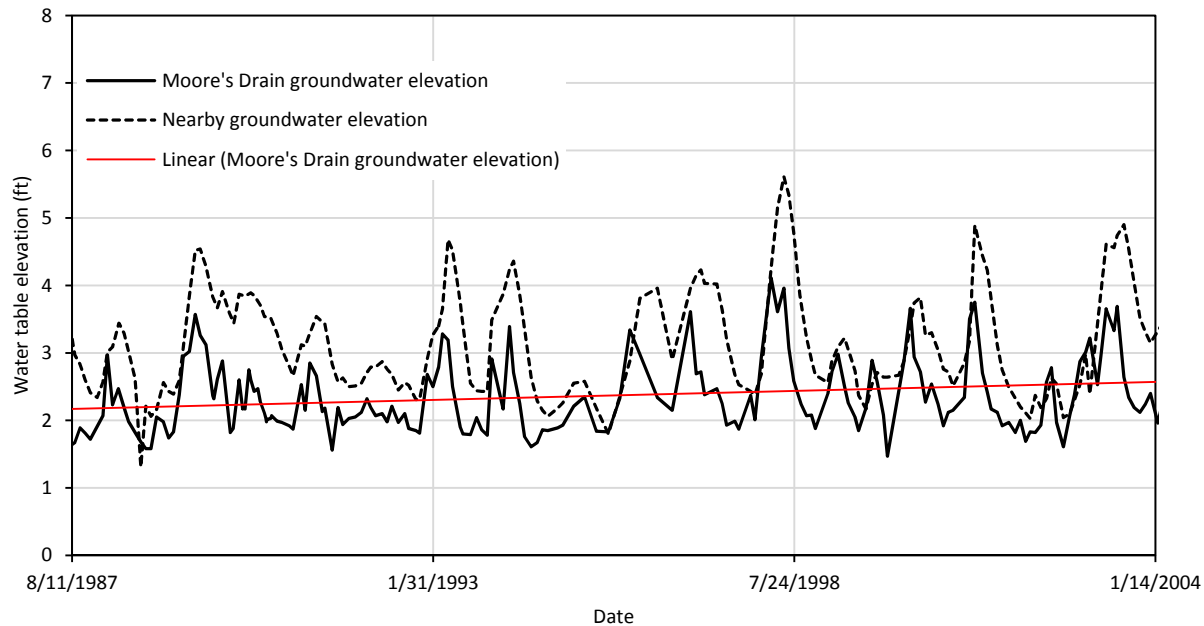
Figure 21: Comparison of groundwater elevations at the gage adjacent to Moore's Drain (USGS 410634072223601) and the nearby gage (USGS 4108580721).

Moore's Drain is constrained by the presence/absence of water in the stream. Little data was available to analyze the frequency of flow presence, though all accounts indicate that flow occurs only during significant rain events. One USGS groundwater elevation gage (410634072223601) is located 1300 ft to the north of the drain. However, only two observations of alewife presence were available to correlate to groundwater elevations, both of which were prior to the installation of the gage. To circumvent this problem, another USGS groundwater elevation gage (410858072171501) was found just east of Greenport near Orient. This data was correlated with the gage adjacent to Moore's Drain.

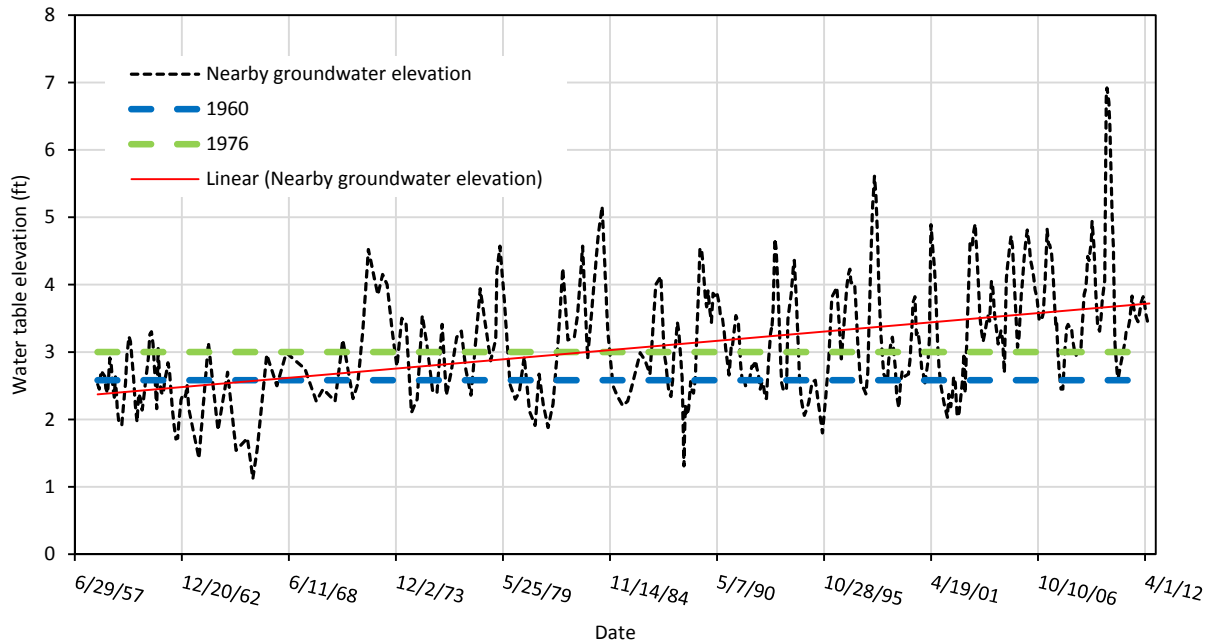
Figure 22: Groundwater elevation at a nearby USGS gage (410858072171501). The 1960 line pertains to the average groundwater elevation that year when three dead alewives were found along the stream bank. The 1976 line pertains to the average groundwater elevation that year when one dead alewife was found along the stream bank.

In 1960 three dead alewives were found along the streambanks and in 1976 one was found. Water level measurements were taken on 11 dates in 1960 and 4 dates in 1976. In 1960, the average of the water level measurements was 2.58 ft, while in 1974 the average was 3.00. Assuming that 2.58 feet is the threshold for water flow in the drain, then all groundwater levels at or above this level should permit fish passage. In spring 2012, however, water levels average 3.61 ft and no water was observed flowing through the drain. Consequently, it is doubtful that groundwater elevations ever reach an elevation to permit continual water flow adequate for fish passage. Moreover, a general linear trendline fit through the data at the nearby groundwater gage indicates that water levels have generally been rising since 1958. This trend is also reflected in the gage adjacent to Moore's Drain. Given this trend and the continued lack of both flow and use by alewife, it appears the drain will remain an artificial conduit for surface water runoff.

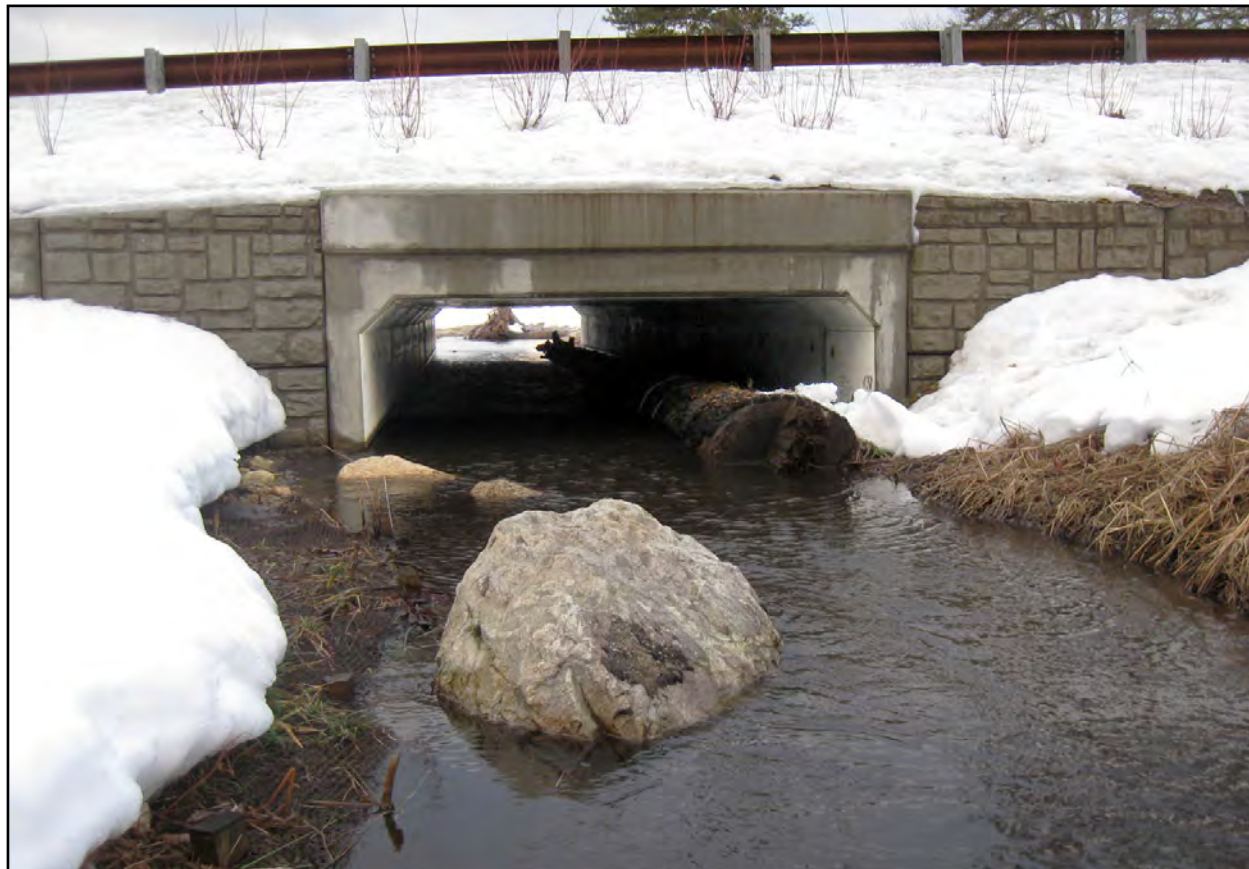
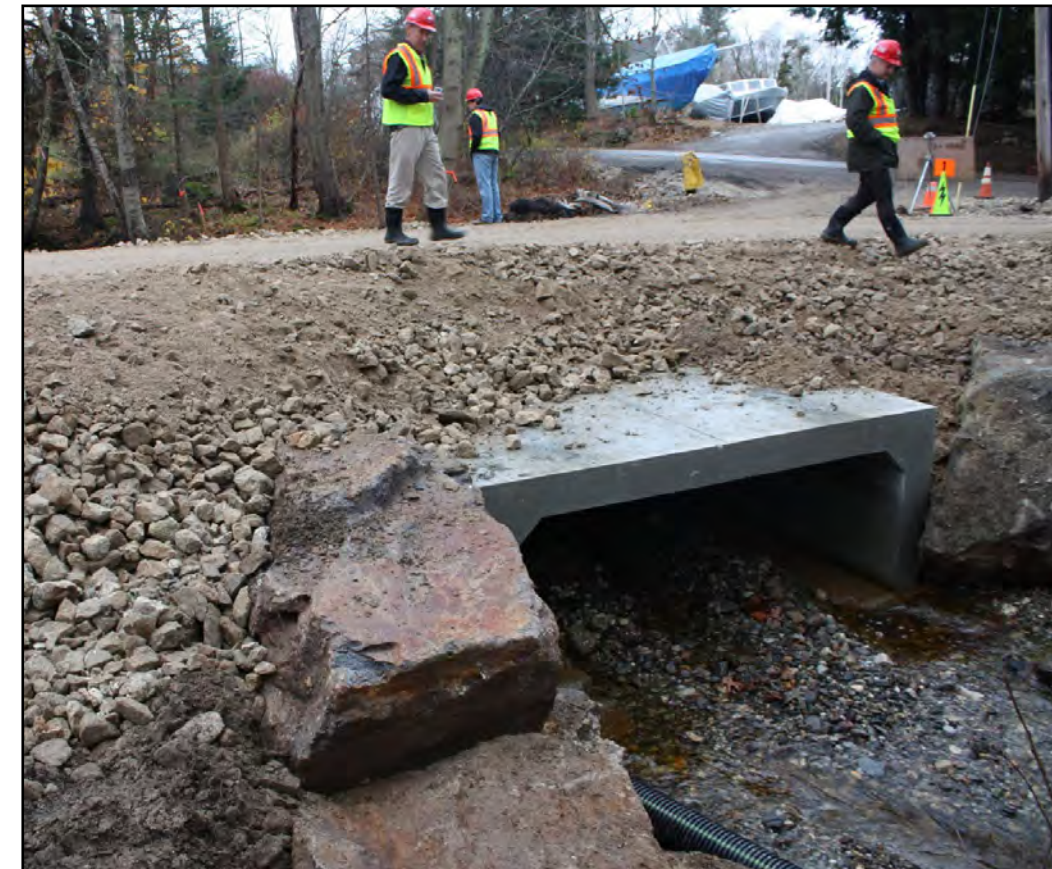
TYPICAL CROSS-SECTION (n.t.s.)

Pre-fabricated concrete box culverts, partially buried to allow a natural bottom substrate, are an effective solution for aquatic passage under roadways and other linear infrastructure barriers. Terrestrial benches incorporated within the cross-section also provide passage for a diversity of riparian species.

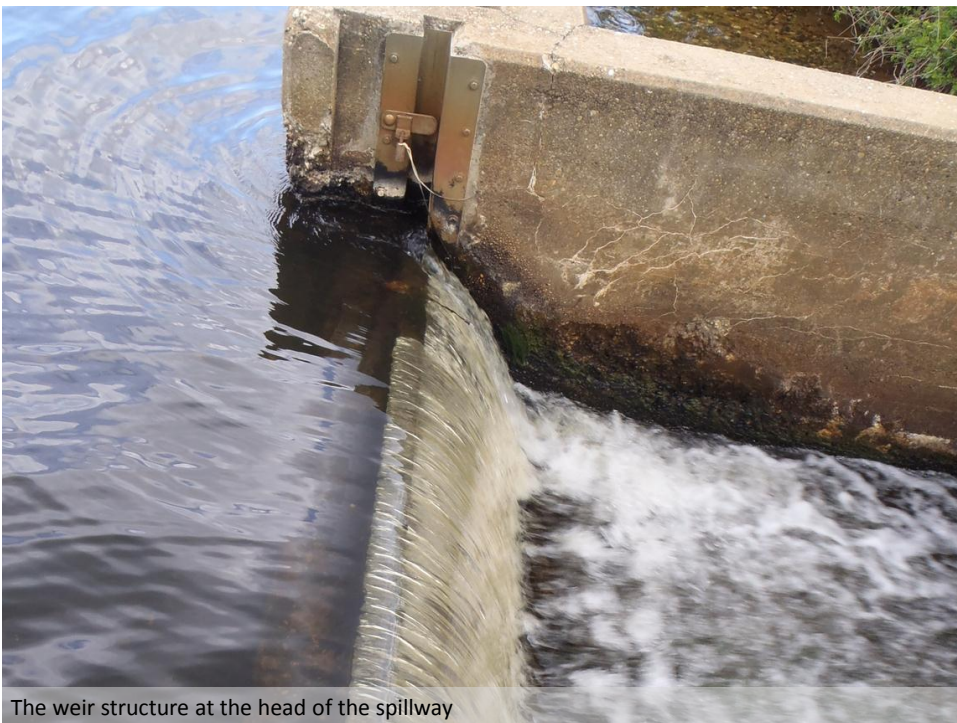
The weir structure at the head of the spillway

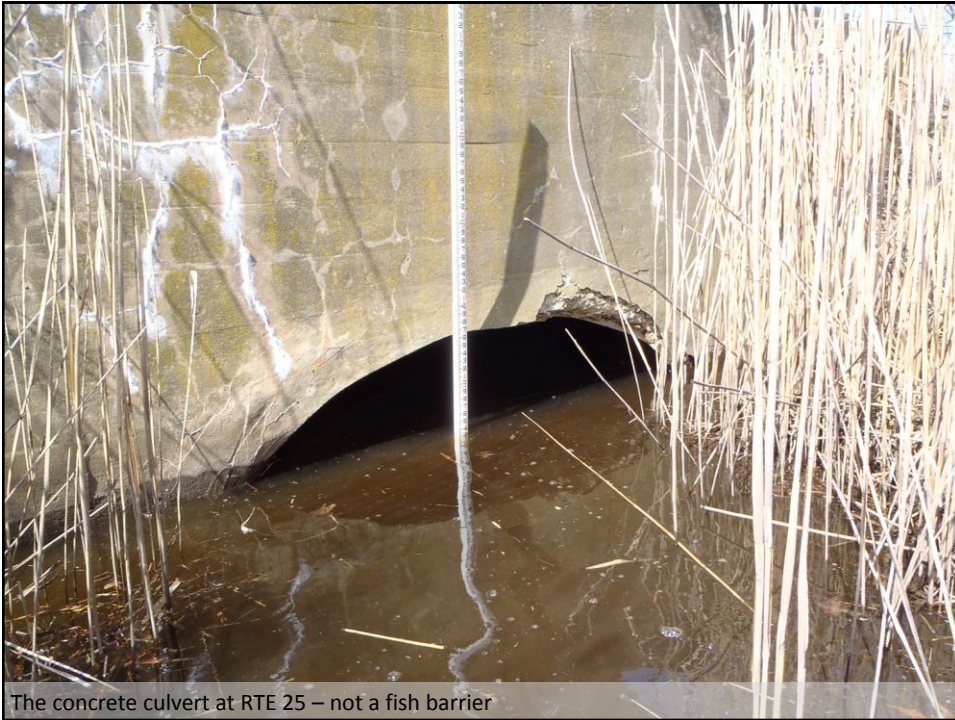
The concrete culvert at RTE 25 – not a fish barrier

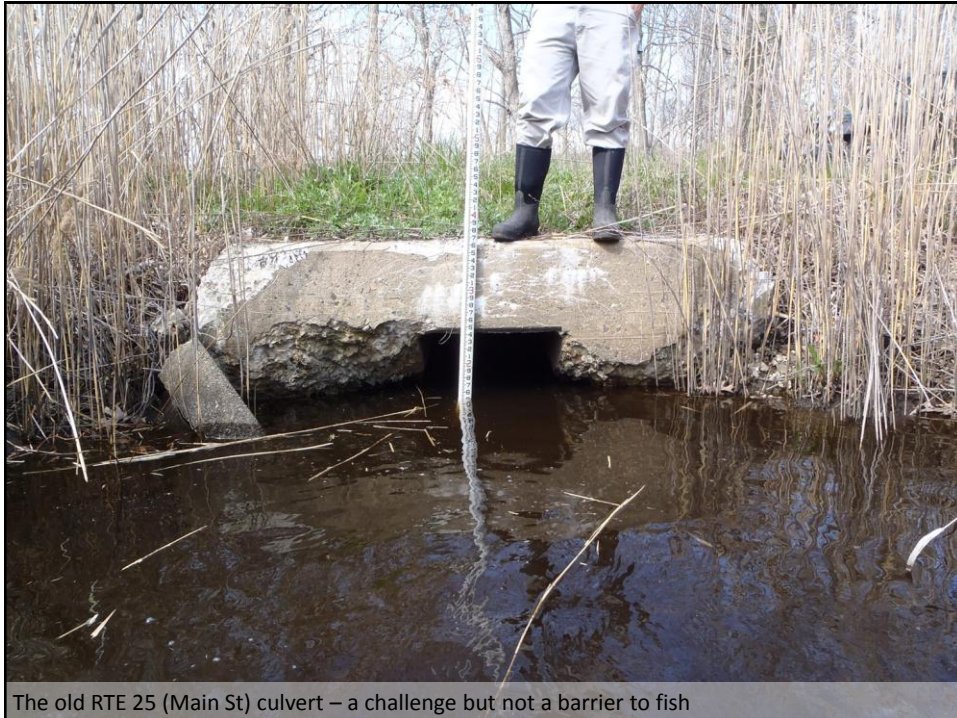
The old RTE 25 (Main St) culvert – a challenge but not a barrier to fish
