Peconic Estuary Program 2011 Long-Term Eelgrass (Zostera marina) Monitoring Program

> DRAFT Progress Report 12 May 25, 2012

> Submitted By: Christopher Pickerell and Stephen Schott

Cornell University Cooperative Extension of Suffolk County Marine Program

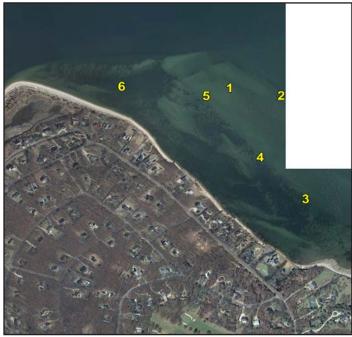
Figure GB-1. An aerial view of the Gardiners Bay eelgrass meadow with monitoring stations indicated by the superimposed numbers.

The Gardiners Bay eelgrass monitoring site is located on the east side of Hay Beach Point on Shelter Island. The eelgrass meadow starts near the channel connecting Greenport Harbor to Gardiners Bay in the north and extends southward toward Cornelius Point (Figure GB-1). This site is the most exposed, high-energy eelgrass meadow of the original six monitoring sites. The eelgrass meadow is very patchy and an aerial view of the meadow (Figures GB-1 and GB-4) illustrates the natural appearance of

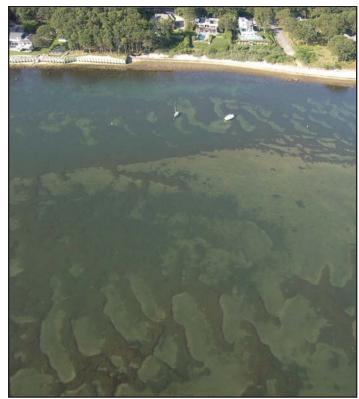
Figure GB-4. An aerial photograph (2008) showing the patchiness of one section of the Gardiners Bay eelgrass meadow.

While most of the conditions in the Gardiners Bay eelgrass meadow are within the tolerance of the plants, the meadow continues to suffer loss of area. Impacts to the meadow from boating (prop scarring) and shellfishing (i.e., recreational clamming) result in fragmentation of the meadow and create edges that can be eroded by waves, currents and animals. The hardening of the shoreline over more than half the length of the meadow exposes the nearshore edge of the meadow to reflected wave forces and erosion.

While the hardened shoreline is not a problem with a simple solution, the impact from boats and shellfishing could potentially be solved with education and the posting of advisories indicating the presence of eelgrass and its importance to the Estuary. Also, the placement of a navigation buoy between Hay Beach Point and the existing buoy would likely reduce the number of boats that "cut" the buoy and cross the eelgrass meadow.

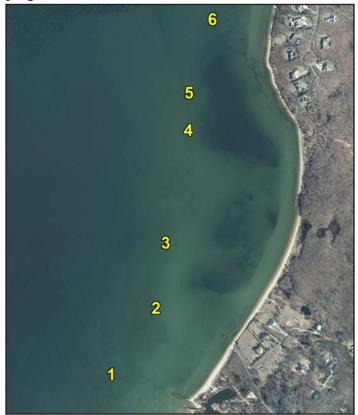
Figure NWH-1. An aerial view of the Northwest Harbor eelgrass meadow with monitoring stations indicated by the superimposed numbers.

As indicated in Figure NWH-1, the monitoring program in Northwest Harbor is relegated to the southern half of the harbor. Within this half of Northwest Harbor, depths range from 3ft (MLW) in the southern areas (Station 1) to 9ft (MLW) at the northernmost stations. The sediment at the site is almost uniform and is dominated by sand. Organic content of the sediment is low, averaging 0.70%. An increase in shell hash, primarily *Crepidula fornicata* shells, has been observed over the years at the deeper stations. The shallow stations, in the southern areas, show a general lack of coarse sediment or shell. As mentioned above, Northwest Harbor is relatively sheltered in all directions. The harbor rarely experiences high wave action and most of the monitoring stations are in water deeper than 6ft (MLW), so there is likely limited impact by waves on these areas of the bed. Current in Northwest Harbor is minimal as well.

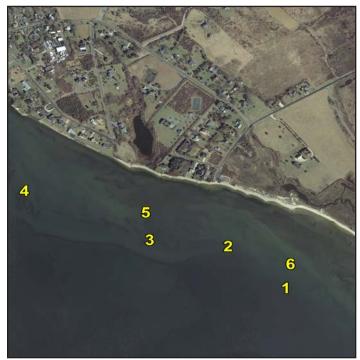
Figure OH-1. An aerial view of the Orient Harbor eelgrass meadow with monitoring stations indicated by the superimposed numbers.

The Orient Harbor eelgrass meadow, while sheltered from most of the prevailing winter winds, does experience moderate wave action from winds out of any of the western directions that blow for a significant duration. The sediment in Orient Harbor is predominantly sand (average of 62.9%), but it also contains a significant gravel fraction of 30.8%. The average organic content is higher than Gardiners Bay and Northwest Harbor, but it is still at a level that is within eelgrass's tolerance at 1.18%. Typically, the coarser sediments are found closer to shore in the shallower waters with the sand and organic content increasing in the offshore portions of the meadow.

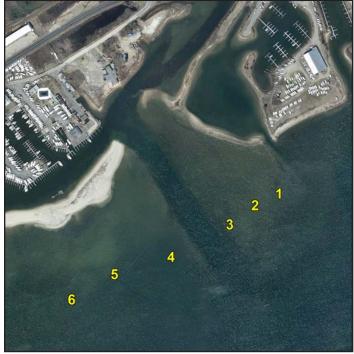
Figure SB-1. An aerial view of the Southold Bay monitoring site with monitoring stations indicated by the superimposed numbers.

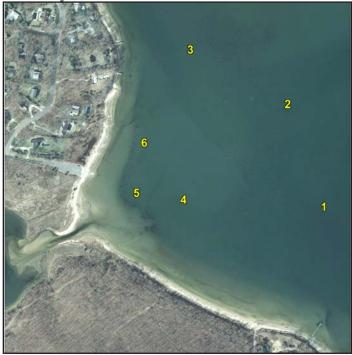
Figure TMH-1. An aerial view of the Three Mile Harbor monitoring site with monitoring stations indicated by the superimposed numbers.

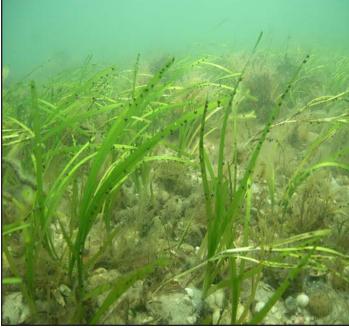
Figure CP-4. An underwater view of an eelgrass patch at Cedar Point, East Hampton.

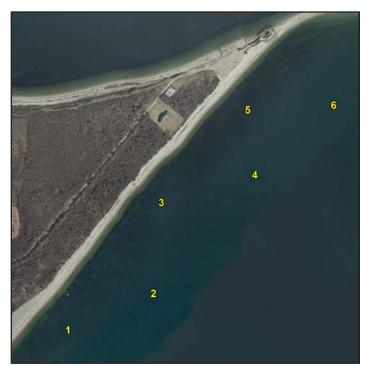
Figure OP-1. An aerial view of the Orient Point monitoring site with monitoring stations indicated by the superimposed numbers.

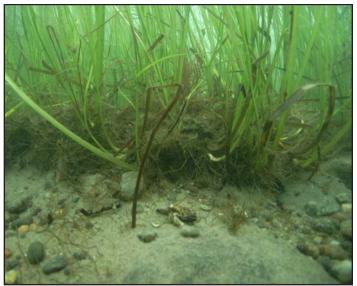
The Orient Point meadow has large fetches in almost all directions. Except for winds out of the west and northwest, the site will feel the influence of almost any wind at the site. Waves, such as those experienced during the storm event in October 2006, can be large and result in mass movement of sediments at this site. Orient Point is considered to be a high wave exposure and moderate current site. The meadow shows obvious indications that the wave and current forces influence the meadow. Erosional "blowouts" are common throughout the shallow portions of the meadow. Where these blowouts occur, the eelgrass meadow abruptly end at a drop off of several inches to one foot. The edge of the meadow is often left hanging over the "blow-out." Figure OP-2 shows

Figure OP-2. A side view of a "blowout" where a opening has been eroded in the meadow. The eelgrass is left to grow out over the edge where it is eventually dislodged. Also notice the coarse sediments left behind after the erosion.

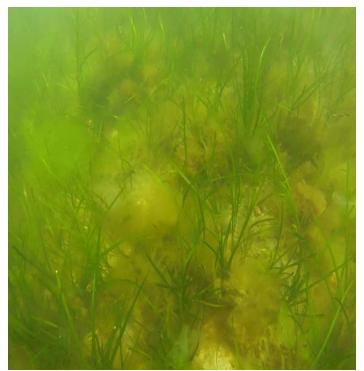
Figure OP-5. Eelgrass growing in the shallow, near-shore area of the Orient Point meadow in April, 2012.
