5.0 Richmond Creek Subwatershed

Restoration Opportunities
Richmond Creek
Subwatershed
Southold, NY

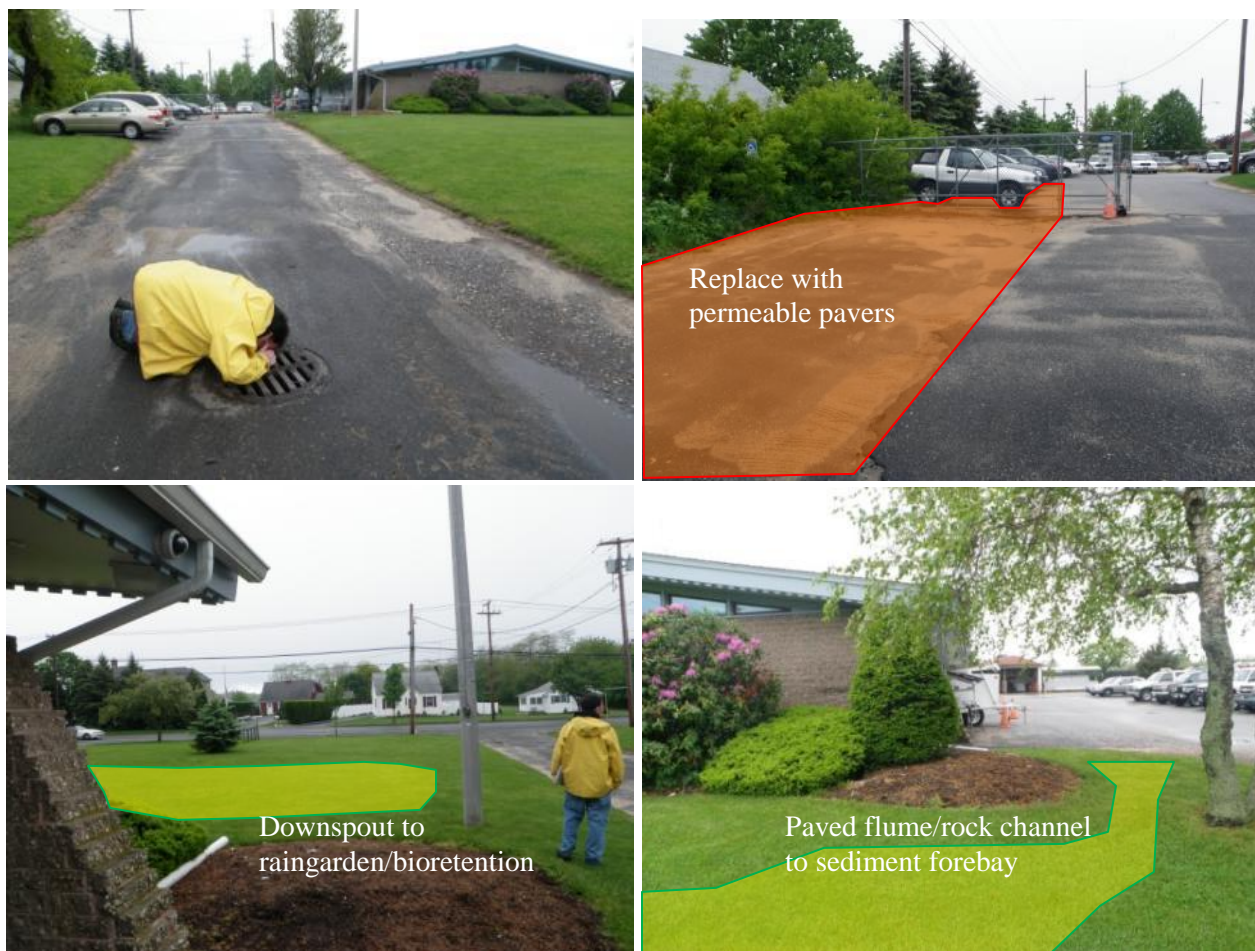
Figure 5.2. Catchbasin at high point in entrance drive (top left); replace deteriorated pavement with permeable pavers (top right); location of bioretention at highly visible location in front lawn area (bottom left and right).

Lane. Full access to the site was restricted during the field assessment; however, the rooftop drains to an extensive lawn area in the front via exposed downspouts. A portion of the parking area on the south side of the building drains down the drive aisle to the street, bypassing an existing leaching catchbasin (Figure 5.2). The parking and fueling areas behind the buildings mostly drain towards an existing catchbasin (presumably leaching) in the rear parking lot. A significant amount of sediment was observed on the pavement, and there is high potential for oil/gas and other auto-related pollutants to be conveyed by stormwater and discharged untreated into groundwater or to a nearby surface stream.

The proposed concept for this site is to divert runoff from the roof and rear fueling/parking lot into a raingarden or **bioretention facility** in the front lawn. The location and design of the practice will depend on the actual location of underground utilities and septic drain field, soils, and other siting and aesthetic preferences of the Police Department. Directing rooftop runoff to this area is relatively simple; redirecting runoff from the catchbasin in the rear of the building may involve modification of the existing structure to direct flows to the practice, or regrading to passively direct flows to a paved flume/channel into a pretreatment forebay. In addition, because the asphalt parking area to the side of the building is in poor condition, we recommend repaving parking spaces with **pervious pavers**. The Town is currently in the process of expanding this parking lot, providing an excellent opportunity to incorporate advanced stormwater management such as the recommended pervious pavers and bioretention facilities in the design as feasible.

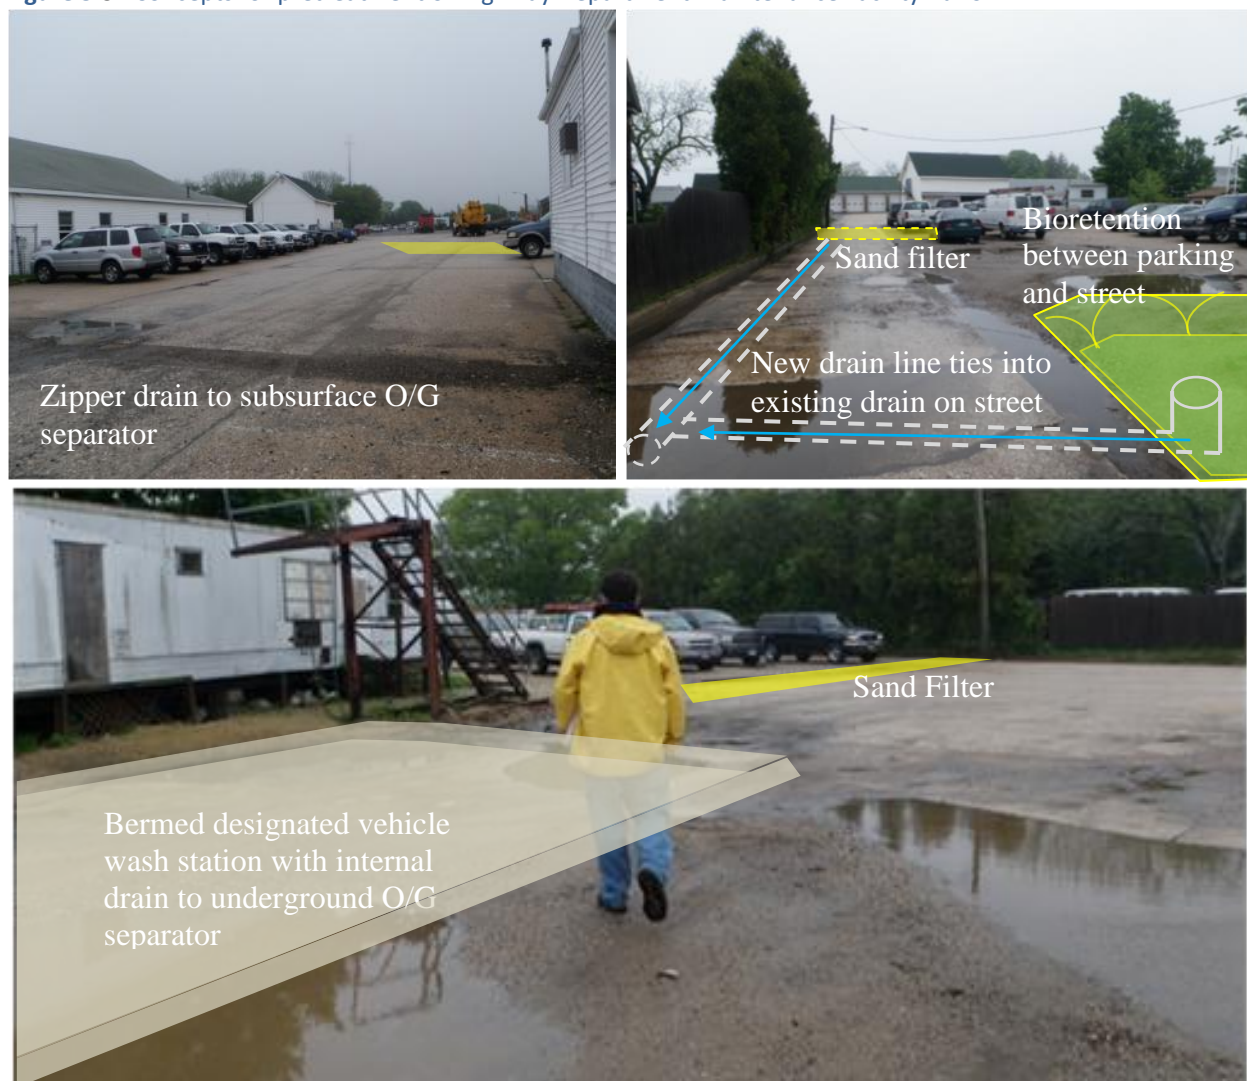
Figure 5.3. Concepts for pretreatment of Highway Department Maintenance Facility Runoff

Located near the corner of Main St. (Route 25) and Peconic Lane, the Highway Facility contains administrative offices, equipment and vehicle storage, material storage, and fueling and maintenance areas and is considered a stormwater hotspot. Currently, there is no formal stormwater management on site. Runoff drains down the entrance road to a clogged catchbasin that is tied into the drainage infrastructure along Main St., which then discharges to the stream. There is one existing leaching catchbasin in the vehicle wash area that is chronically clogged.

The proposed concepts for this site include: a) pretreatment of runoff from the fueling and garage area with a **two-chambered perimeter sand filter** and providing a designated wash station with **oil/grit separator**; b) collection of runoff from roof and parking/driving lanes in the northern portion of site in a zipper drain to be conveyed to an **underground oil/grit separator**; and c) paving of south parking area and installation of a **bioretention cell** between the sidewalk and parking lot (Figure 5.3). Overflows from each of these practices will tie back into the existing drain lines on the street. The Town is currently in the process of providing new facilities at this location, providing an opportunity to incorporate the recommended stormwater management practices in the design as feasible.

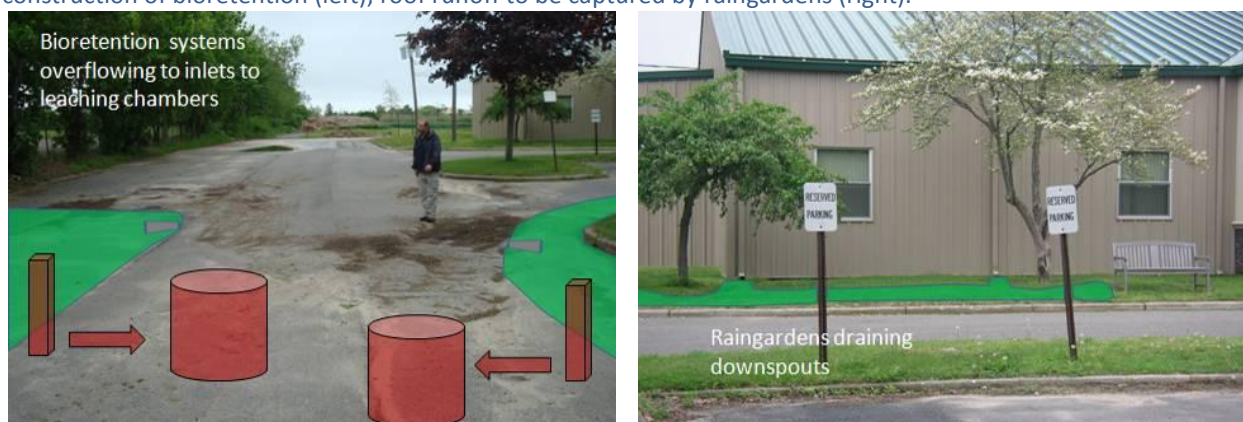
Figure 5.4. Northernmost entrance to Southold Town Recreation Center with proposed pavement reduction and construction of bioretention (left); roof runoff to be captured by raingardens (right).

The Southold Recreation Center is located northeast of Peconic Lane between Route 25 (Main Street) and Carroll Avenue. The facility is surrounded to the east/southeast by vineyards. The site has two wide access entrances off of Peconic Lane and supports a parking area to the east and west of the Recreation Center building. The rear (eastern portion of the site) supports a small dog park and a large detention basin. The access driveways and parking areas mostly drain towards the detention basin. A significant amount of sediment was observed on the pavement. The proposed BMP concept for this site would be to **reduce pavement** along the entrance driveways, and constructing **bioretention systems** that would overflow to inlets and then into **leaching chambers** (Figure 5.4). Rooftop runoff from the building itself would be directed to small **raingardens** along the building. No reduction in dog run area is needed, and reductions in excess pavements will reduce the Town's future paving costs. Non-structural practices such as **street sweeping** are also recommended, and this is good location for **educational signage**.

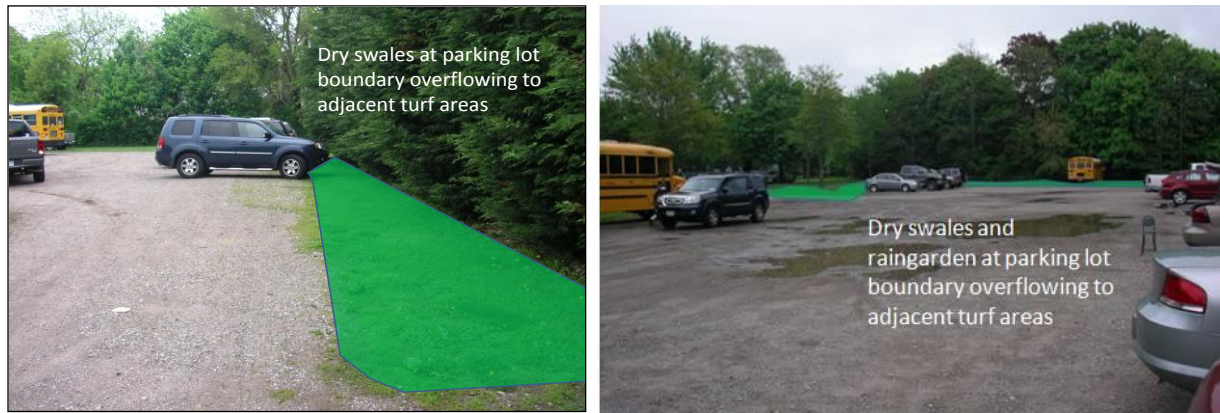
Figure 5.5. Location of proposed dry swales and raingardens.

The Jean W. Cochran Park is located southwest of Peconic Lane south of the existing railway and northwest of the Carroll Avenue/Peconic Lane intersection. The existing gravel parking lot has no existing stormwater management practices and ponded stormwater was observed at the time of the site visits (Figure 5.5). The proposed concept for this site is to direct runoff from the gravel parking lot to **dry swales** and convey stormwater to twin **raingardens** along the park entrance driveway. Overflow would be directed to adjacent turf areas and the existing drainage swale next to the hockey rink, which already has overflows to underground leaching chambers. Additional vegetation could be added to the existing swale make it more effective. Because this site is a public recreational park, this site is highly visible, and the proposed stormwater retrofit practices could be used as an educational opportunity. The aesthetics of this retrofit site would be important, and **educational signage** describing the stormwater practices and their importance is encouraged.

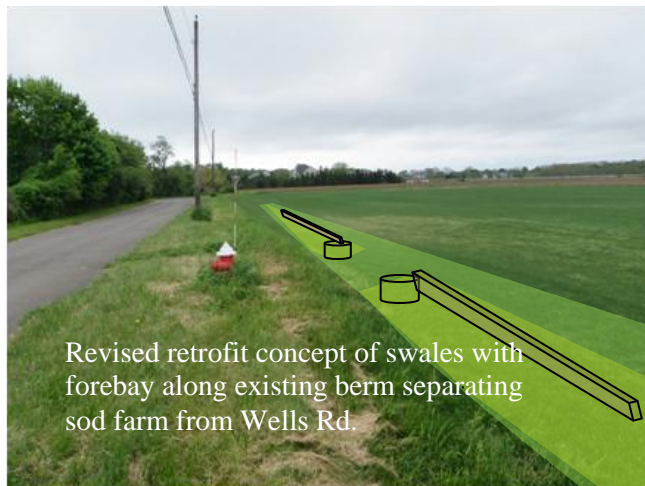
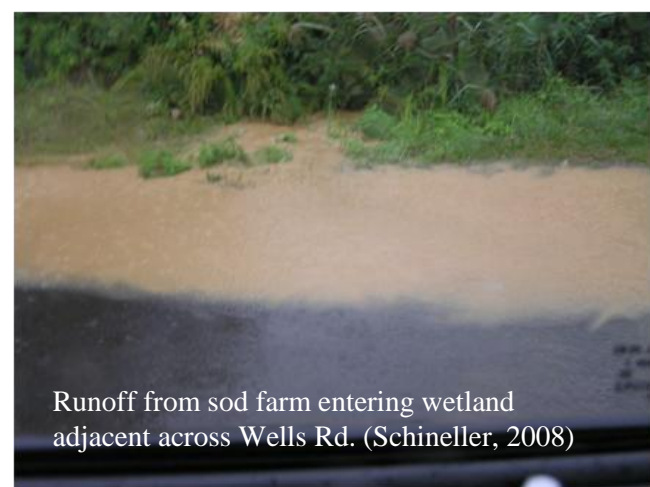
Figure 5.7. Series of photographs documenting stormwater conditions and proposed retrofit concepts at sod farm.

During large rain events, runoff from the sod farm overflows across Wells Road in two primary locations, where it ultimately is discharged into the adjacent wetlands. When the sod has been harvested, runoff over exposed soils mobilizes fine soil particles and results in turbid stormwater plumes into the open water (Figure 5.7). Additional pollutants of concern include high levels of agricultural chemicals such as fertilizers and pesticides. A proposed retrofit design plan has already been prepared (provided by P. Schineller, 2011) that involves swales with infiltration leachers in the newly Town-acquired 50-ft wide parcel (RC-R8) and within a 50-ft wide easement (RC-R9) immediately adjacent to the Wells Road right-of-way. Given the amount of suspended sediment anticipated and the absence of pretreatment provided in the proposed design, clogging of the practice is likely. To avoid this issue, we recommend a modification of the design to include a **berm, check dams, or timber weirs in the swales** to create a **pretreatment forebay** and to extend the flow path prior to outlet at leaching basins. The Town already intends to install a barrier between the sod farm and the swale area to prevent inadvertent encroachment by future farming operations, which will be very effective. We also recommend maintaining a **grass filter strip** from the edge of the swale bed and thick native grasses in the secondary portion of the swale to increase sediment deposition prior to infiltration. Overflows from the swales should be directed to the existing culvert across Wells Rd. Maintenance will require removal of sediment from the pretreatment chamber.

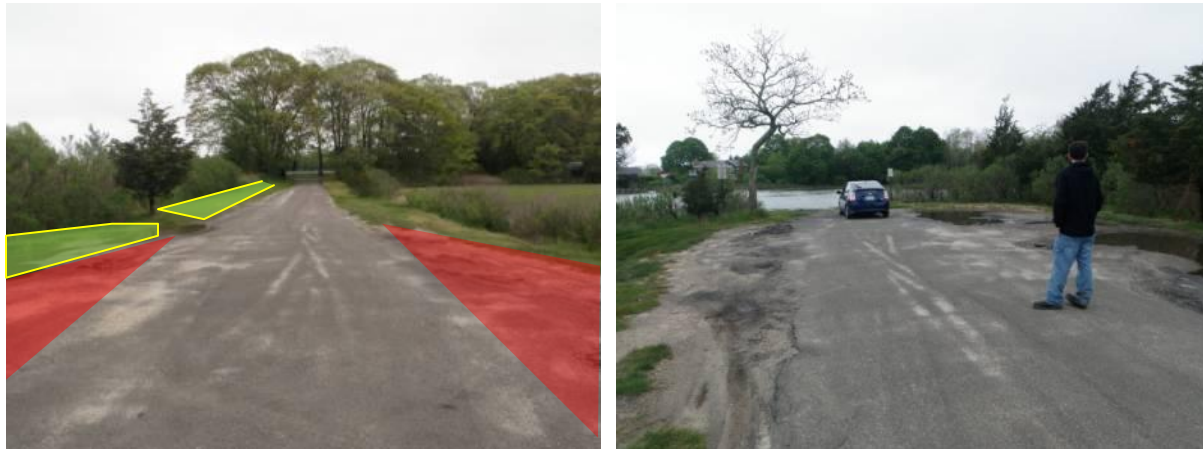
Figure 5.8. Deteriorated pavement at Wells Rd. landing and potential retrofit areas.

A public boat ramp is located at the end of Wells Rd. that, reportedly, is infrequently used. Installation of a **dry swale** along the northside of entrance drive could provide some water quality benefit and help reduce ponding that occurs on the turnaround bulb (Figure 5.8). There may also be opportunity for installation of a small **raingarden** on the north side of the turnaround bulb where ponding occurs. Space for parking is still available on the southern side of the entrance way. Much of the pavement and ramp at this location is deteriorated. If repaving occurs, consider replacing some of the existing pavement on the bulb flare-outs with concrete **grid pavers** filled with crushed oyster shell or stone. No construction should occur within the surrounding wetland areas.

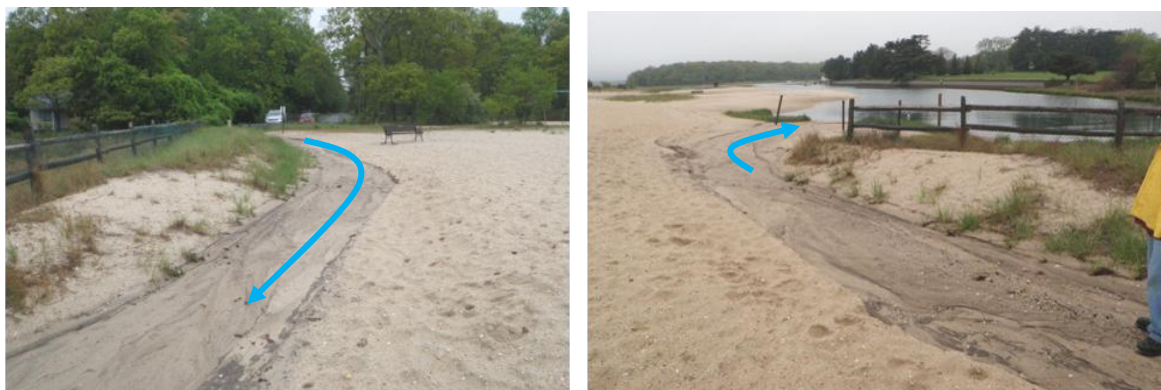
Figure 5.9. Runoff from road drains from parking area, across beach, and into waterway at South Harbor Park.

This site is a highly visible location for a demonstration project at a local beach park where untreated runoff currently leaves a visible gully to the adjacent waterway. Currently, runoff from South Harbor Rd. flows along the edge of pavement to the road end and carves a channel through beach sand then into waterbody (Figure 5.9). The retrofit concept here is to **remove approximately 75 feet of pavement** at the dead end and capture remaining runoff in a **bioretention area** (Figure 5.10), while maintaining a pathway to the beach. We recommend conveying flows to the bioretention area via shallow roadside swales and paved flumes where necessary, with overflows directed to the existing wetland area. This project will add vegetated buffer to the wetland area, water quality treatment, and public education.

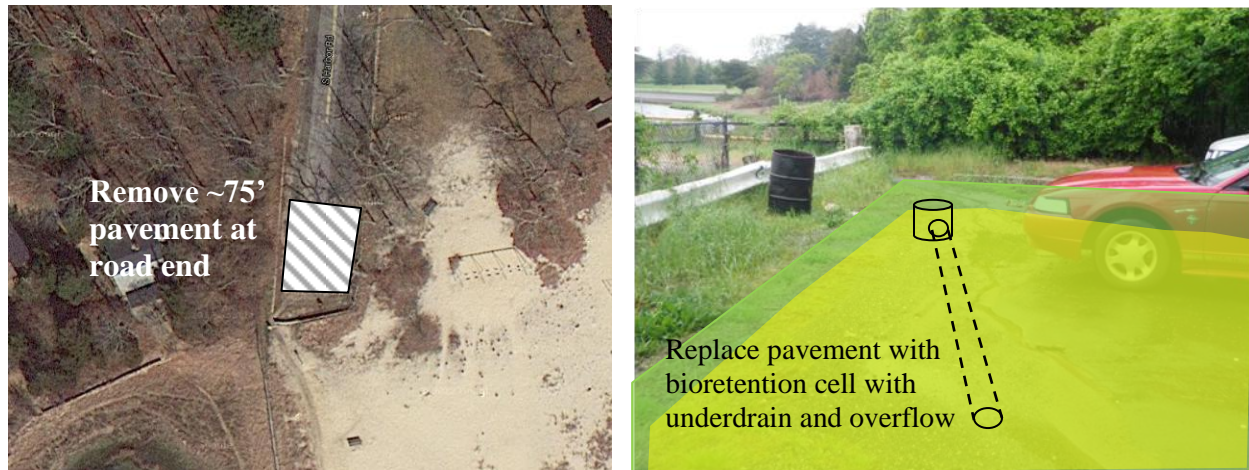
Figure 5.10. Retrofit concept at South Harbor Park.

The retrofit concept here is to **remove approximately 75 feet of pavement** at the dead end and capture remaining runoff in a **bioretention area**, while maintaining a pathway to the beach. Shallow roadside swales and paved flumes where necessary should be used to convey flows to the bioretention area, with overflows directed to the existing wetland area. A shallow berm/speed hump should be used as needed at the park entrance drive to keep runoff along the road flowing towards the bioretention.

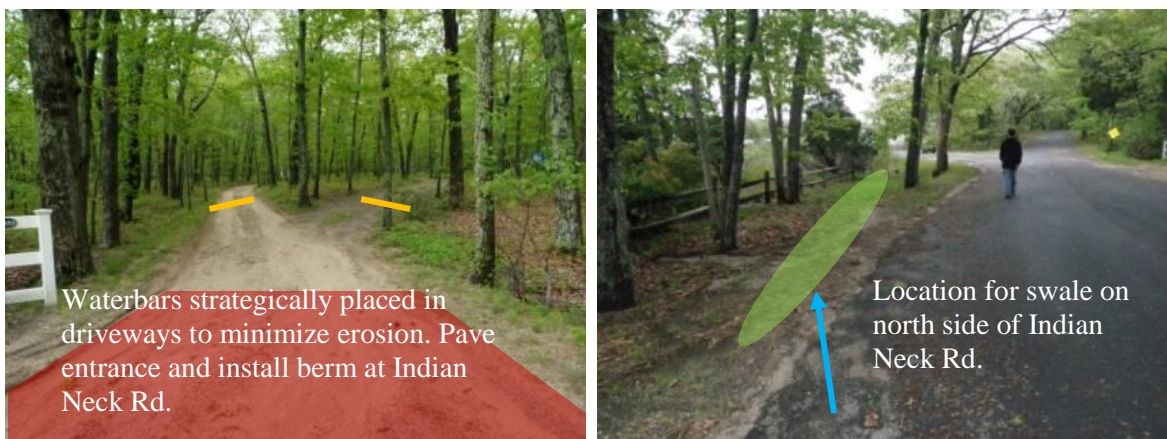
Figure 5.11. Proposed retrofit and erosion control practices at Indian Neck Landing.

The proposed concept is to **remove some of the pavement** on the eastern side of the entrance and install a **shallow bioretention cell** with a sediment forebay and salt tolerant intertidal plant species (Figure 5.11 and 12). On the other side of the landing, a narrow **vegetated swale with check dams** could be inserted into the road right-of-way to capture a portion of Indian Neck Rd. No construction should occur within the surrounding wetland areas, nor should boat trailer turnaround access be restricted. Strategically located **waterbars** along the private, unpaved drive could help reduce road surface erosion and the deposition of sediment at the landing (the Town would need to collaborate with private property owners or gain easements for this work). Opportunities exist for enhancing existing wetland vegetation and educating users on watershed issues.

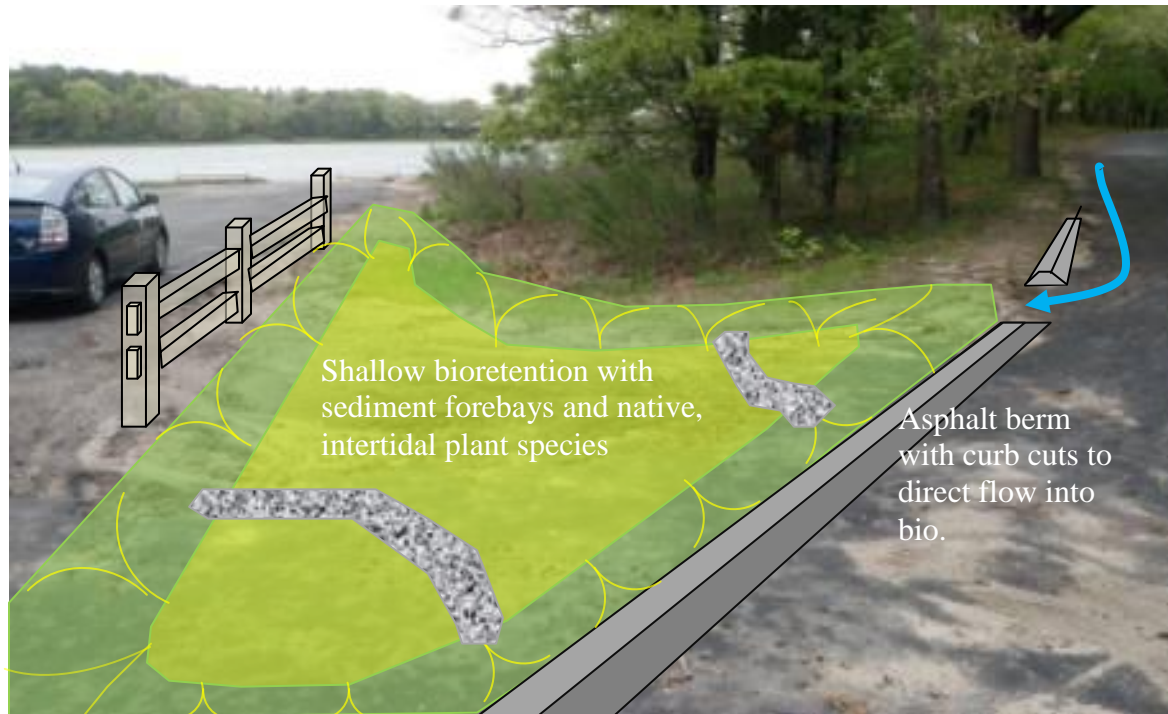
Figure 5.12. Proposed retrofit and erosion control practices at Indian Neck Landing.

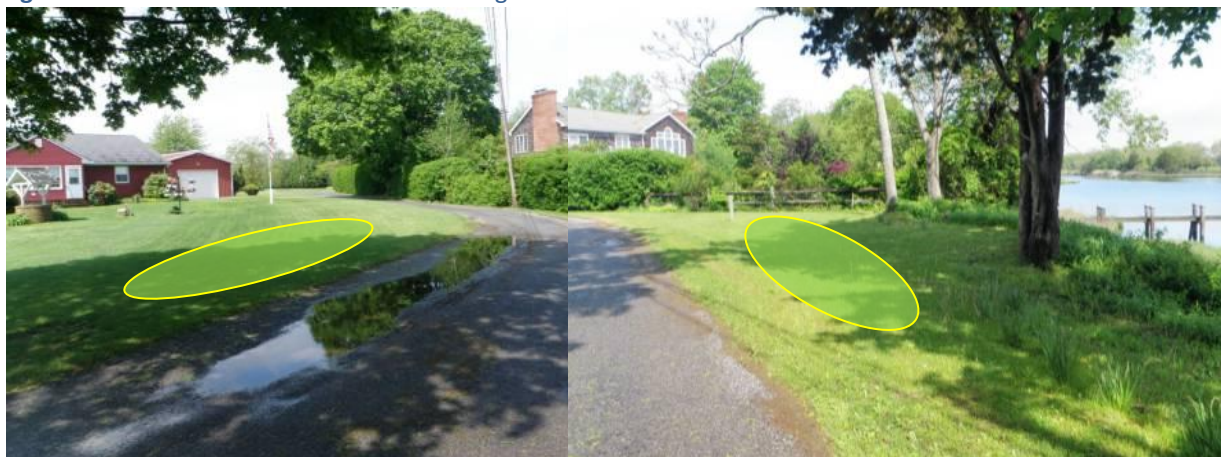
Figure 5.13. Location of small residential raingardens on Kielbasa Rd.

There is no formalized drainage network along this residential road; however there is a good opportunity for demonstration raingardens adjacent to the water (Figure 5.13). Installation of a **raingarden** on either side of the road may help alleviate ponding on the road and extend the longevity of the asphalt, provide some water quality treatment, and provide an opportunity for community stewardship. Easements will be needed for work along this private road.

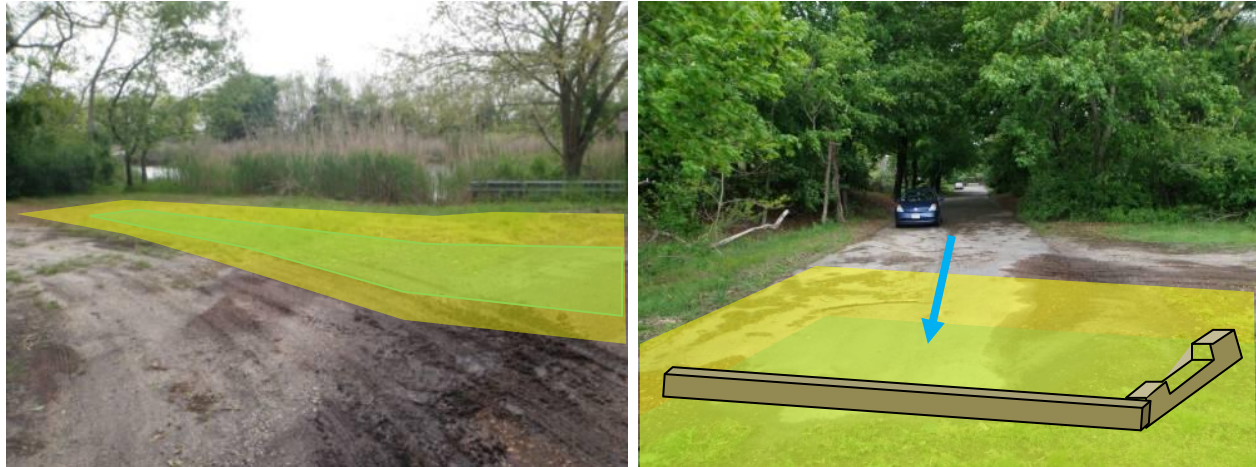
Figure 5.14. Spring Lane bioretention with pretreatment forebay.

The site is at the end of a residential dead end street in a grassed open space area, with an access trail to the water. Runoff currently flows down the road to the end, where sediments and organics are deposited and ponding occurs. There is also an unpaved cul-de-sac used for turnarounds, which looks to be used fairly often. The concept for this site is to **remove excess pavement** at the end and install a large **bioretention** with overflow outlet to the marsh (Figure 5.14). Paved flumes and asphalt berms are proposed to direct flow into a sediment forebay (made with timber weir) for pretreatment. In addition, the concept recommends formalizing the parking area with **gravel-pave** (or other pervious pavement option), installing a split rail fence to prevent vehicle access, providing educational signage, stabilizing the unpaved turnaround, and restoring native buffer vegetation.

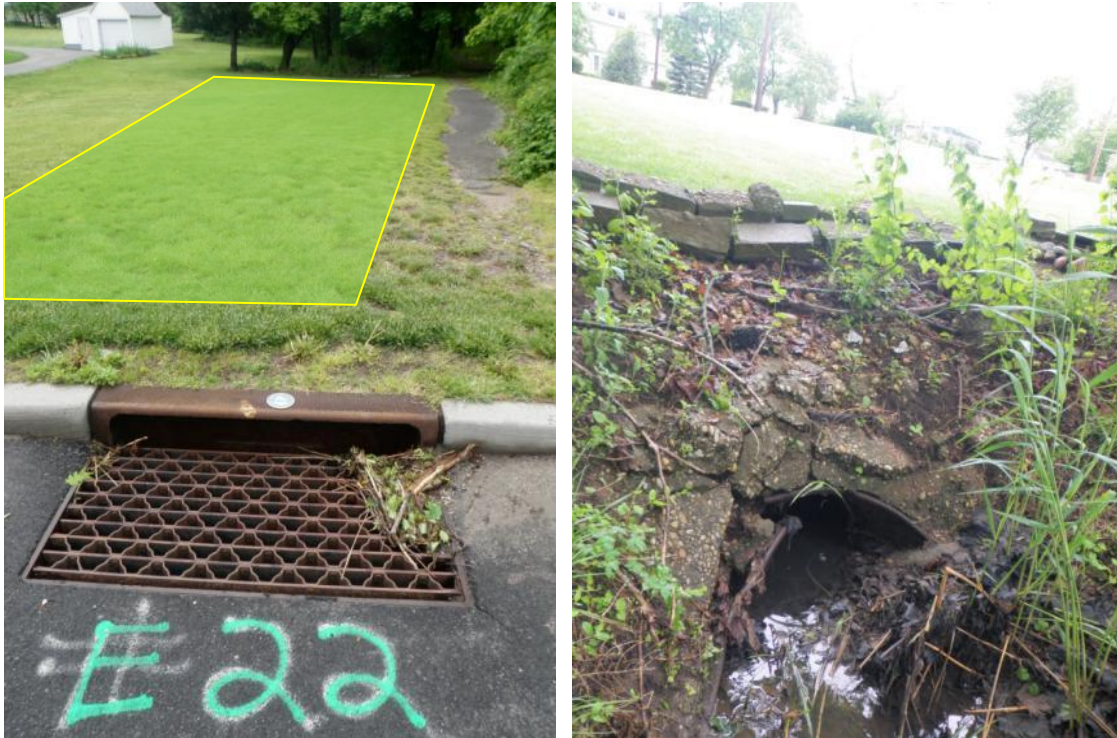
Figure 5.15. Proposed location for bioretention cell between existing catchbasin and outfall pipe.

This site provides an opportunity to divert flows from the drainage system on Main St. into an off-line, bioretention system prior to discharge at an existing 36-inch corrugated metal outfall pipe. There is a small open grassed area between a catchbasin on the road and the outfall, which discharges to a surface stream. The outfall pipe and headwall are in need of repair/maintenance (Figure 5.15). The concept is to modify the existing catchbasin (or install up-gradient inlets) to divert low flows to a surface **bioretention** to filter the water before it discharges through an underdrain system back to the outfall pipe. Large flows can bypass the system. It is assumed that this area is part of an existing drainage easement. There is a paved access path adjacent to the stream, and a wetland restoration project could be coupled with the installation of the bioretention facility.

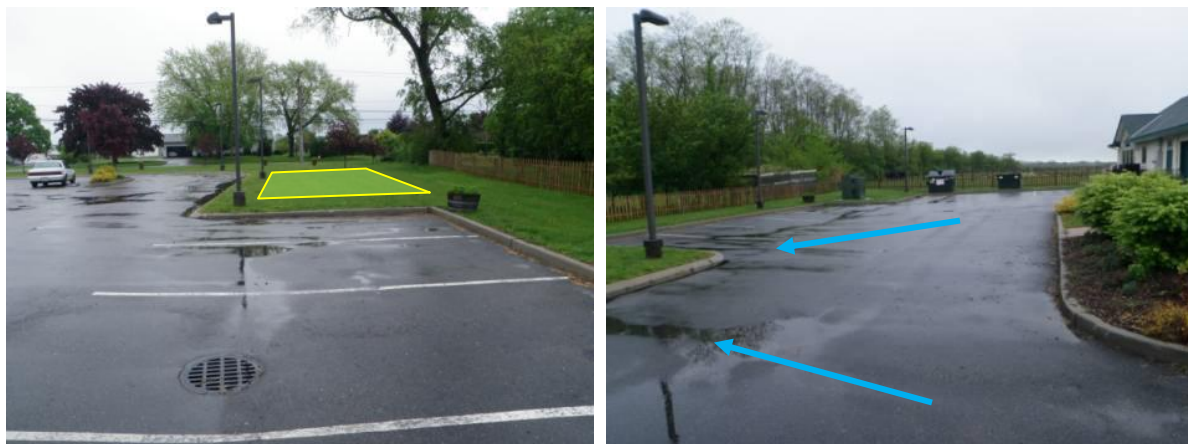
Figure 5.16. Location of existing catchbasin and proposed bioretention.

Runoff from the parking area in the front of the building currently drains directly to a leaching catchbasin with no pretreatment for water quality. There is an existing grassed area adjacent to and downhill from this parking area that can be easily converted to **bioretention facility** (Figure 5.16). The concept includes covering the existing catchbasin and regrading the surrounding pavement to convey flows to the practice area. Install curb cuts and paved flumes where necessary to convey flows into the practice. Relocate the leaching basin to bioretention to manage overflow. This is an opportunity for a property owner to construct a stormwater retrofit for positive marketing, and/or an easement would be required to install this retrofit.

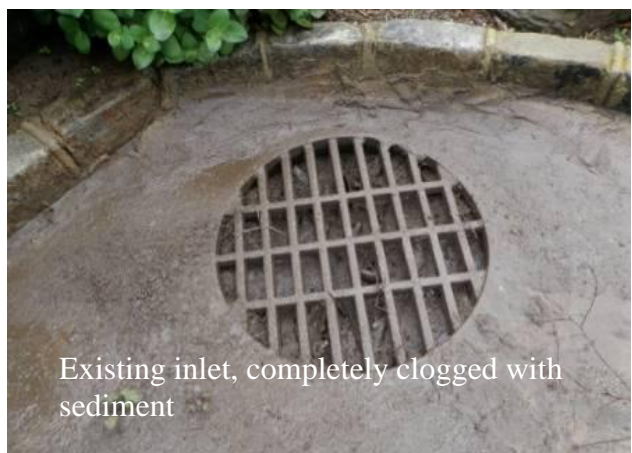
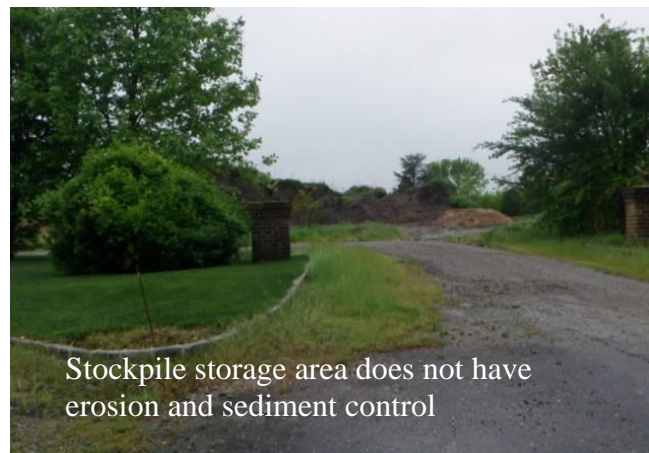
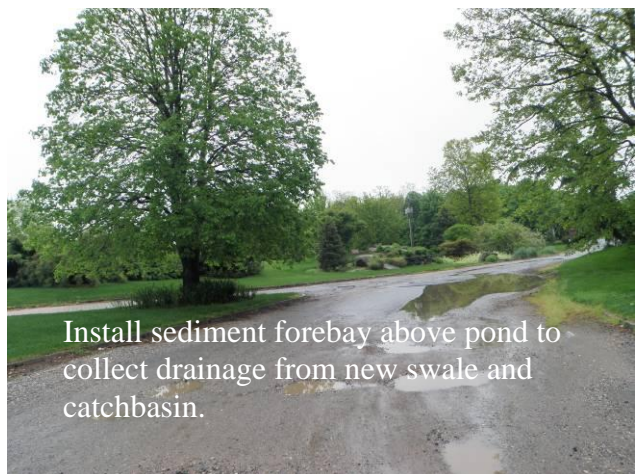
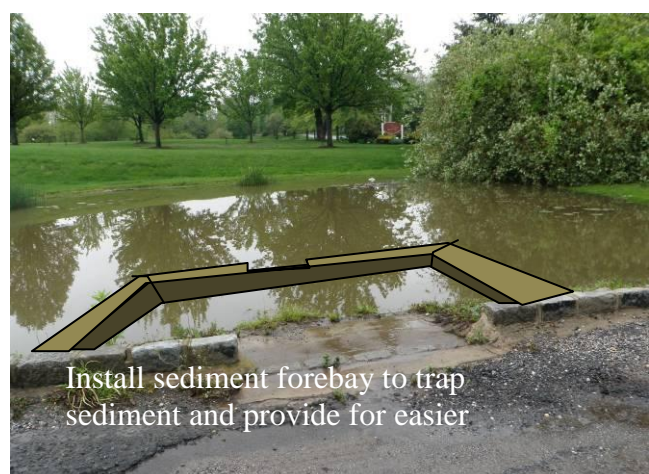
Figure 5.17. Sedimentation from surrounding area has clogged existing drainage infrastructure. Stabilizing exposed stockpiles and providing pretreatment for existing detention basins can help reduce maintenance and enhance pollutant removal.

Much of this private site drains to an existing wet pond that also serves as a focal point for the business. The existing drainage inlet to the practice is clogged with sediment, and the pond has likely lost some capacity. Much of the sedimentation may be derived from erosion of exposed stockpiles stored in the back of the property. Simple modification of the pond inlet structures should help improve pond performance and improve ease of maintenance. We recommend installing an **in-pond forebay** at the existing paved flume, as well as excavating a forebay up-gradient of the pond. In addition to the pond modification, we recommend providing erosion and sediment control for the uncovered stockpile area, and installation of a swale system and small raingarden to convey/filter runoff to the new sediment forebay above the pond (Figure 5.17). This is an opportunity for a property owner to construct a stormwater retrofit for positive marketing, and/or an easement would be required to install this retrofit.

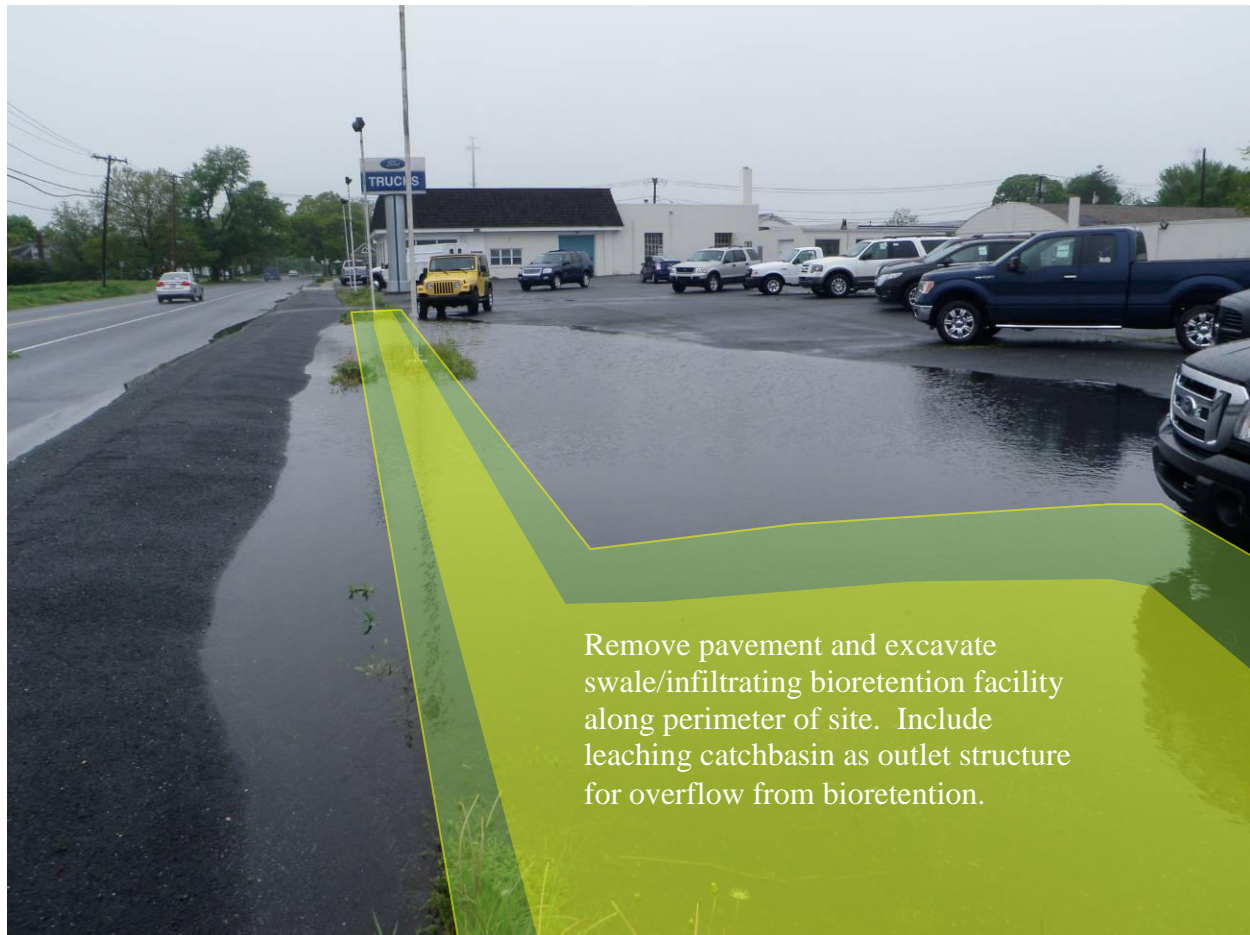
Figure 5.18. Location of ponding in corner of old Ford dealership.

This property is for currently sale; however, a recently constructed berm along the road results in a ponding situation in the northeast corner of the site. The site is almost 100% impervious, with no formal stormwater management system. All drainage flows to inlets on Main St., or evaporates. The recommended retrofit concept at this site includes installing a **pretreatment swale** to convey sheet flow from the roof and parking lot into a **bioretention facility** in the northwest corner (Figure 5.18). The soil

survey indicates good infiltration capacity at this location; therefore, we recommend the use of a **leaching chamber** as the overflow mechanism for the bioretention facility. This is an opportunity for a property owner to construct a stormwater retrofit for positive marketing, and/or an easement would be required to install this retrofit.

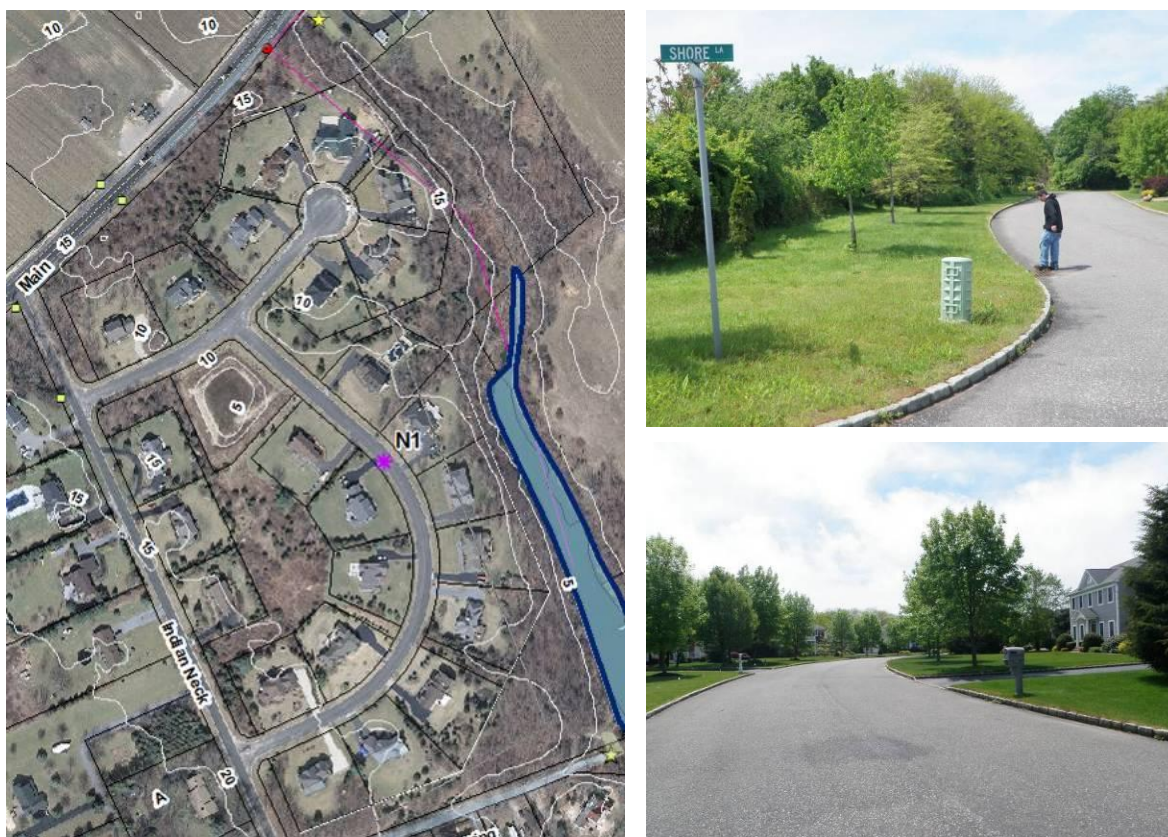
Figure 5.19. Richmond Lane neighborhood with wide streets and curb/gutter system.

Richmond lane is a newer neighborhood of 24 single-family detached dwellings that appears to be approximately five to ten years old. Located off of Indian Neck Road, the neighborhood has two main streets, Richmond and Shore Lanes. Three of the homes are accessed from Indian Neck Rd. and six homes are located around a 98-100 ft diameter, paved cul-de-sac. Both streets are relatively wide (28 ft paved) with an overall right-of-way width of approximately 50 ft. There are no sidewalks (Figure 5.19). Stormwater runoff is collected via a curb-and-gutter system and is conveyed to a central infiltration basin. The facility is fenced, thickly vegetated, and inaccessible, which limited our ability to evaluate the design or condition of the practice. The neighborhood is approximately 23 acres, a quarter of which was left as forested open space, including a protective riparian buffer that ranges between 30 and 170 ft from rear lot lines. Lots are typically half an acre in size, and on average, each lot is comprised of 20-30% impervious cover, 50% grass cover, and 20-30% landscaped area/trees. Almost all the driveways are impervious. No permanent irrigation was observed; however, a majority (60%) of the lawns appear to have high management requirements. Some sediment accumulation along curbs was observed, but no pet waste, trash, or dumping of debris was seen.

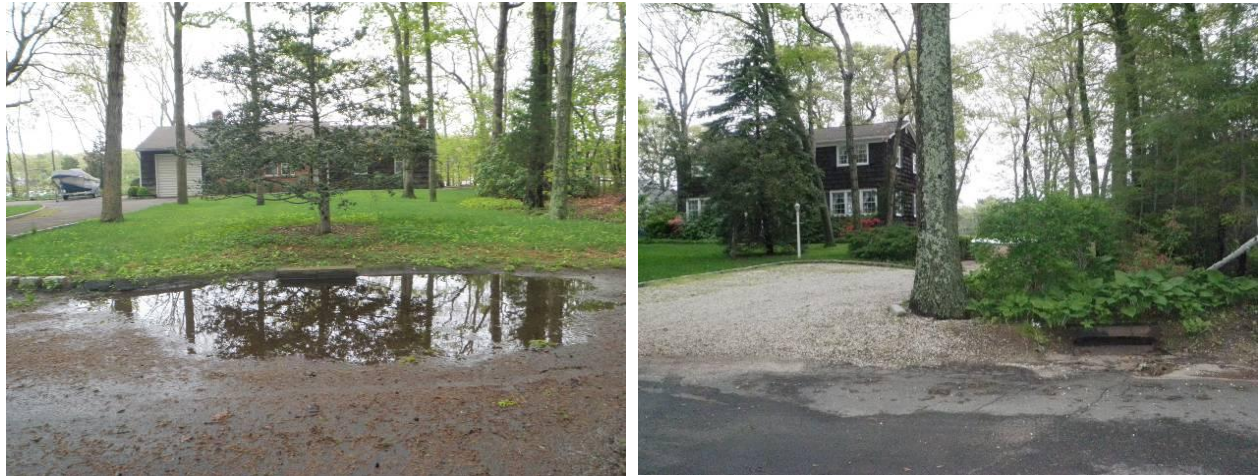
Figure 5.20. Ponding at leaching catchbasin, gravel driveway

The Wells Road residential area is located off Main Road (Route 25), south of the sod farm and north of the boat landing. This area consists of approximately 20 single-family homes on either side of Wells Rd. that appear to be approximately 5 to 25 years of age. Wells Rd. is a 26-28 ft wide, paved, open-section road with a handful of catchbasins at the low points in the road. Ponding water was observed at some of the drain inlets, most likely due to sediment accumulation (Figure 5.20). No outfalls were observed, and the catchbasins are assumed to be leaching facilities. There are no sidewalks present, and the road surface shows signs of deterioration. The overall size of the area is approximately 17 acres, of which more than half is forested. Most of the lots are waterfront and range in size from 1/2 to 1 acre; there are a few larger parcels. Lot cover east of the road typically consists of 20% impervious cover, 70% turf grass, and 10% landscaped beds underneath tree canopy. Most of the driveways are impervious and many are crushed shell. Most waterfront lots have docks. Lots on the west side of the road have minimal tree cover. No permanent irrigation was observed, and the majority of the homes appear to have low maintenance requirements. The neighborhood was clean at the time of observation without visible pet waste, trash, or illegal dumping.

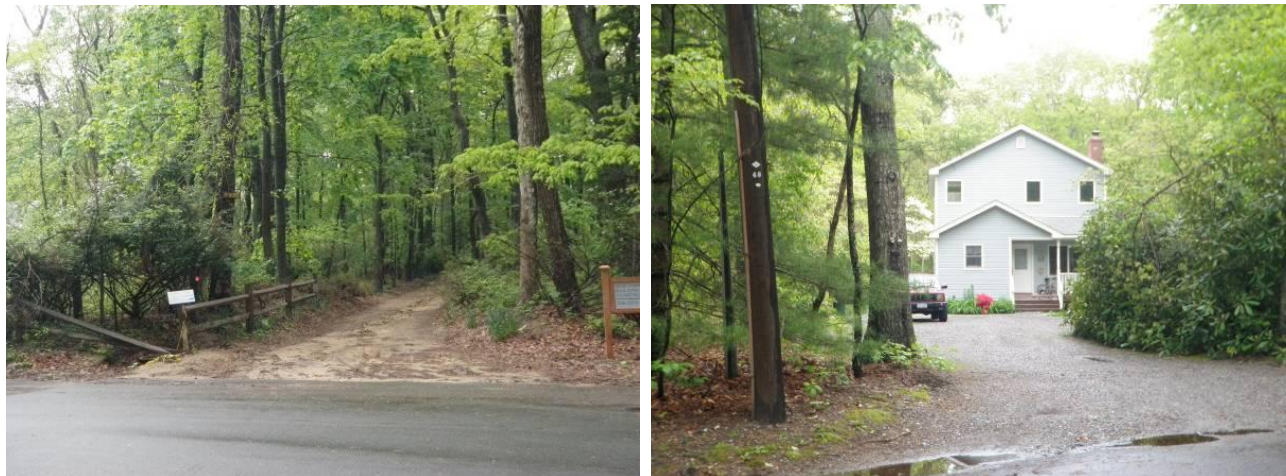
Figure 5.21. Dirt road entrance off Indian Neck Road (left); typical house lot (right)

The Wood Lane neighborhood area is located off Indian Neck Rd. and consists of single-family homes that appear to be approximately 30 years of age. All roads within the neighborhood are dirt with no formal stormwater infrastructure. The overall size of the areas is approximately 20 acres, of which about 70% of the neighborhood is forested. Lots are typically greater than 1 acre in size, and many of the lots are waterfront. Typical lot cover consists on average of 20% impervious cover, 35% turf grass, and 45% landscaped beds or natural areas. Permanent irrigation was observed at one home, but the majority of the lots appear to have low lawn maintenance burden. No visible pet waste, trash, or dumping was observed.

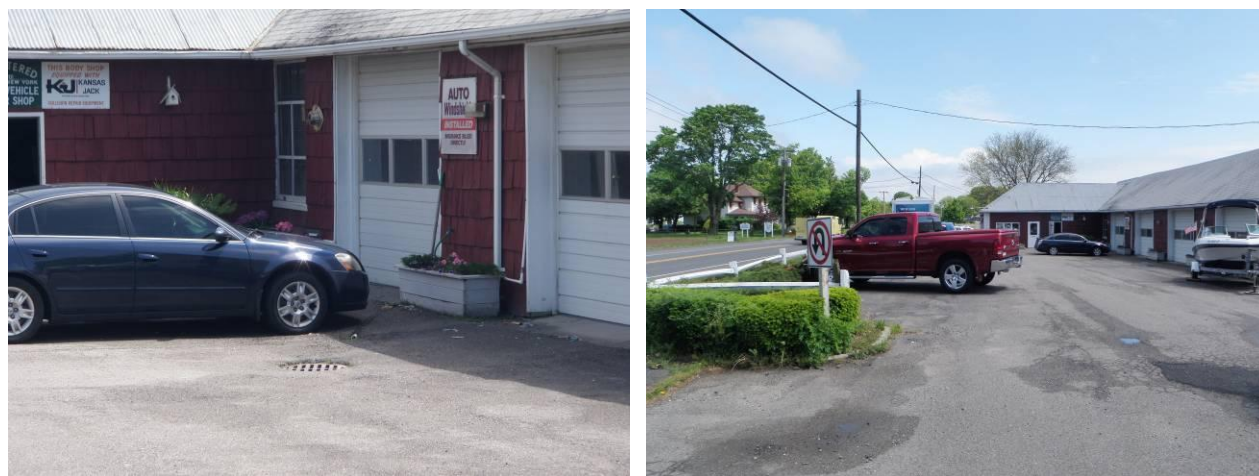
Figure 5.22. Ted's Autobody parking lot with leaching catchbasin

At Ted's Autobody there is one leaching catchbasin located outside the building to service the parking area and front portion of the roof (Figure 5.22). It is assumed that all repair work occurs inside the enclosed garage. The catchbasin is located directly outside the garage doors in front of the building. Any automotive fluids, paints, or other chemicals washed towards the catchbasin have the potential to be injected directly into the groundwater without pretreatment; therefore, it is important that proper procedures are followed to prevent the discharge of materials from the garage area to the catchbasin. Spill prevention measures and facility washing procedures should be established to minimize the potential for contaminated runoff into the catchbasin.

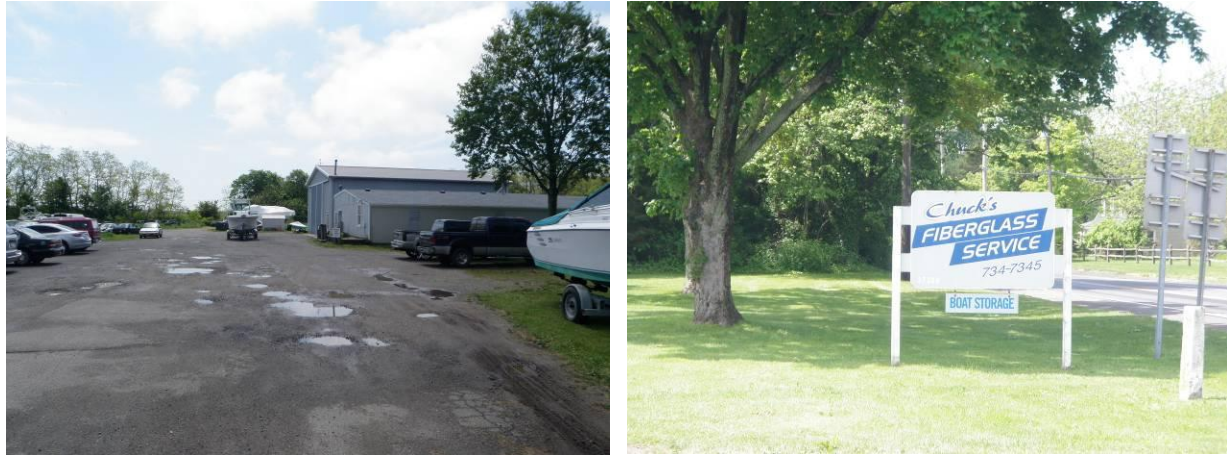
Figure 5.23. Chucks Fiberglass parking area

Chucks Fiberglass includes a large, flat, unpaved storage yard and surrounding turf grass area and does not appear to discharge a significant amount of runoff from the storage area offsite. There are no observed stormwater management practices. Boats are washed and stored outside while fiberglass work takes place in the large building onsite. A designated boat washing area with an oil/water separator for wash water pretreatment is recommended. Paving of the dirt drive and parking area would help stabilize area and reduce any sediment laden runoff.

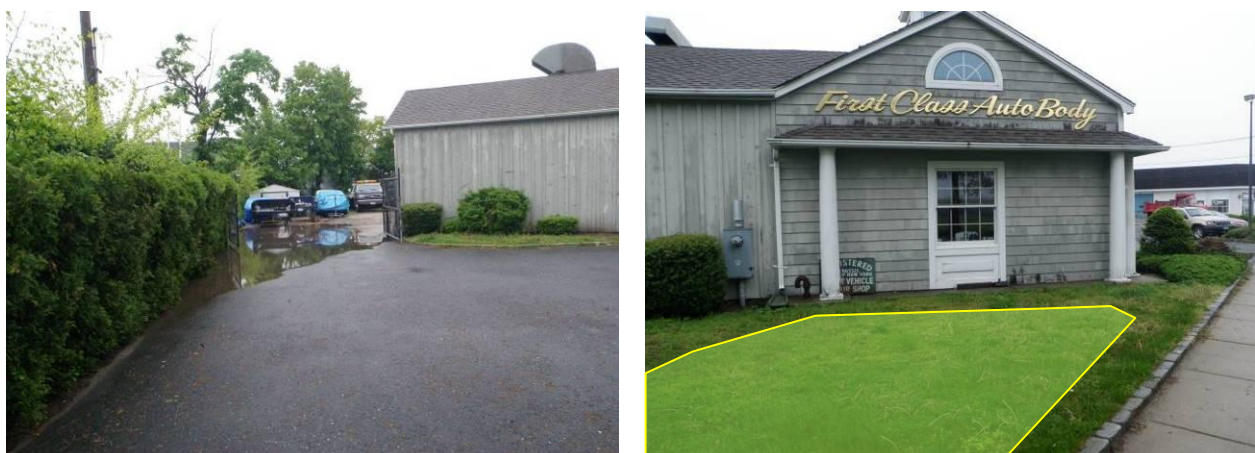
Figure 5.24. First Class Autobody flooding in rear and raingarden opportunity to reduce stormwater volume

At First Class Autobody, there is one leaching catchbasin located in the front parking area and a second basin in the rear of the building that is reportedly subject to chronic clogging and requires frequent maintenance (Figure 5.24). In addition, run-on from adjacent Highway Department is likely contributing to the problem. Based on observed operations, this location was not necessarily considered a hotspot; however, the flooding in the rear of the property is an issue. Retrofit upgrades at the Highway Department may help alleviate some of the issue; however, providing pretreatment prior to infiltration may be necessary to reduce catchbasin clogging issues. In addition, a small grass area in front of the building could be utilized as a raingarden to collect roof runoff, reduce volume to rear catchbasin, and serve as an education demo (it is adjacent to the bus stop on Main St.). Operational procedures should be followed by employees to prevent automotive fluids, paints, or other chemicals from draining to these catchbasins.
