5.0 Richmond Creek Subwatershed

Restoration Opportunities
Richmond Creek
Subwatershed
Southold, NY

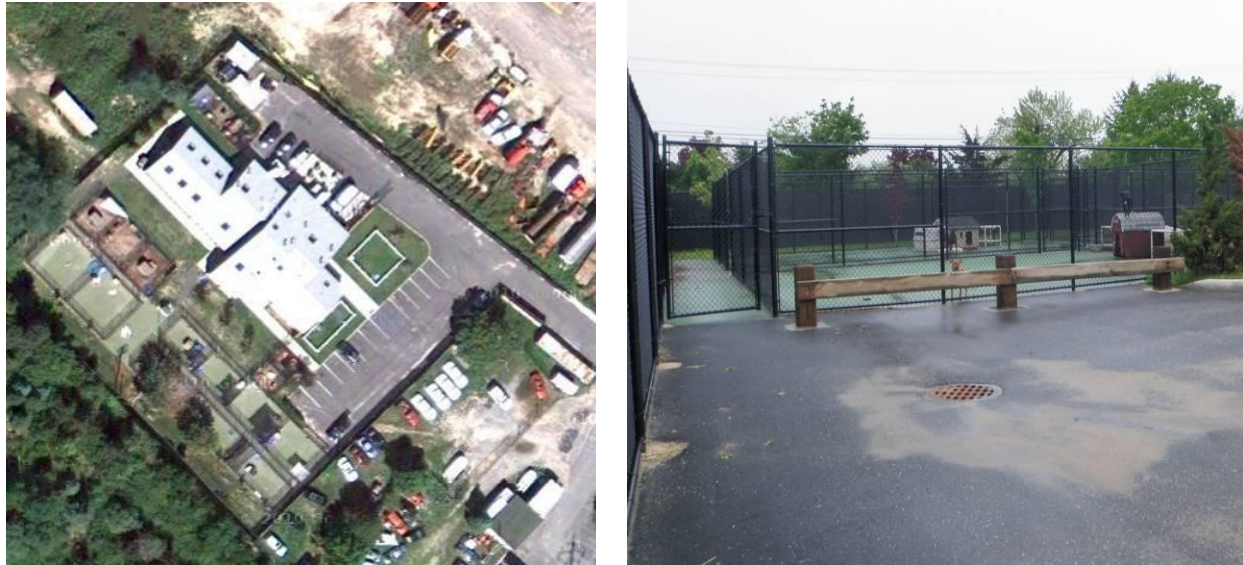
Figure 5.25. Location of kennels adjacent to catchbasin (Source: Google Maps 2011 aerials)

There are a number of outdoor kennels adjacent to the parking lot at the animal shelter. Urine and feces deposited on the concrete surfaces in the kennels may wash off into adjacent catchbasins in the parking lot (Figure 5.25). Depending on animal density, washdown practices, and design of storm drain system, this site could be considered a pollution hotspot for nitrogen and bacteria. At a minimum, kennel cleaning procedures should direct washwater towards the grassed areas rather than to drain inlets. Additional site investigation is necessary to more fully evaluate wastewater and stormwater pollution potential.

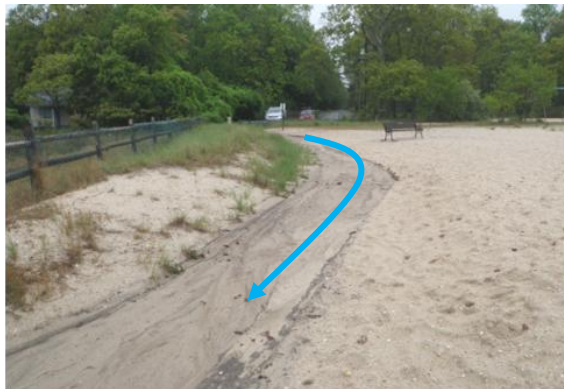
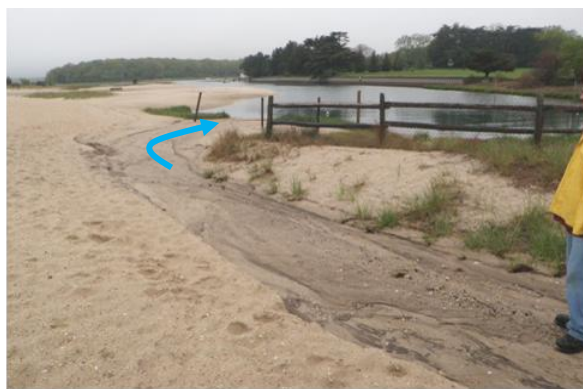
Existing Conditions

This site is a highly visible location for a demonstration project near a local beach park. Currently, runoff from South Harbor Road flows along the edge of pavement to the road end and erodes a channel through beach sand then into the adjacent waterway, which is near the mouth of Richmond Creek.

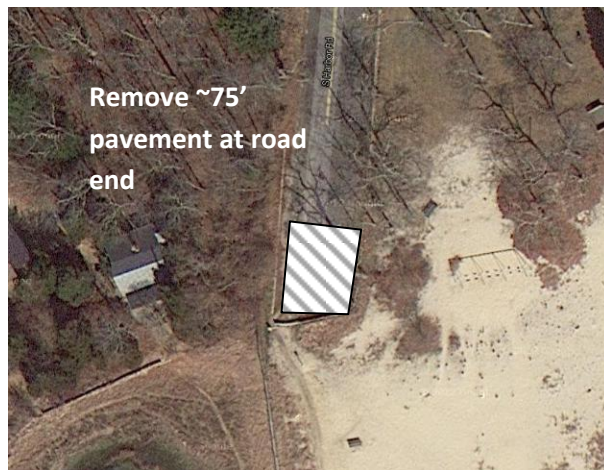
Proposed Concept Sketch

The retrofit concept here is to **remove approximately 75 feet of pavement** at the dead end and capture remaining runoff in a **bioretention area**, while maintaining a pathway to the beach. Shallow roadside swales and paved flumes where necessary should be used to convey flows to the bioretention area, with overflows directed to the existing wetland area. A shallow berm/speed hump should be used as needed at the park entrance drive to keep runoff along the road flowing towards the bioretention.

The bioretention area should be sized for treating the water quality volume. This equates to approximately 2,100 SF of required treatment area. There is sufficient available surface area at this location to provide the full 2,100 SF. The bioretention should be designed to allow a maximum of 6 inches of ponding

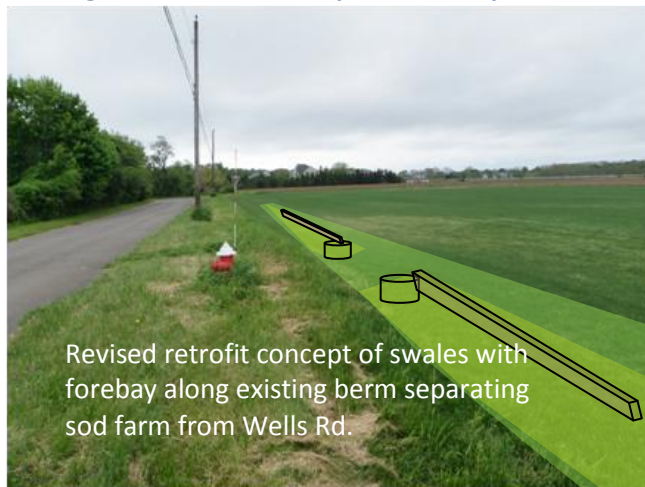
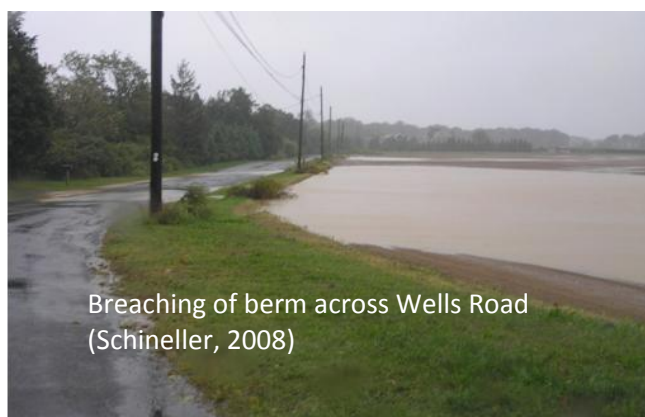
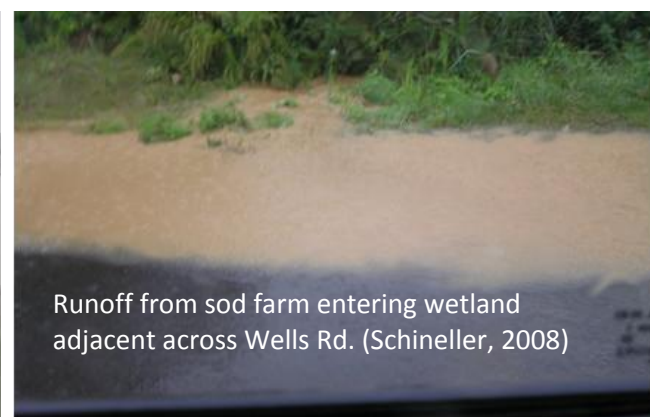
Existing Conditions and Proposed Concept Sketch

A proposed retrofit design plan has already been prepared (provided by P. Schineller, 2011) that involves swales with infiltration leaching chambers in the newly Town-acquired 50-ft wide parcel (RC-R8) and within a 50-ft wide easement (RC-R9) immediately adjacent to the Wells Road right-of-way. Given the amount of suspended sediment anticipated and the absence of pretreatment provided in the proposed design, clogging of the practice is likely to occur on a frequent basis. To avoid this issue and reduce anticipated maintenance, the Town and sod farm should consider a modification of the design to include a berm, check dams, or timber weirs in the swale to create a **pretreatment forebay** and to extend the flow path prior to outlet at leaching basins. The Town already intends to install a barrier between the sod farm and the swale area to prevent inadvertent encroachment by future farming operations, which will be very effective. A **grass filter strip** from the edge of the swale bed and thick native grasses in the secondary portion of the swale should also be constructed and maintained to increase sediment deposition prior to infiltration. Overflows from the swales should be directed to the existing culvert across Wells Road. Maintenance will

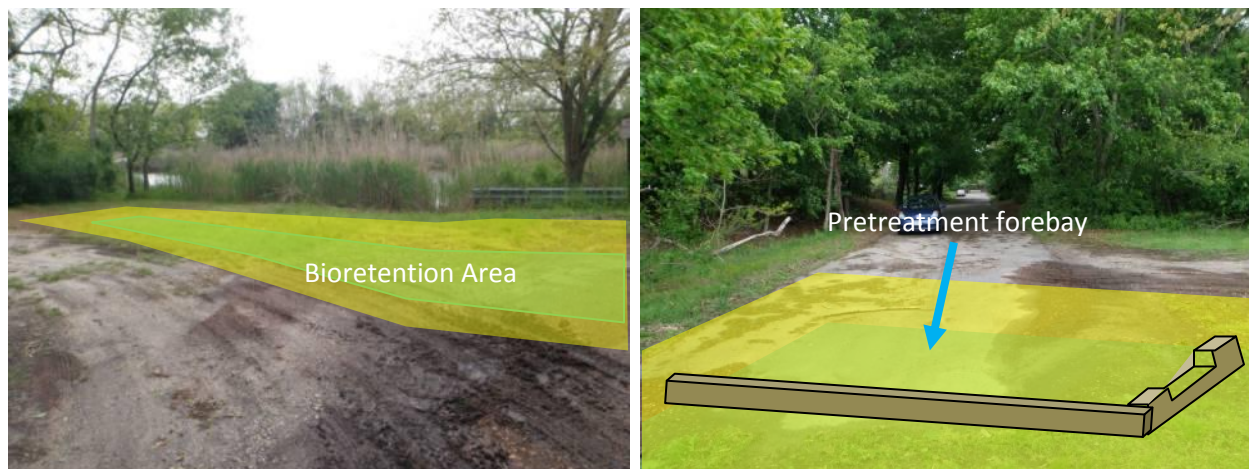
Proposed Concept Sketch

The concept for this site is to **remove excess pavement** at the end of the road and install a large **bioretention area** with an overflow outlet to the adjacent marsh. Paved flumes and asphalt berms are proposed to direct flow into a sediment forebay (made with a timber weir) for pretreatment. In addition, the concept recommends formalizing the parking area with **gravel-pave** (or other pervious pavement option), **installing a split rail fence** to prevent vehicle access to the bioretention area, providing **educational signage**, **stabilizing the unpaved turnaround**, and **restoring native buffer vegetation** to the marsh.

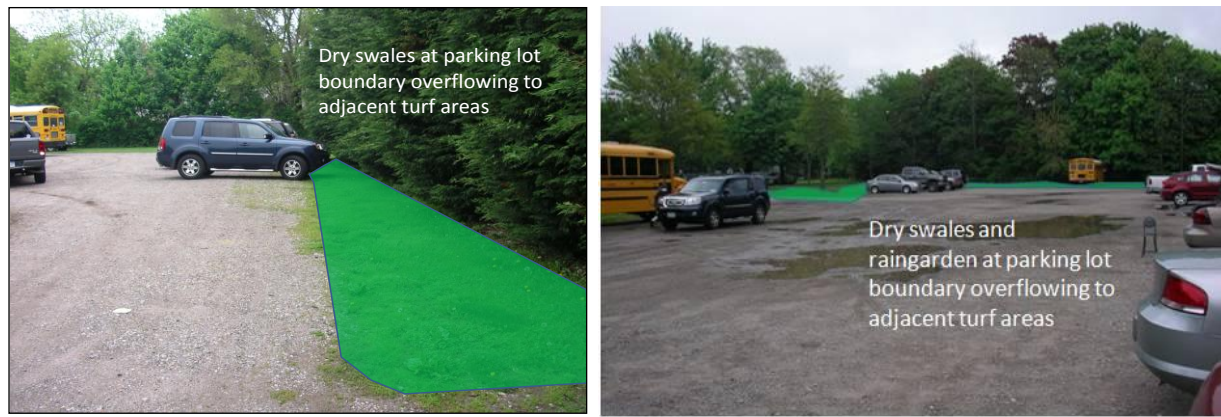
Proposed Concept Sketch

The Jean W. Cochran Park is located southwest of Peconic Lane, south of the existing railway and northwest of the Carroll Avenue/Peconic Lane intersection. The existing gravel parking lot has no existing stormwater management practices, and ponded stormwater was observed at the time of the site visits. However, there is an existing drainage swale next to the hockey rink, which already has overflows to underground leaching chambers.

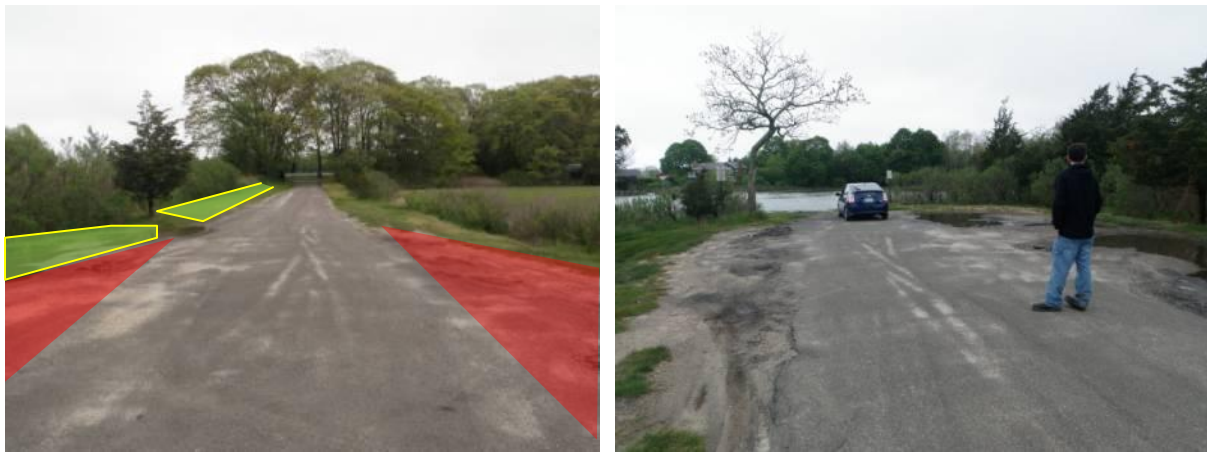
Existing Conditions and Proposed Concept Sketch

A public boat ramp for Richmond Creek is located at the end of Wells Road that, reportedly, is infrequently used. Much of the road pavement and ramp at this location is deteriorated. The turnaround area near the ramp is unpaved, and there is evidence of ponding and erosion in this area. There are wetlands on either side of the road.
