Sebonac Creek Subwatershed Management Plan

June 2013

The Peconic Estuary Program

Horsley Witten Group, Inc.

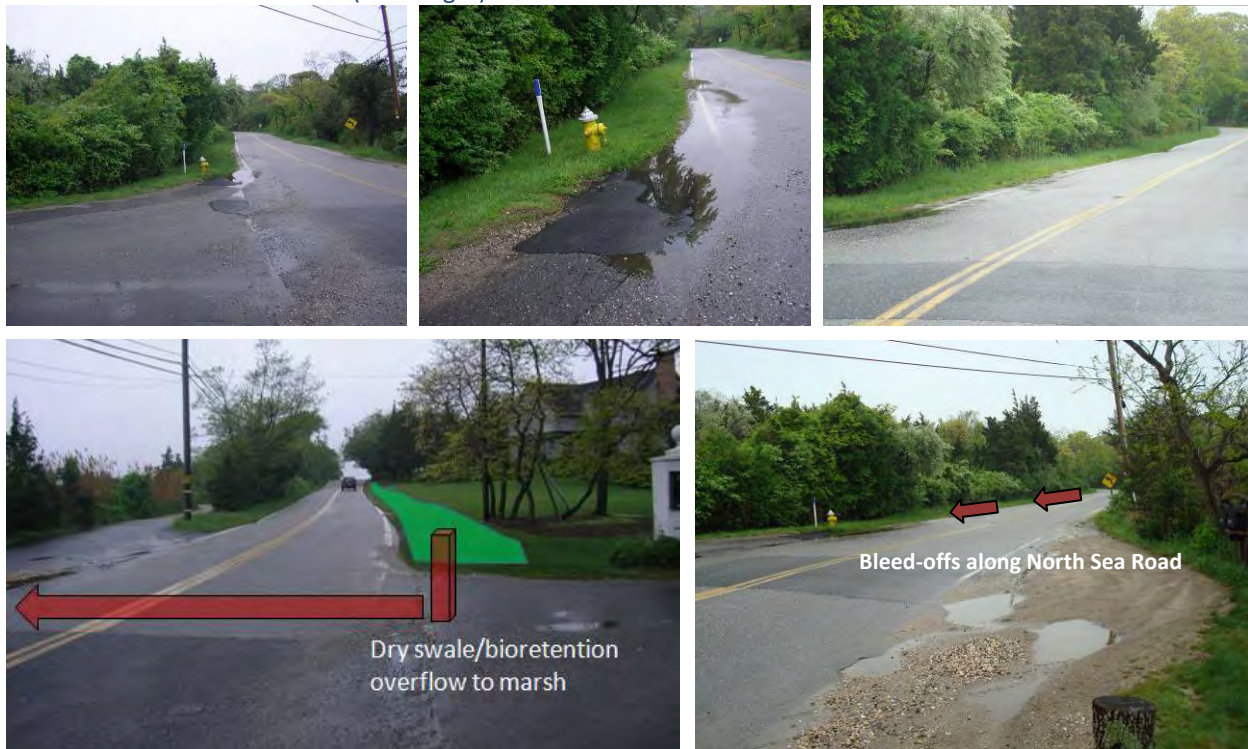
Figure 3.2. Existing conditions along North Sea Road and Intersection with South Street (top). Proposed dry swale/bioretention along right-of-way with overflow to salt marsh (lower left) and paved bleed-offs along roadway to the south of the intersection (lower right).

The intersection at North Sea Road and South Street is at the far northern end of the subwatershed at the entrance to the North Sea Beach Colony Homeowners Association. In this location, the existing stormwater infrastructure consists of leaching catchbasins, many of which are partially or fully clogged with sediment. Stormwater and sediment collects within the roadway. The proposed stormwater retrofit concept in this location includes construction of a **dry swale/bioretention** along the right-of-way (ROW) with an overflow to the salt marsh along Scallop Pond. Possible constraints include the width of the ROW to accommodate an adequately sized swale/bioretention system for the drainage area. In order to treat additional stormwater flow, an easement from the property owner may be needed. The proposed retrofit concept also includes paved "bleed-offs" along the east side of the roadway directed to two existing ponds located southeast of the intersection to allow for overland flow of stormwater away from the marsh. The retrofit concept will allow for improved water quality treatment and some groundwater recharge.

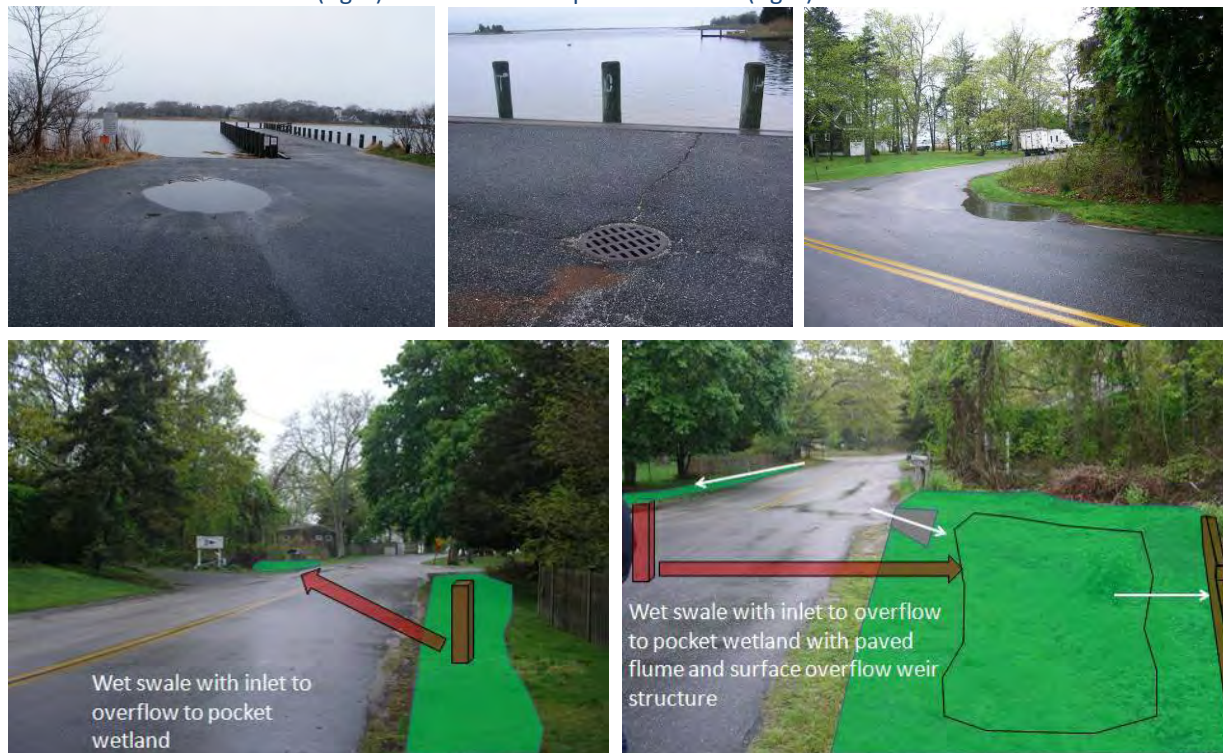
End of West Neck Road (SC-R3)

Figure 3.4. Existing conditions at the end of West Neck Road (top). Proposed retrofit concept consisting of a wet swale with inlet to overflow (right) to a constructed pocket wetland (right).

The end of West Neck Road is located directly south of Island Creek Road, which dead ends at a paved pier and boat ramp to Sebonac Creek. Existing stormwater infrastructure consists of leaching catchbasins, many of which are partially or fully clogged with sediment. As a result, stormwater ponds within the roadway, and sediment and debris were observed along the low points in the road. The proposed retrofit concept involves the construction of a **wet swale** along the north side of West Neck Road with overflows to a **constructed pocket wetland** located across from the westernmost intersection with West Neck Circle. This location appears to be a “vacant” lot, where lawn and landscaping waste are dumped. Further south, there appears to be a small wetland area. The pocket wetland would be designed with a surface overflow weir structure; a paved flume would also direct surface flow toward the pocket wetland. Construction of this retrofit concept would require an easement from the property owner and would allow for water quality treatment.

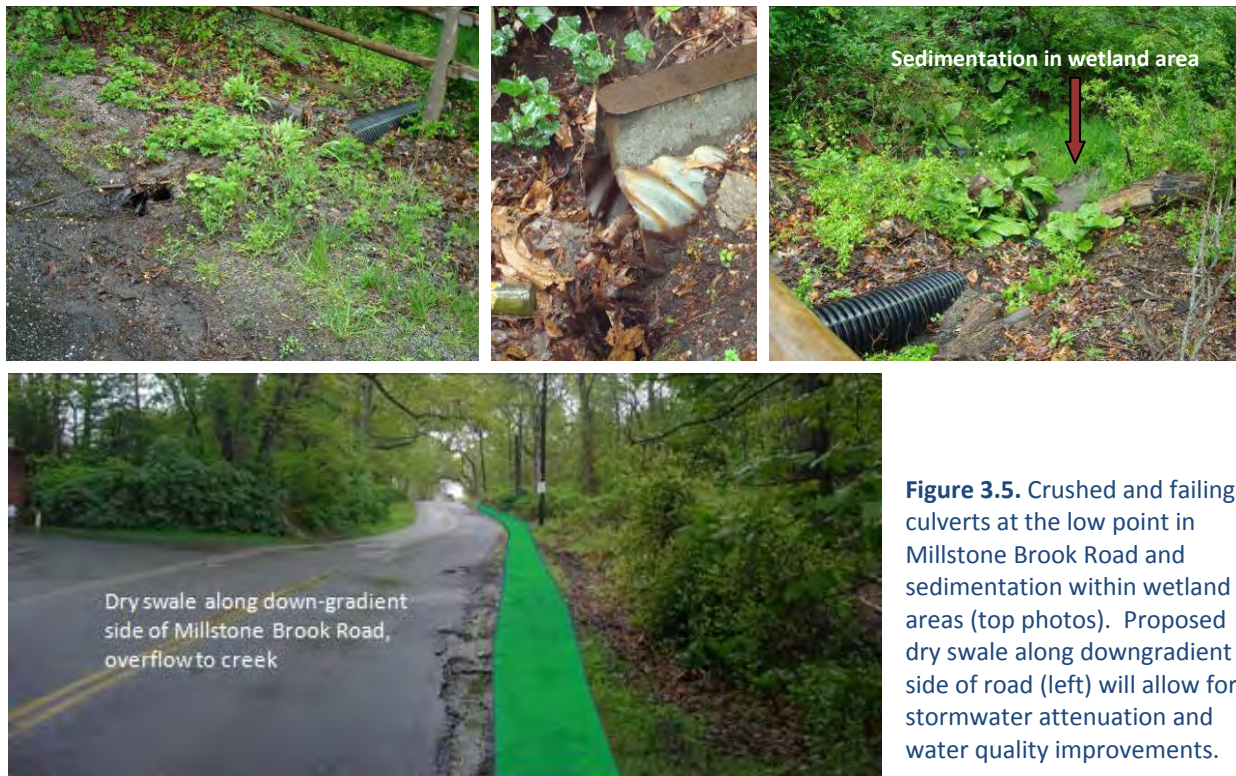
Drainage culvert crossing Millstone Brook Road (SC-R5)

Figure 3.5. Crushed and failing culverts at the low point in Millstone Brook Road and sedimentation within wetland areas (top photos). Proposed dry swale along downgradient side of road (left) will allow for stormwater attenuation and water quality improvements.

Millstone Brook Road extends in a northeast-southwest direction between North Sea Road and Barkers Island Road in the central portion of the subwatershed. There are a series of crushed and or presumably clogged culverts at the low point in the roadway, which is flanked to the north and south by existing wetlands. Some minor erosion was observed along the road and sedimentation was evident within the downgradient wetland. Private driveways contribute minimally to drainage, which discharges to a small stream. The proposed retrofit concept includes construction of a **dry swale** along the downgradient side of Millstone Brook Road to provide stormwater attenuation and water quality improvements within the downgradient resources.

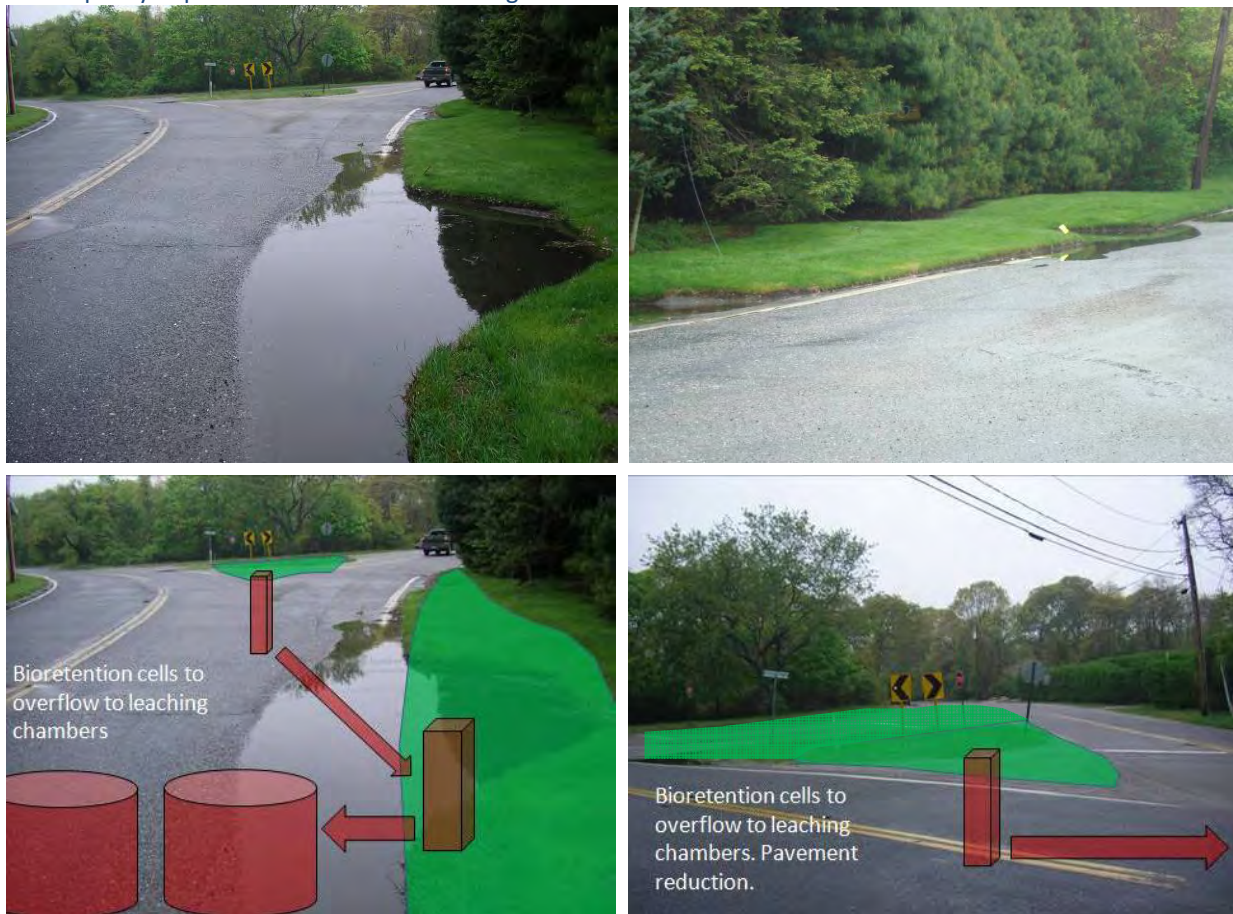
Intersection of Sebonac Inlet Road and Sebonac Road (SC-R9)

Figure 3.6. Existing clogged leaching catchbasins at the intersection of Sebonac Inlet Road and Sebonac Road
Proposed bioretention cells with overflow to leaching chambers will allow for increased groundwater recharge and water quality improvements within the drainage area.

The intersection of Sebonac Inlet Road and Sebonac Road is located in the far southeastern section of the subwatershed, where partially or fully clogged leaching catchbasins causing water to pond along the roadway. The intersection is marked by a small triangular center island. The proposed retrofit concept would involve **reconstruction of the intersection geometry, pavement removal**, and construction of **bioretention cells** within the intersection area and along the grassed right-of-way to the southeast of the intersection with overflow to **leaching chambers**. The proposed concept would allow for water quality improvements and groundwater recharge, depending on underlying soil constraints. The existing utilities (water main and overhead wires) may pose possible conflicts for construction of this retrofit practice.

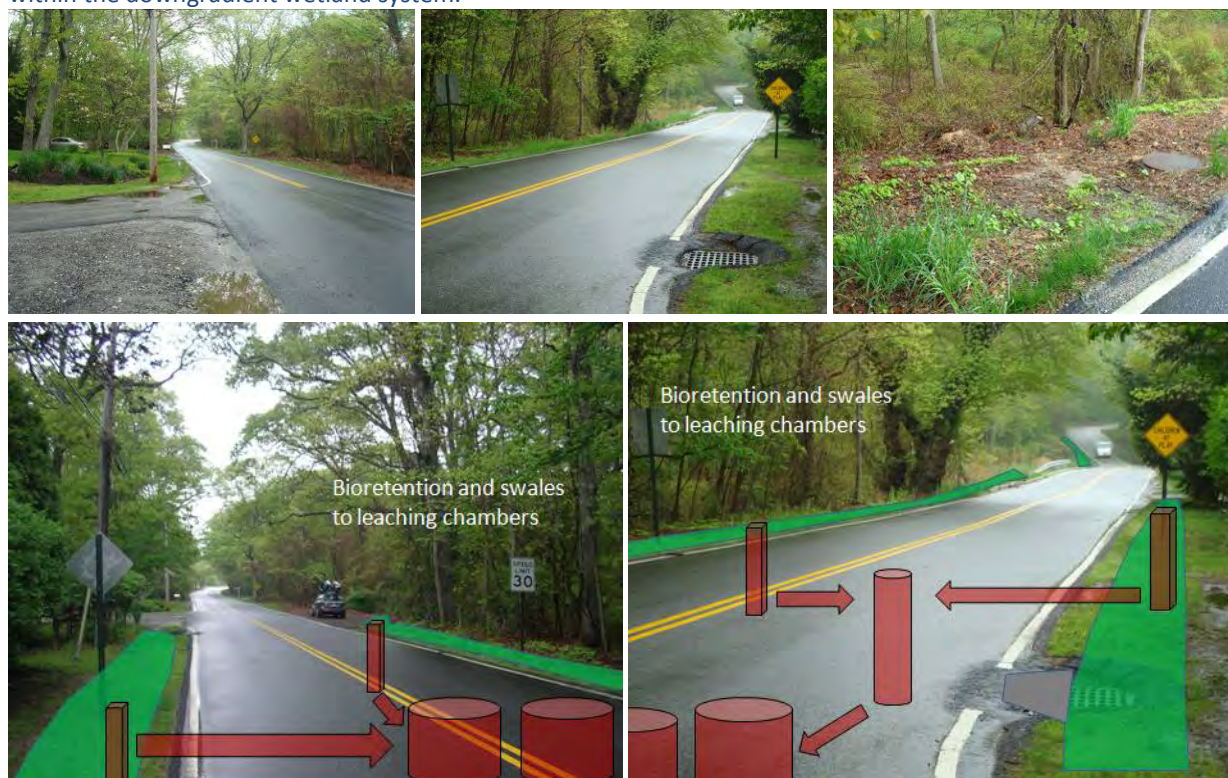
Intersection of Millstone Brook and Millstone Lane (SC-R12)

Figure 3.7. Existing conditions along Millstone Road at the intersection with Millstone Lane (top). Proposed bioretention areas and swales with overflow inlets to leaching chambers will improve water quality and recharge within the downgradient wetland system.

The intersection of Millstone Brook Road and Millstone Lane is located in the center of the subwatershed, and just northeast of SC-R5 (see above). Millstone Lane is an unimproved gravel roadway. The existing stormwater management system includes leaching catchbasins and bermed construction along the roadway. The proposed retrofit concept would modify the existing catchbasins to divert flow into **bioretention areas and dry swales** with overflow inlets to **leaching chambers** within the roadway. The proposed stormwater retrofit would result in improved water quality and recharge within the drainage area. Possible conflicts for the design include mature trees and adjacent wetlands along the roadway.

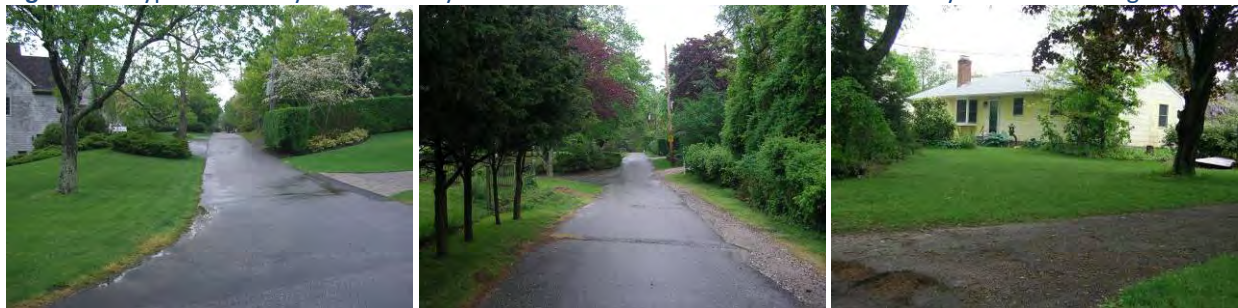
Figure 3.8. Typical roadway and driveway conditions within the North Sea Beach Colony Association neighborhood.

Paved roads within the neighborhood are somewhat variable: some being in generally good condition while others display cracked or broken pavement. The stormwater system primarily consists of individual leaching catchbasins. Many of the leaching catchbasins are in poor or failing condition and have high accumulations of sediment and organic matter. As a result, runoff is bypassing up gradient basins in the neighborhood study area and entering down-gradient catchbasins that directly discharge to the creek via Scallop Pond.

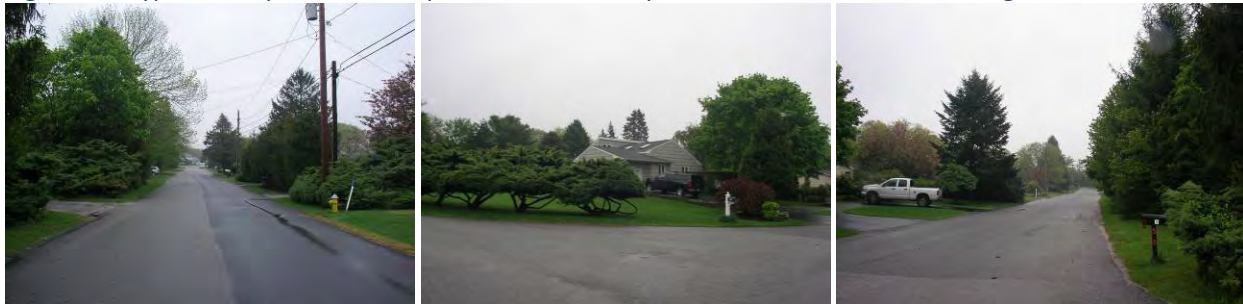
Figure 3.9. Typical overly-wide roadways within the Country Club Drive/Knollwood Drive neighborhood.

Paved roads within the neighborhood are 28 feet wide and are generally in good condition. No curbs are present, but the adjacent raised turf acts as curbing during the growing season. The stormwater system primarily consists of individual leaching catchbasins. Many of the leaching catchbasins are in poor or failing condition and have accumulations of sediment and organic matter. As a result, stormwater runoff ponds on the roads.

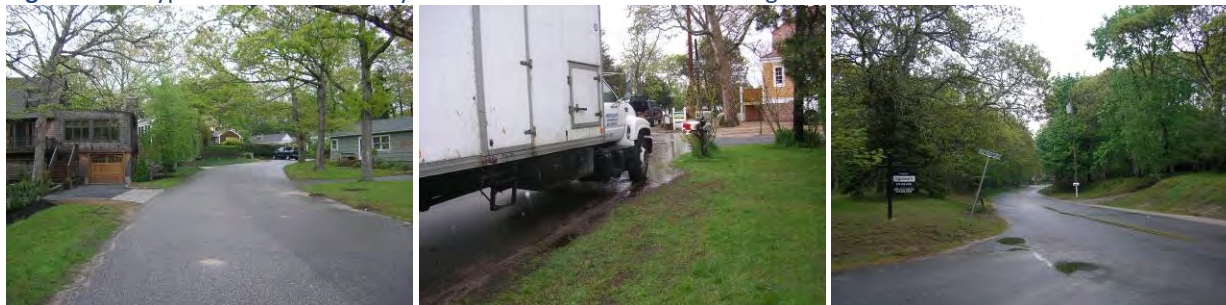
Figure 3.10. Typical lots and roadways within the West Neck Circle neighborhood.

The West Neck Circle neighborhood is an older neighborhood of single-family detached dwellings that appear to be approximately 60 to 80 years of age (1930s-1950s construction). The overall size of the neighborhood is 13 acres, with lot sizes ranging from ¼-½ an acre. A typical lot is 40% impervious cover, with a maintained yard condition of 40% grass cover and 20% landscaped beds, although this varies somewhat. About 90% of the yards appear to have low maintenance requirements, and the remaining 10% require a medium level of maintenance. Approximately 50% of the driveways are impervious.

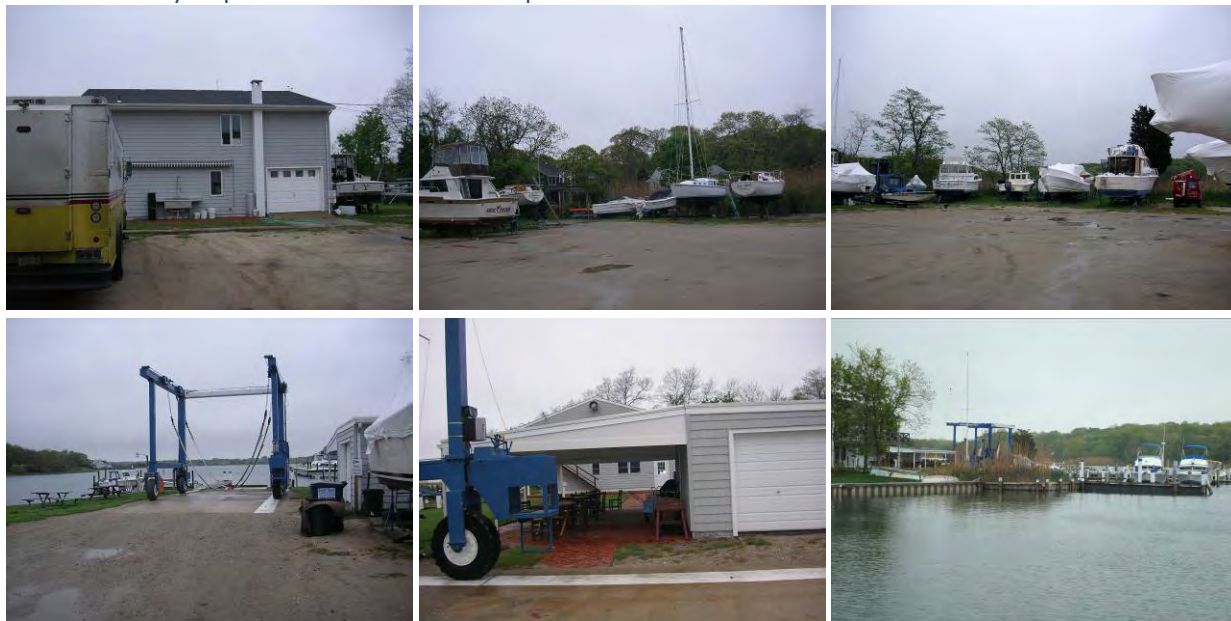
Figure 3.11. Bullhead Yacht Club facilities. The site could benefit from educational signage for boat owners on environmentally responsible boat maintenance practices.

The Bullhead Yacht Club is a very small private yacht club located at end of West Neck Road and immediately southeast of the West Neck Circle Neighborhood. The boatyard is gravel/unimproved, with a boat launching facility, storage areas, small grassed areas, and a snack bar, with no observed significant maintenance facilities. The yacht club is more of a boat storage facility. However, boat owners likely perform small-scale boat maintenance (washing, painting). There is a low to medium risk of contaminants from heavy metals from paint on boats, and possible oil/grease from boat engine repair. Stormwater from the site either infiltrates or flows directly into Sebonac Creek. Educational signage for boat washing and minor maintenance activities by boat owners is recommended.

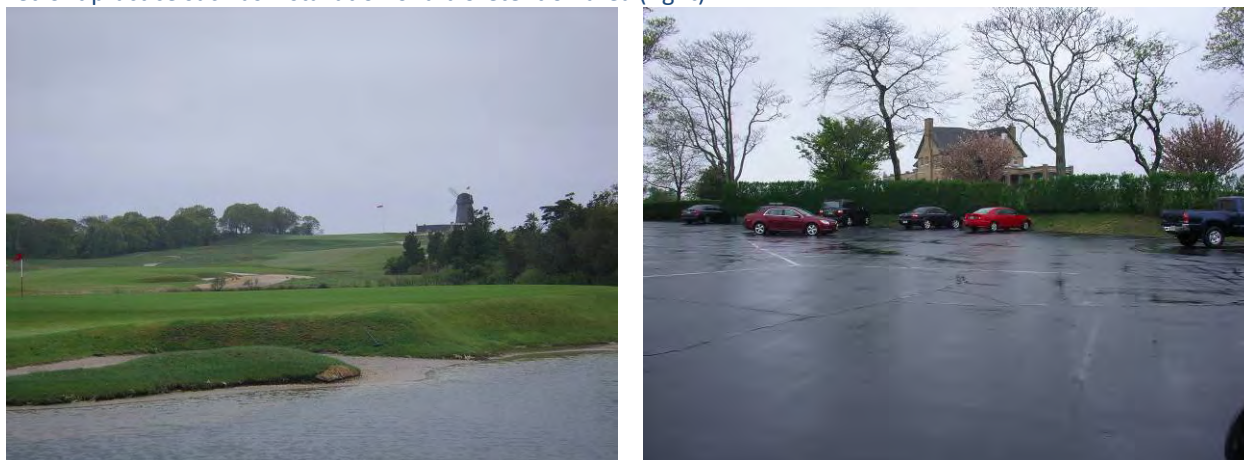
Figure 3.12. National Links Golf Club near Bullhead Bay Inlet pond (left) where buffer plantings would provide increased nutrient uptake and water quality benefits. The clubhouse parking lot may benefit from a stormwater retrofit practice such as installation of a bioretention area (right).

The clubhouse parking lot is relatively small but may benefit from incorporation of a bioretention area or other retrofit BMP. The Golf Club could also include enhanced plantings of native vegetation along Bullhead Bay Inlet pond, which increases vegetative buffering along the shoreline while also discouraging waterfowl from gathering along maintained surfaces, potentially reducing bacteria within stormwater runoff.

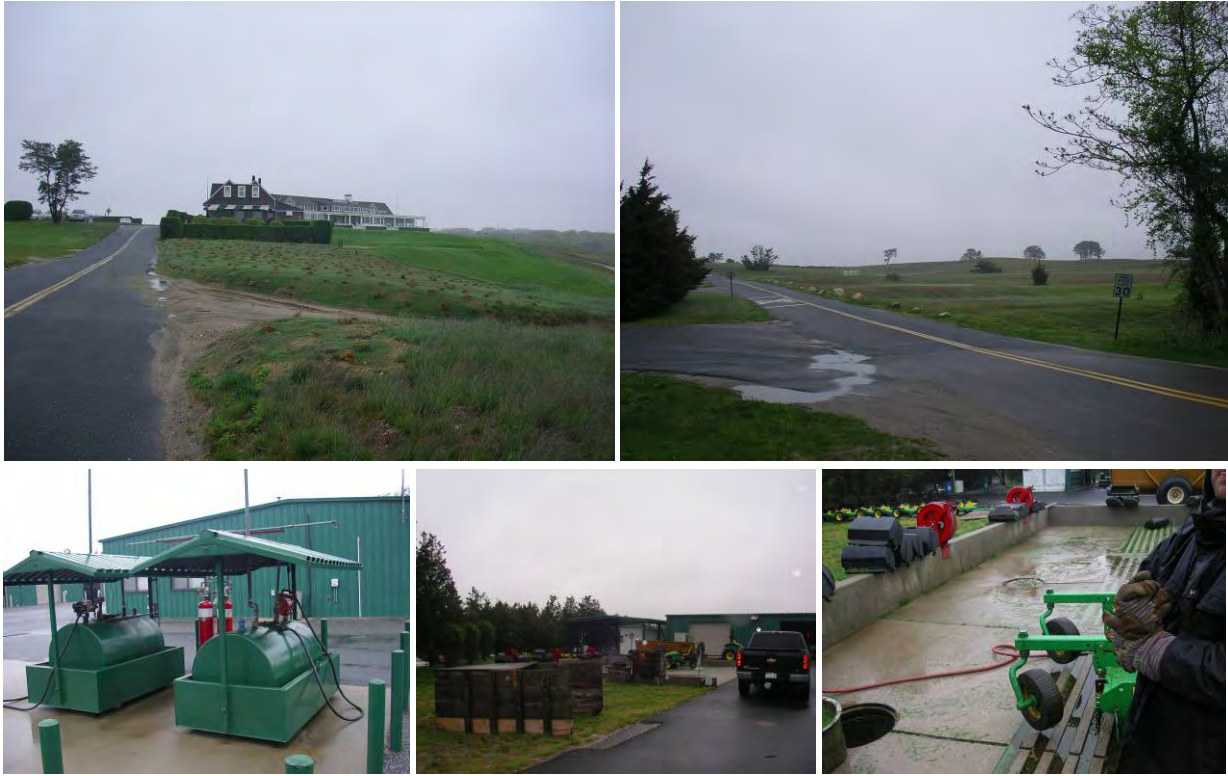
Figure 3.14. Shinnecock Hills Golf Club (top). The maintenance facility includes covered fuel and materials storage, a contained equipment maintenance facility (bottom).

Shinnecock Hills Golf Club occupies the majority of the southern portion of the subwatershed. The maintenance facility was investigated and found to have a covered fuel storage area with containment and indoor storage of materials. The mowing equipment cleaning area is contained and drains to a leaching system with pretreatment with a down-gradient detention pond. No action is recommended for this site.

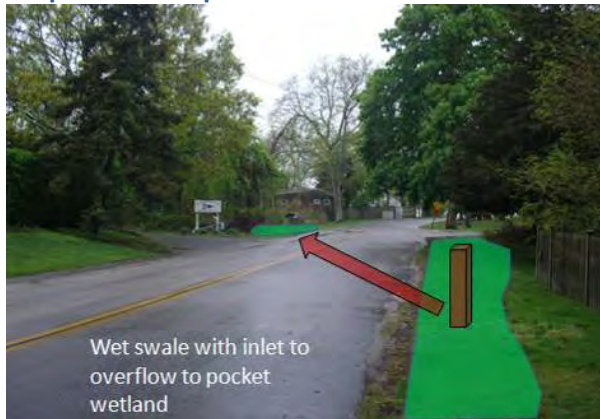
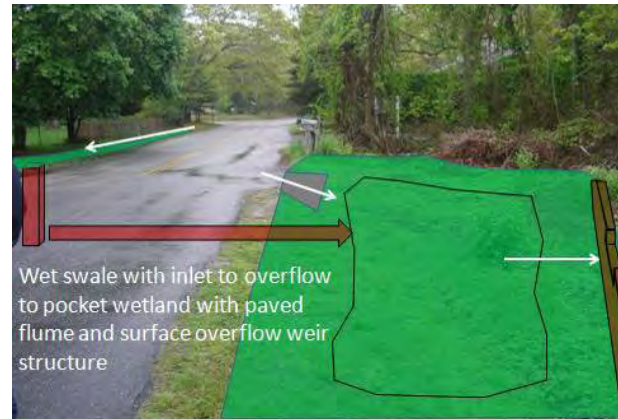
Examples of a pocket wetland (left) and a newly constructed wet swale (right)
