Reeves Bay Watershed Management Plan

July, 2006

The Peconic Estuary Program

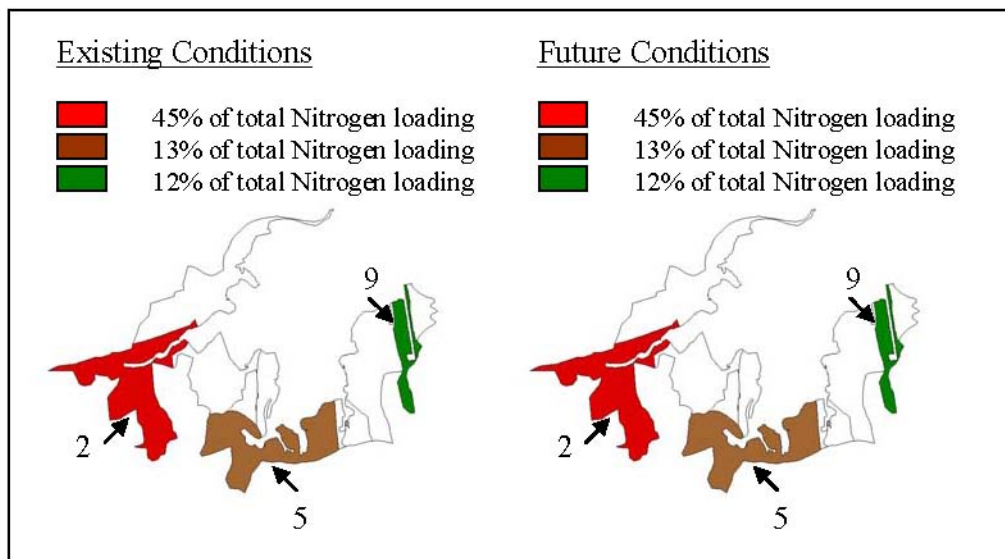
Figure 2-5. Reeves Bay watershed – highest priority subwatersheds for nitrogen loading under existing and future conditions.

*The subwatershed numbers for those subwatersheds contributing the highest estimated pollutant loading are labeled in the diagram above.

As part of the modeling of both existing and future conditions, HW identified the three subwatersheds that contributed the highest levels of pollution. Figure 2-4 and Figure 2-5 illustrate the highest contributors of fecal coliform bacteria and nitrogen for both existing and future conditions. The model shows that subwatersheds 2, 5, and 9 will continue to be the highest contributors of both fecal coliform and nitrogen under existing and buildout conditions. Subwatershed 2 contributes almost half of the fecal coliform and nitrogen loading for the entire watershed under both scenarios.

In order to control potential future loading from Subwatersheds 2, 3, and 5 it is recommended that stormwater management controls be employed that allow for enhanced nitrogen and bacterial removals. Infiltration of stormwater runoff (with pre-treatment) from all impervious and pervious surfaces, buffers between lawns and water resources, and other best management practices (BMPs) described further in sections 3 and 4 that remove 50% of the total nitrogen and 90% of the fecal coliform can reduce future loads accordingly.

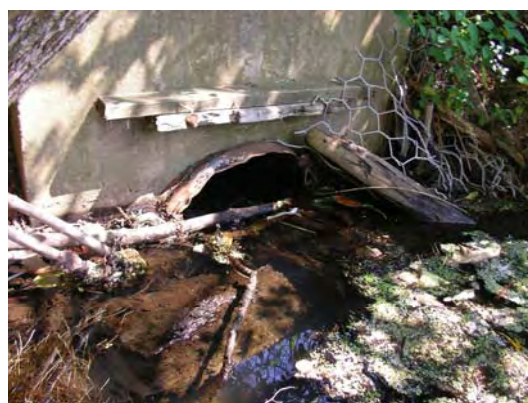
R-2A Outlet Pipe in Disrepair
