Town of Southold Subwatersheds Management Plan

June 2013

Horsley Witten Group, Inc.

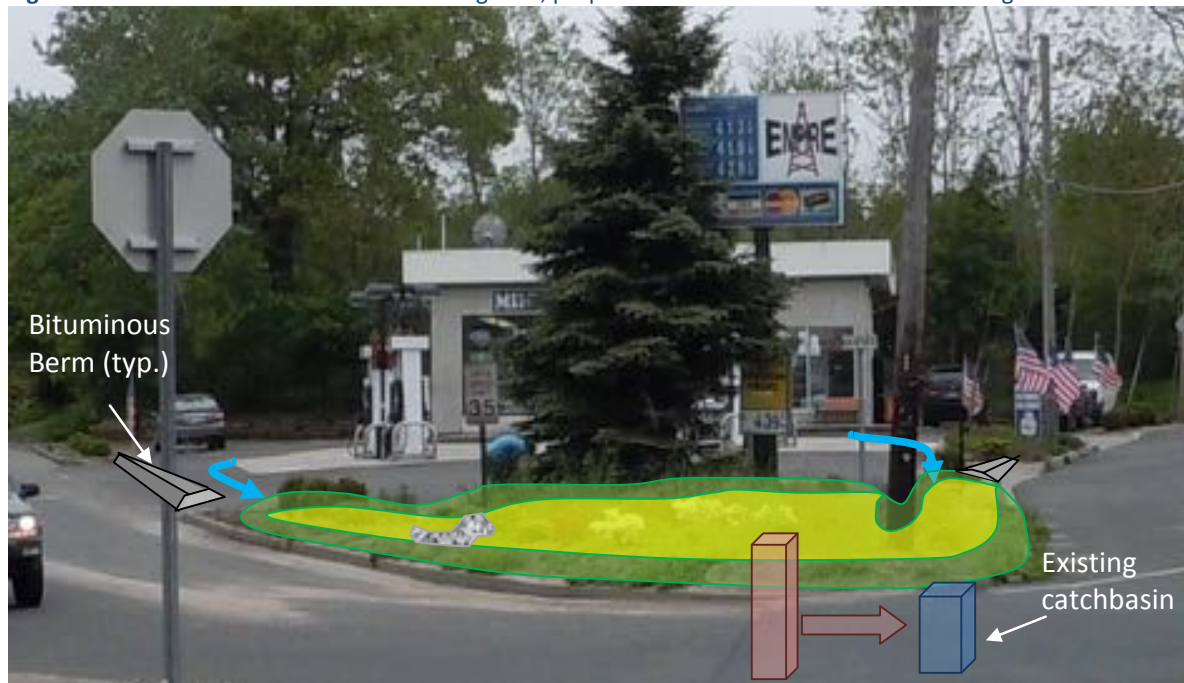
The Empire Mini-Mart Gas Station is located at the intersection of NY 25 (NY DOT) and Main Bayview Roads. Currently, there is no stormwater infrastructure on site, and runoff from the site sheet flows onto the adjacent roads. This site recently went through the Site Planning process with the Town Planning Board, at which time, no additional stormwater practices were required. However, this site is a hotspot with a potential pollutant problem of medium severity because of observed sediments and a high likelihood of hydrocarbon-derived pollutants from the uncovered vehicle fueling area (see Section 3.3 for more on the hotspot inventory). The recommended BMPs for this site are **lined vegetated swales** and a **lined bioretention area** in the landscape area located on the north end of the property. The proposed bioretention area should be routed to the existing catchbasin shown in the image below for discharge of treated runoff and overflow generated in large storm events. Additionally, the vehicle fueling area should be covered to minimize the amount of runoff generated and flowing off the fuel pad, as there is a high likelihood that hydrocarbon-derived pollutants could be transported from this area by runoff. This site is private; however, the Town should work with the owners to address this important site.

Figure 3.2. Gas station with uncovered fueling area; proposed bioretention area shown shaded green.

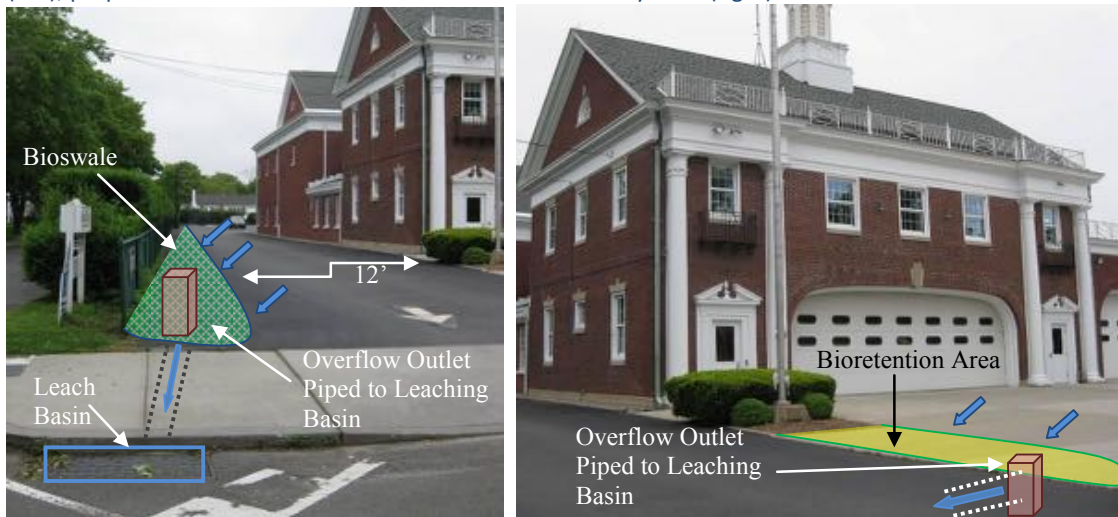
Currently, stormwater runoff generated at the site is either collected/infiltrated by leaching catchbasins located in the parking area or flows offsite onto Main Road (NY 25). Stormwater treatment could be improved at this site by installing some or all of the following practices: (A) **remove pavement** and install a **bio swale** along the west side of the exit driveway; (B) a **bioretention** along the west side of the apron at the entrance to the garage bays; (C) **bioretention** along the west side of the entrance driveway; (D) replacing some of the impervious pavement with **porous asphalt** in the overflow parking area; and (E) **dumpster containment** to prevent leachate from flowing onto pavement that contributes runoff to a leaching basin. Overflow from the proposed swales and bioretention areas should be piped to existing leaching basins. This site is owned and operated by a private entity; the Town will need an easement if the Fire Department does not intend to maintain the stormwater facilities.

Figure 3.3. Area of pavement along one-way exit drive to be removed and replaced with bioswale shaded in green (left); proposed location of bioretention area shown shaded yellow (right).

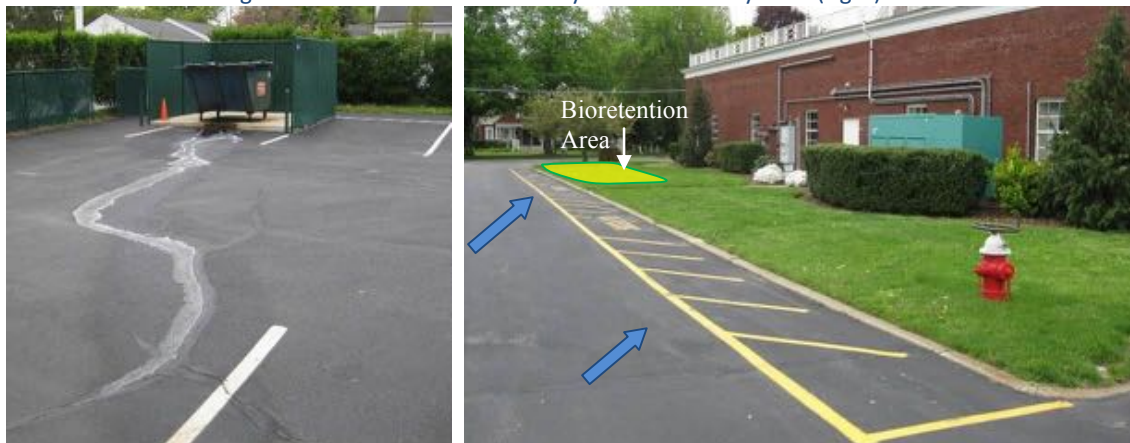
Figure 3.4. Dumpster at fire station with staining on pavement from dumpster leachate (left); proposed bioretention area along west side of entrance driveway shown shaded yellow (right).

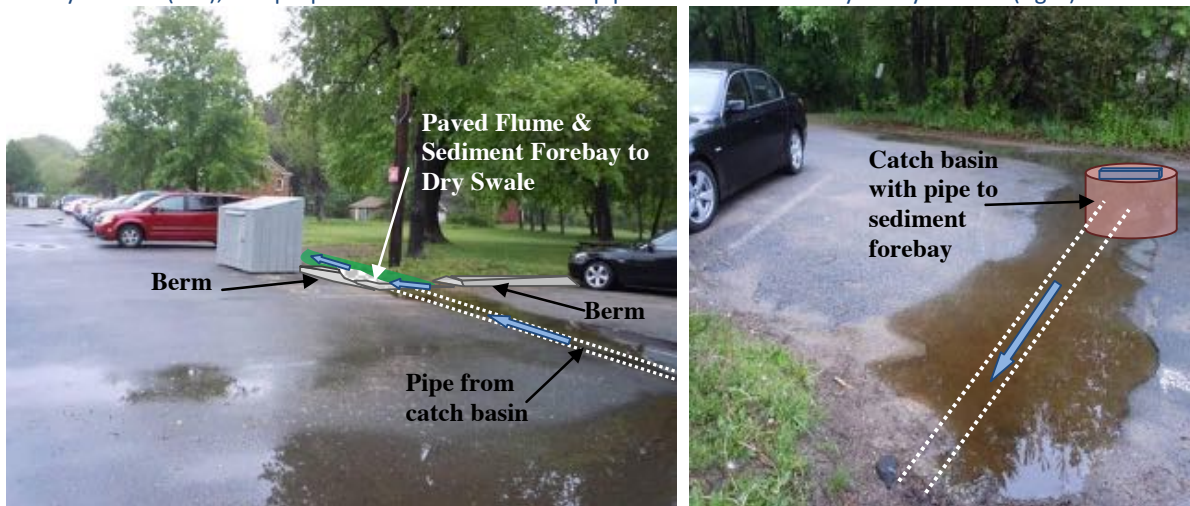
Figure 3.9. Flooding at intersection of driveway from Traveler Road and the main parking area, paved flume inlet for dry swale 2 (left); and proposed catchbasin inlet and pipe to sediment forebay of dry swale 2 (right).

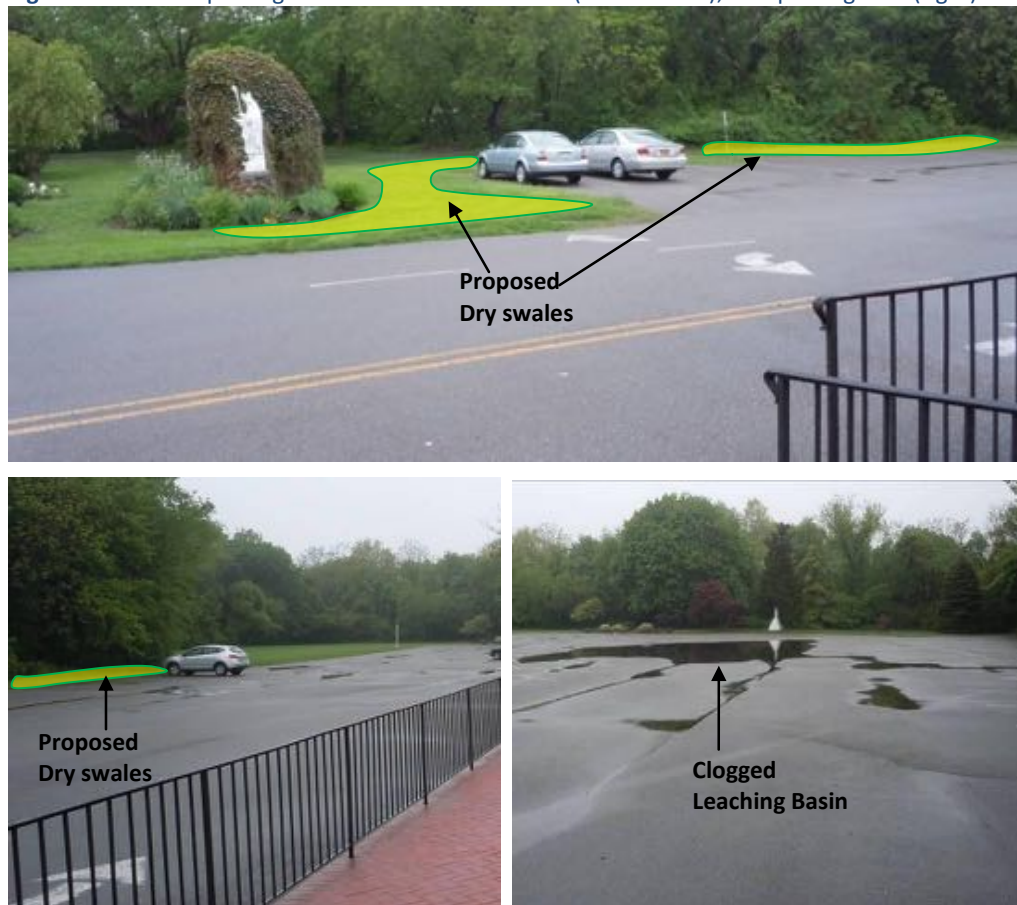
Figure 3.11. Front parking area at St. Patrick's Church (left & above); rear parking area (right)

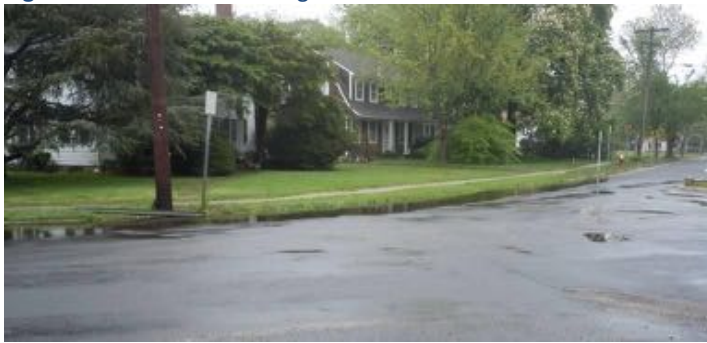
At the intersection of Tuckers Lane and NY 25, there is a clogged leaching basin that causes roadway flooding issues. The clogged leaching catchbasin should be upgraded with a system that can provide water quality treatment prior to infiltration. To correct the flooding issue and provide water quality treatment of the runoff, we recommend a “green streets” type stormwater management practice that consists of “bumpout” bioretention cells (see Figure 3.13). The bumpouts (TJ-R9A) could be located between the edge of pavement and the sidewalk, and should include a sediment forebay at the inlet for pretreatment as well as a treatment area that includes soil media for filtering the runoff prior to discharge to a functioning infiltration structure.

Figure 3.12. Area of flooding at intersection of NY 25 and Tucker Road

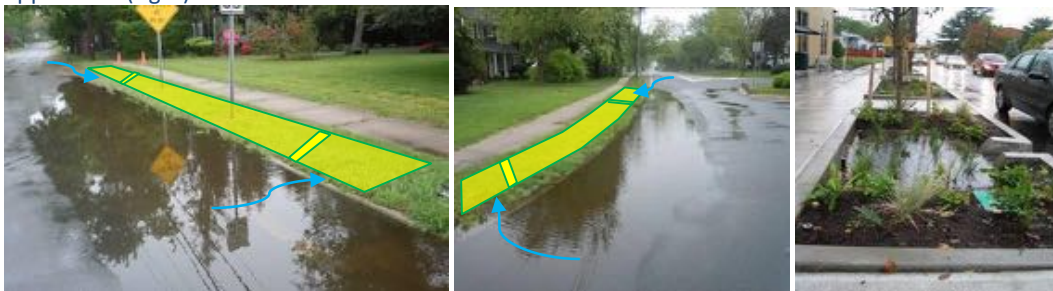
Figure 3.13. Proposed green street planter shown shaded (left and middle), example of a similar green street application (right).

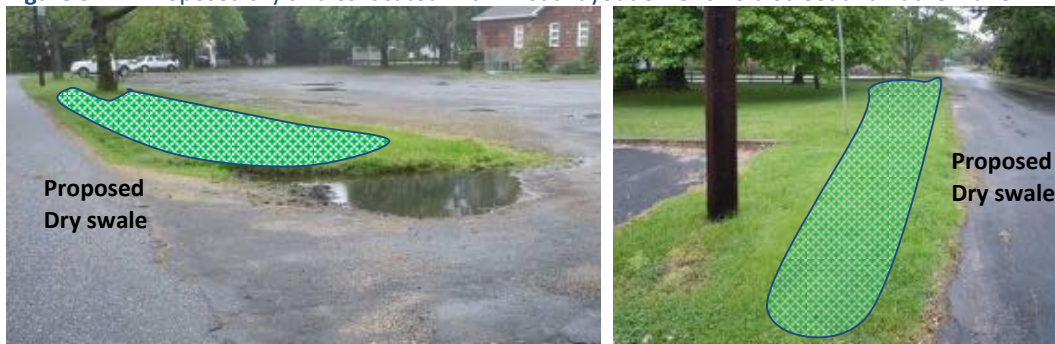
Figure 3.14. Proposed dry swales located within road layout on Griswold Street and Tucker Lane

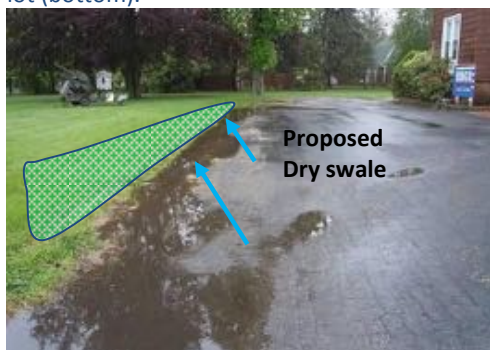
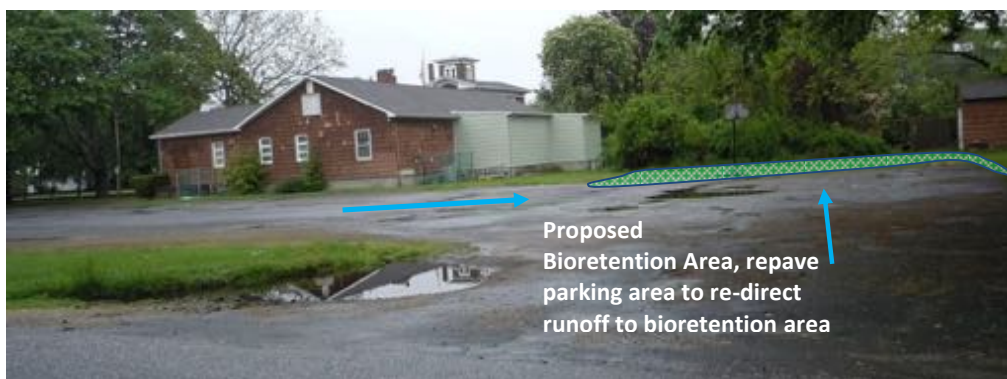
Currently, stormwater infrastructure at this site consists of leaching catchbasins, and the pavement on both the driveway and parking area is in need of repair. Prior to repaving the parking lot, the area should be re-graded to direct runoff to a large open area located to the north of the building that is ideal for installation of a **bioretention area**. The bioretention area will provide greater water quality treatment than the leaching catchbasins. To treat runoff from the driveway at the front of the building, shallow **dry swales** should be installed that are sized for the water quality volume. Easements would be

Figure 3.15. Proposed dry swales located along the driveway (top), and proposed bioretention area at rear parking lot (bottom).

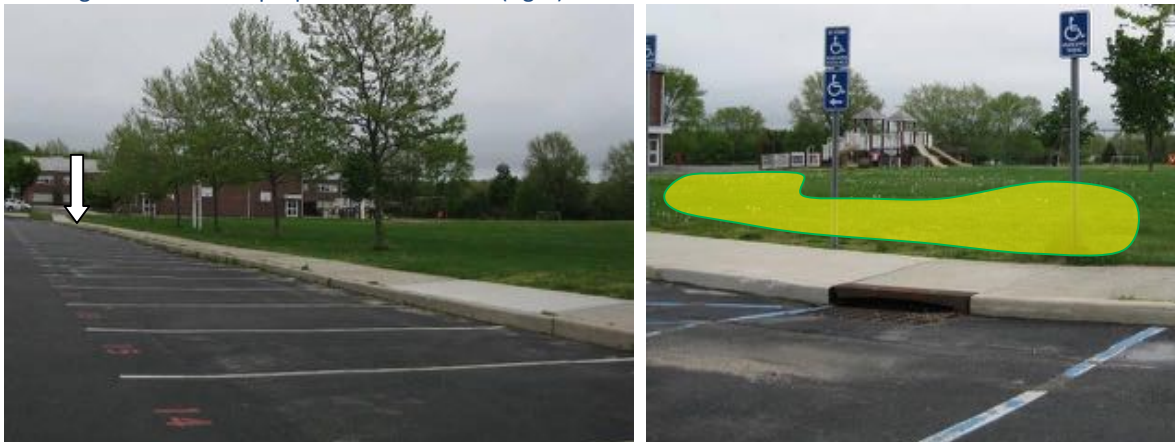
Figure 3.18. Parking area and sidewalk adjacent to parking area, existing leaching catchbasin noted by arrow (left); leaching catchbasin and proposed bioretention (right).

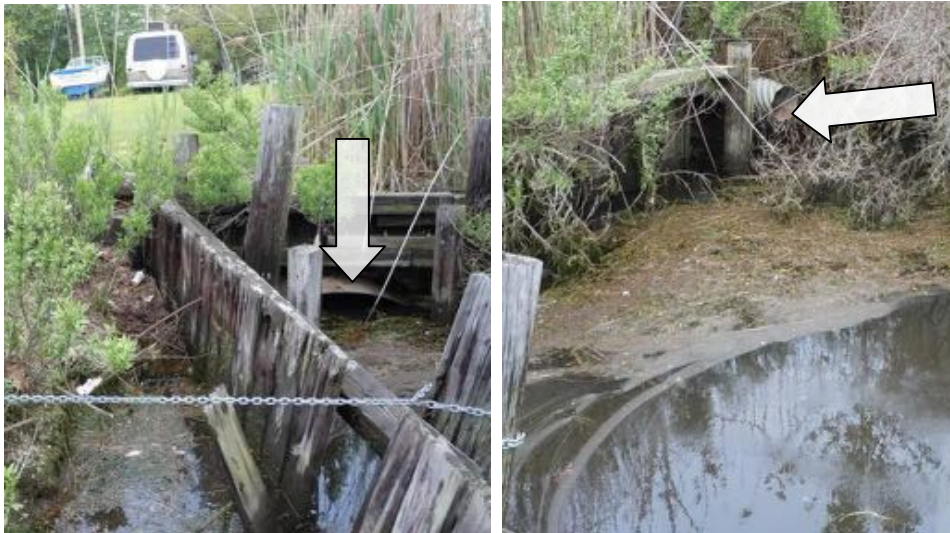
Figure 3.20. Five-foot diameter outfall from NY 25 below arrow (left), observed film (potential pollutants) in Jockey Creek below outfall, and 12 inch diameter outfall from adjacent property is indicated by arrow (right).

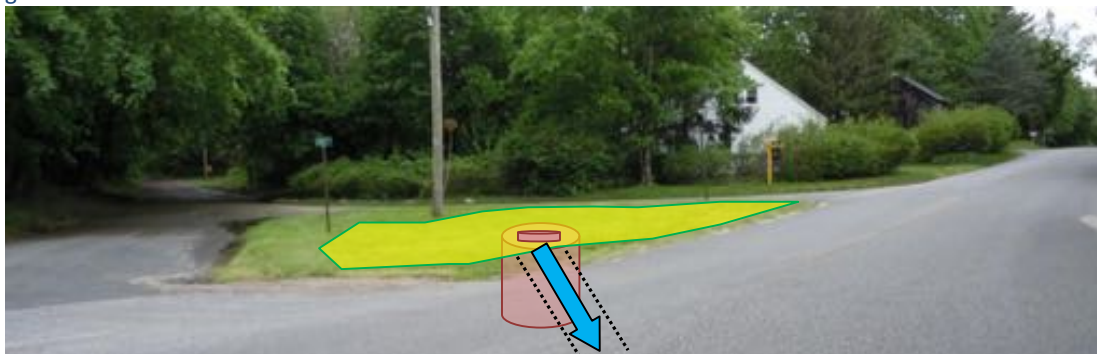
Figure 3.23. Proposed bioretention area at intersection of Lower Road and Ackerly Pond Lane shown shaded green.

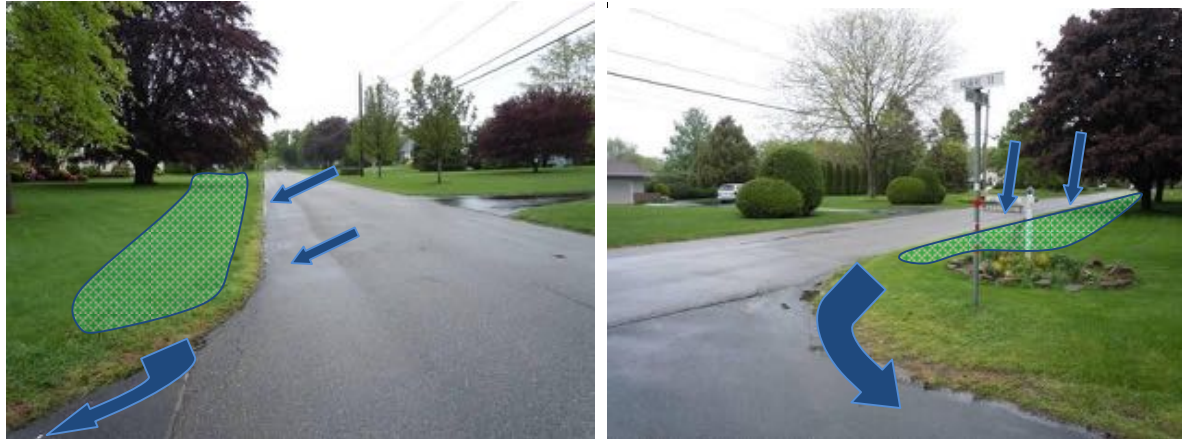
Figure 3.24. Dry swales (shown shaded green) along the south side of Jockey Creek Drive to the east (right) and west (left) of the Gilbert Road intersection. The blue arrows indicate runoff flow conditions.

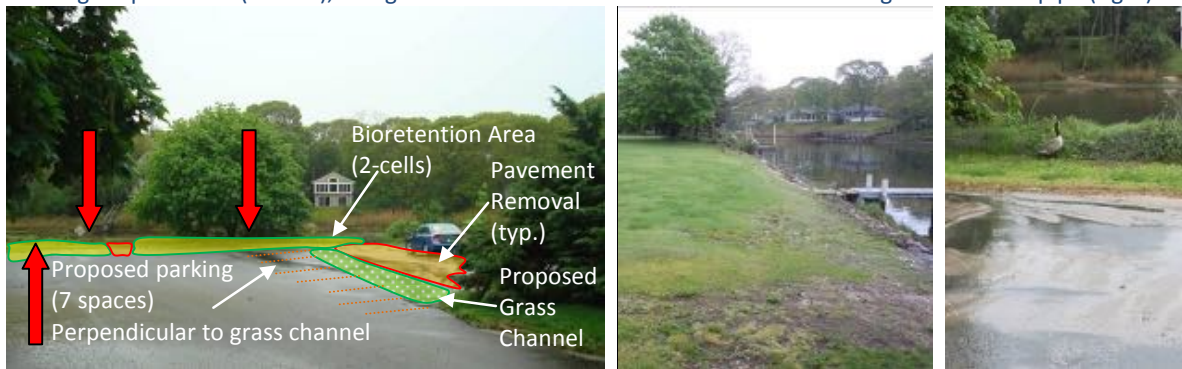
Figure 3.25. Gilbert Road parking area with arrows pointing to existing direct outfalls (left), Neighboring yard with lawn right up to creek (middle), and goose and sediment observed in front of existing direct outfall pipe (right).

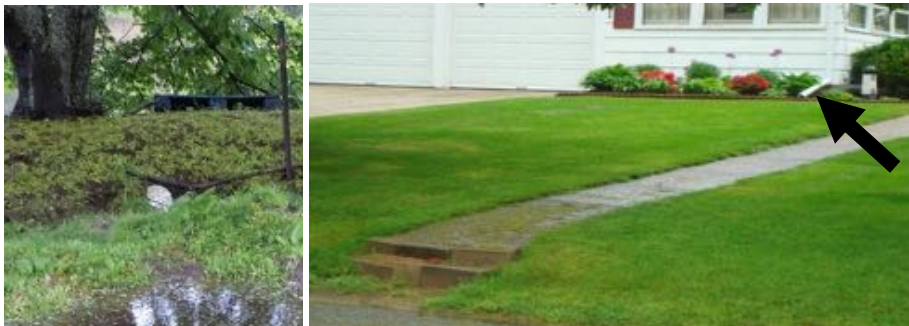
Figure 3.26. One of the three outfalls (left), and downspout at residence directly connected to walkway and driveway (right).

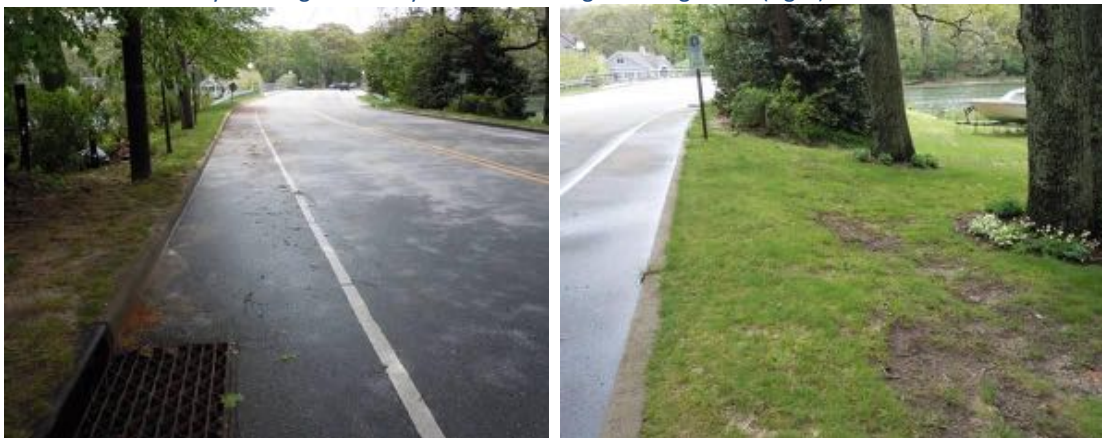
Figure 3.27. Catchbasin on east side of road near bridge (left). Limited space and mature trees in the right-of-way reduce the feasibility of using a swale system for the large drainage area (right).

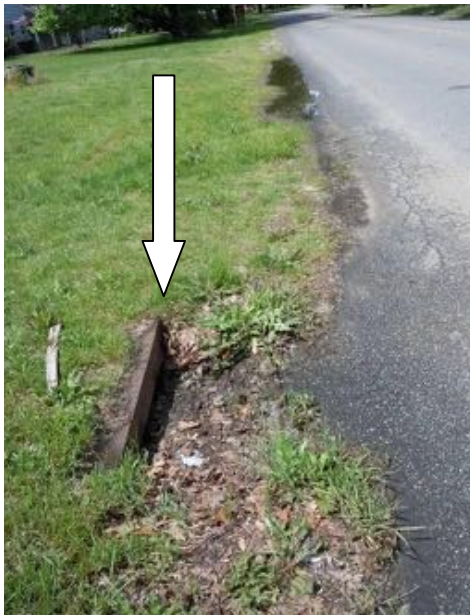
Additionally, the south side of Pine Neck Road contributes runoff to a leaching catchbasin that is located at the intersection of Pine Neck and Oaklawn Roads. Since the leaching catchbasin is clogged, it is recommended that runoff in this area instead be managed utilizing **dry swales and a leaching basin**. There is space available along most of the south side of Pine Neck Road for construction of dry swales. The dry swales should be designed to manage the water quality volume, have paved flume inlets with sediment forebays, and an underdrain system with overflow outlet device to direct runoff to subsurface infiltration structures. These practices will provide water quality treatment for both nitrogen and bacteria. Since runoff will receive pretreatment at easily accessible and maintainable sediment forebays prior to infiltration, general maintenance activities will be simplified which should improve the overall longevity and function of the infiltration practice in comparison to the existing leaching catchbasin.

Figure 3.29. Existing clogged leaching catchbasin (indicated by arrow) near intersection (on southwest corner of intersection) of Pine Neck Road and Oaklawn Ave. (left); Proposed dry swale and overflow device to an infiltration structure proposed to replace the clogged leaching catchbasin at intersection (right).

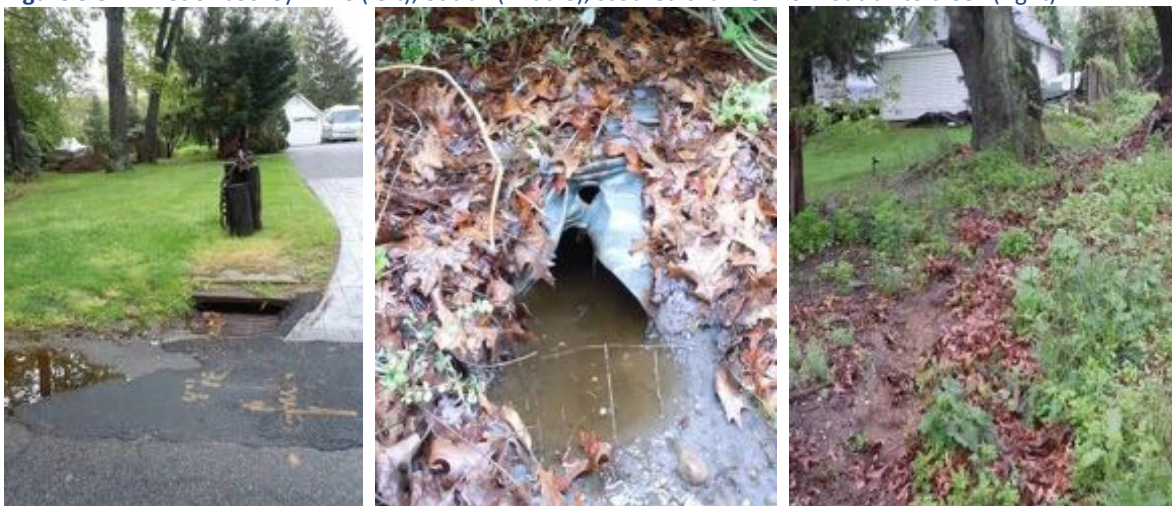
Figure 3.31. Inlet on Jockey Drive (left), outfall (middle), scoured channel from outfall to creek (right).

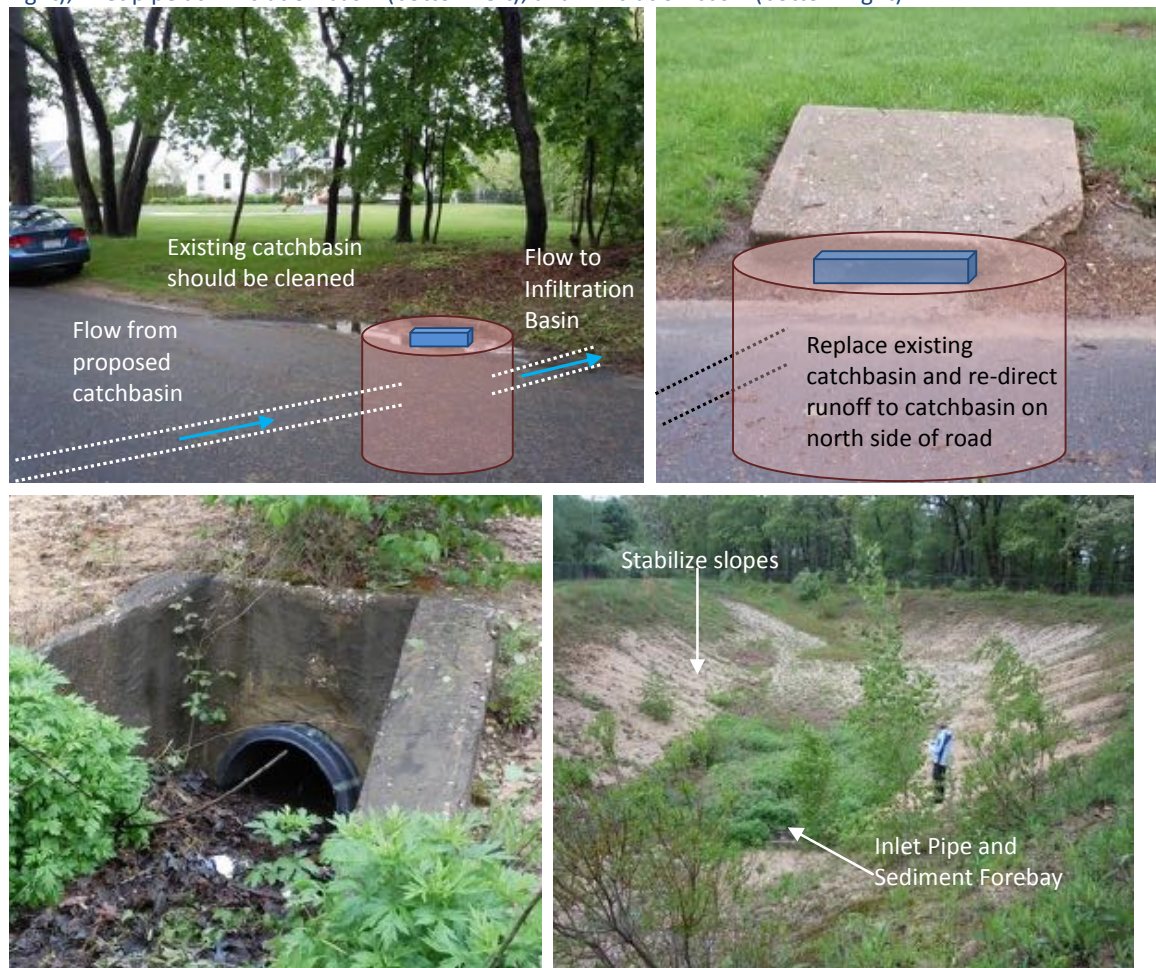
Figure 3.32. Catchbasin inlet on north side of Wells Avenue (top left); Inlet on south side of Wells Avenue (top right); Inlet pipe at infiltration basin (bottom left); and infiltration basin (bottom right).

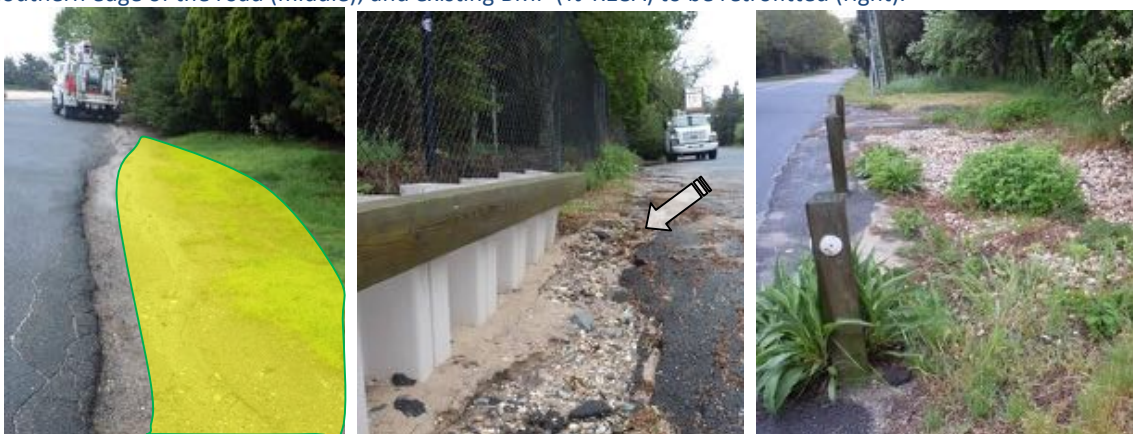
Figure 3.33. Proposed bioretention (TJ-R18B) along south side of Pine Neck Road (left); eroded channel along the southern edge of the road (middle); and existing BMP (TJ-R18A) to be retrofitted (right).

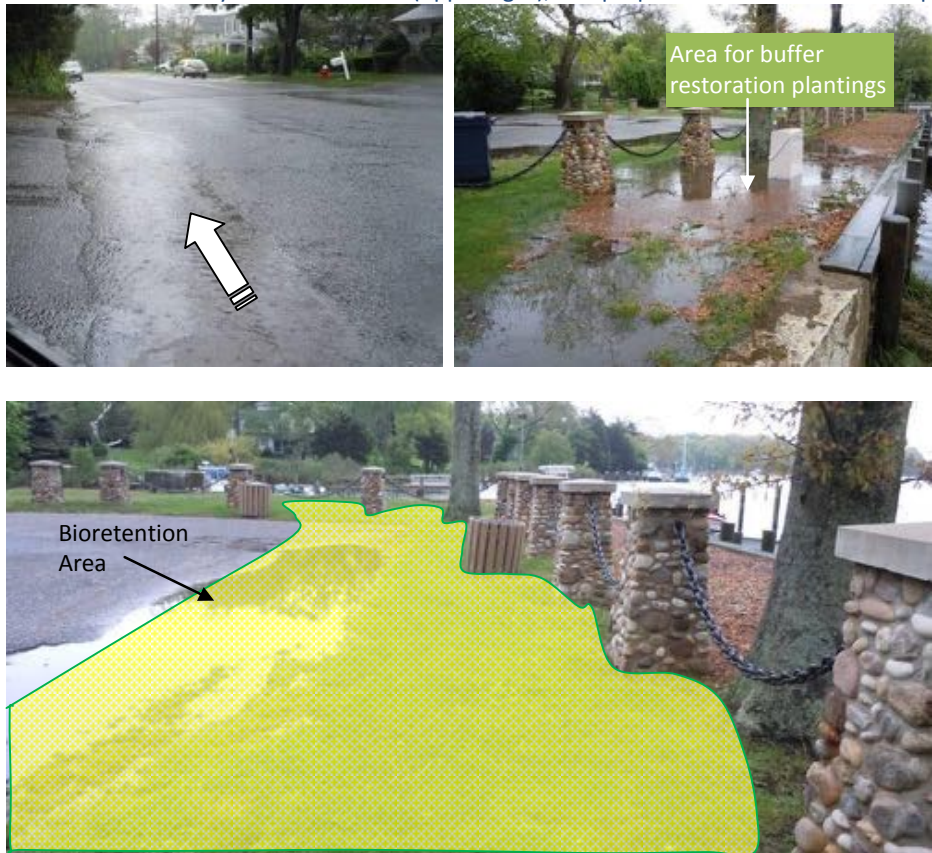
Figure 3.34. Runoff flowing down Youngs Avenue from NY 25 (upper left). Parking area and runoff from Youngs Avenue flows directly into Town Creek (upper right), and proposed bioretention area in park (bottom).

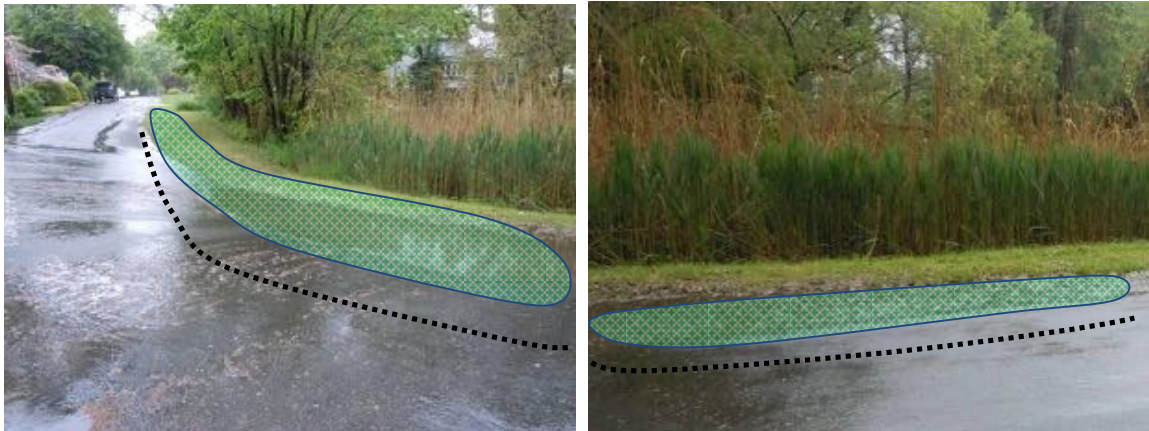
Figure 3.36. Runoff transporting sediment and organics along Mechanics Street flows to the adjacent wetland. The dashed lines show the proposed limit of pavement removal, and the swale footprint is shown shaded green.

Mechanic Street is a good location for **pavement removal** and installation of a **water quality swale** between the edge of pavement and the wetland. This would provide water quality treatment prior to discharge into the wetland. In addition, the 15-inch culvert between the Mechanic Street wetland and the Youngs Avenue wetland and the two 18-inch culverts connecting Youngs Avenue to Town Creek should be inspected and maintained as needed to ensure maximum flushing.

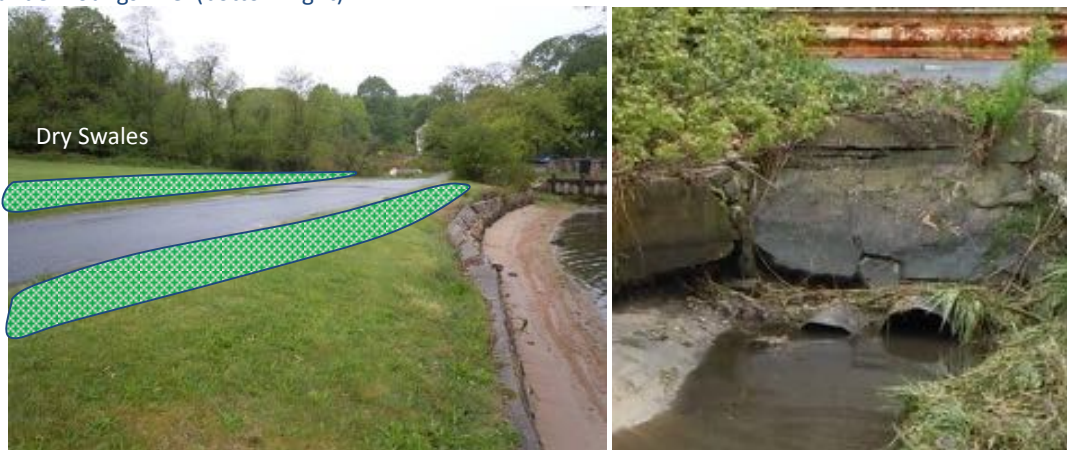
Figure 3.37. Proposed dry swales along Youngs Ave. on south side of culvert under road (left), and existing culverts under Youngs Ave. (bottom right).

Dry swales are proposed to provide treatment for runoff that is generated along Youngs Avenue on the south side of the culvert under the road. The swales should be constructed in open space located in the ROW on both sides of Youngs Avenue in this area (see Figure 3.35). The swales should have a reinforced spillway for overflow to open space adjacent to the wetland in storm events that exceed the water quality volume. This practice will provide water quality treatment of runoff prior to discharge to the creek. Currently, this runoff is directly discharging to the creek without any treatment.

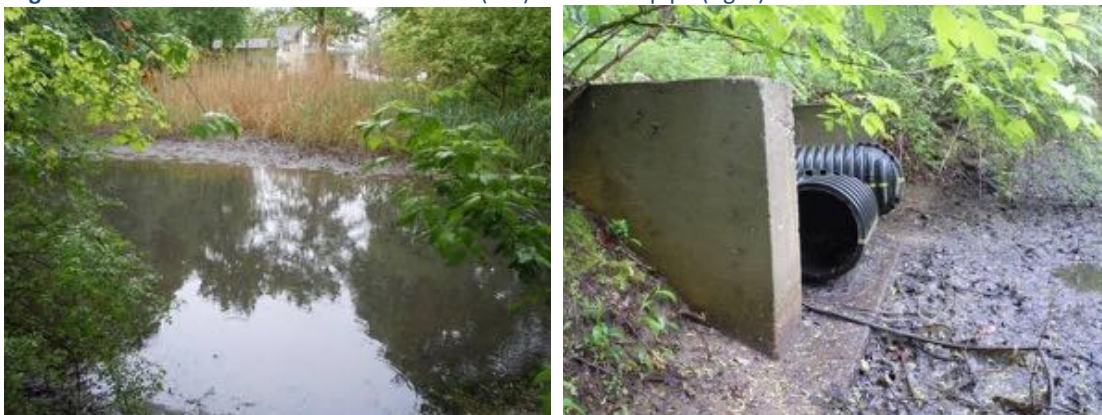
Figure 3.38. Hobart Avenue detention basin (left) and outlet pipe (right).

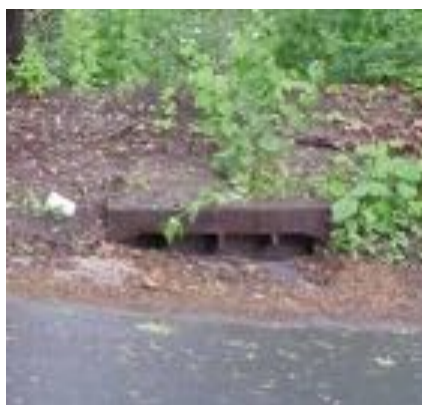
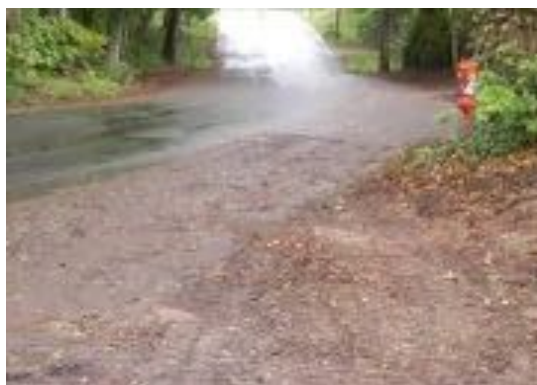
This site is located at a low point in Hobart Avenue adjacent to a wetland and Town Creek. This area is at a relatively low elevation, and the infiltration capabilities of the existing leaching catchbasin may be limited due to high groundwater. The north side of the road at this site is a good candidate for a **bioretention area** within the right-of-way, but an easement will be required if the practice is sized for the optimal treatment volume, and a wetland delineation should be performed to ensure no construction occurs within a wetland resource. A catchbasin on the south side of the road and a paved flume should be constructed to direct runoff into the bioretention area, with overflows from large storm events directed into the existing leaching catchbasin. The leaching catchbasin here has major buildup of sediment and organics most likely resulting from nearby dumping of yard waste and upgradient development activities. This catchbasin should be maintained, and areas contributing sediment should be stabilized using proper erosion and sediment control measures.

Figure 3.41. Hobart Avenue view looking southeast, showing proposed retrofit (left); clogged leaching catchbasin (middle); and sediment and organics from construction site upgradient of leaching catchbasin without proper erosion and sediment control measures in place (right).

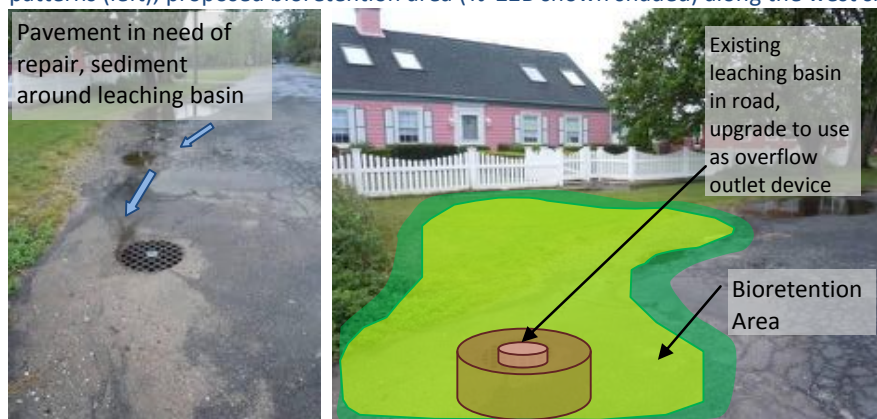
Figure 3.43. Existing condition of pavement and leaching catchbasin on Terry Lane, arrows indicate runoff flow patterns (left); proposed bioretention area (TJ-22B shown shaded) along the west side of Terry Lane.

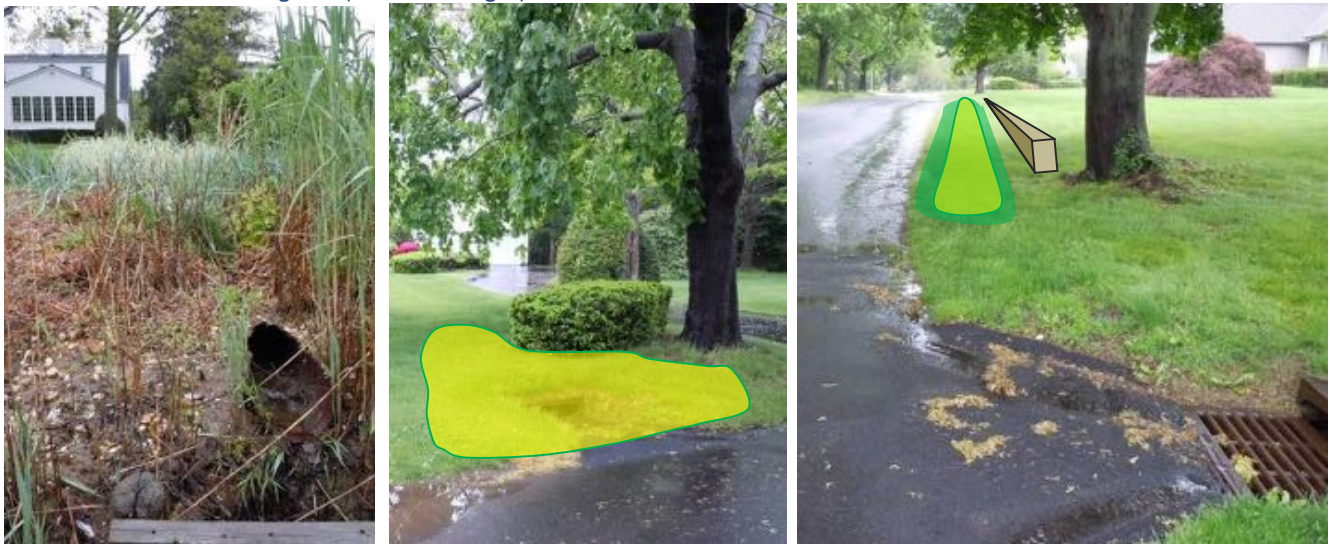
Figure 3.45. Outfall at #575 Hill Road (left); Inlet on south side of Hill Road with proposed raingarden and dry swale shown shaded green (center and right).

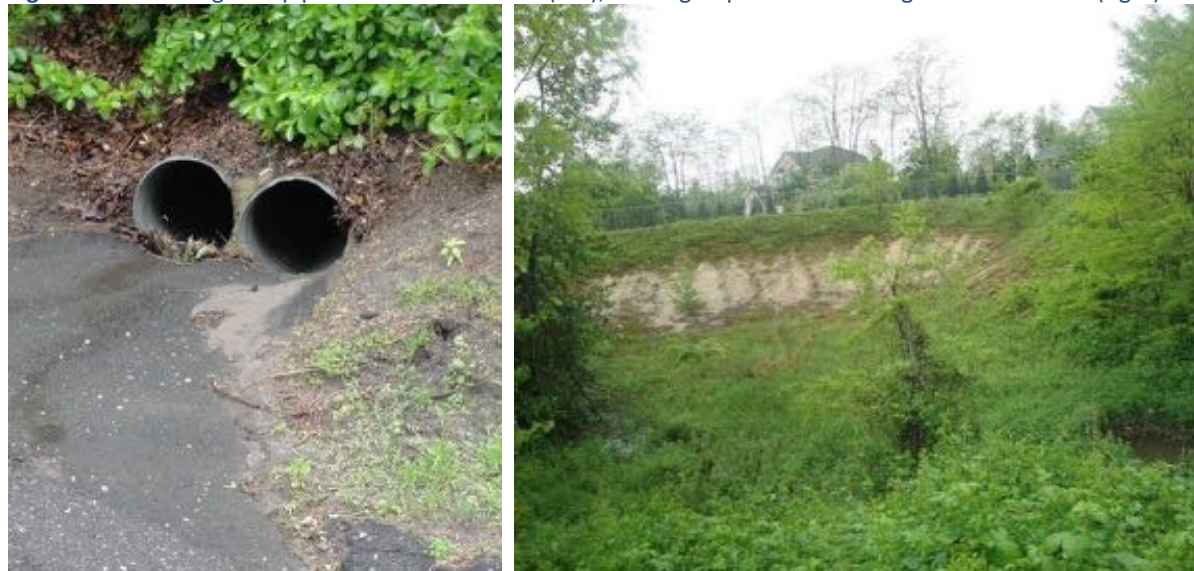
Figure 3.47. Existing inlet pipes to infiltration basin (left); eroding slopes in the existing infiltration basin (right).

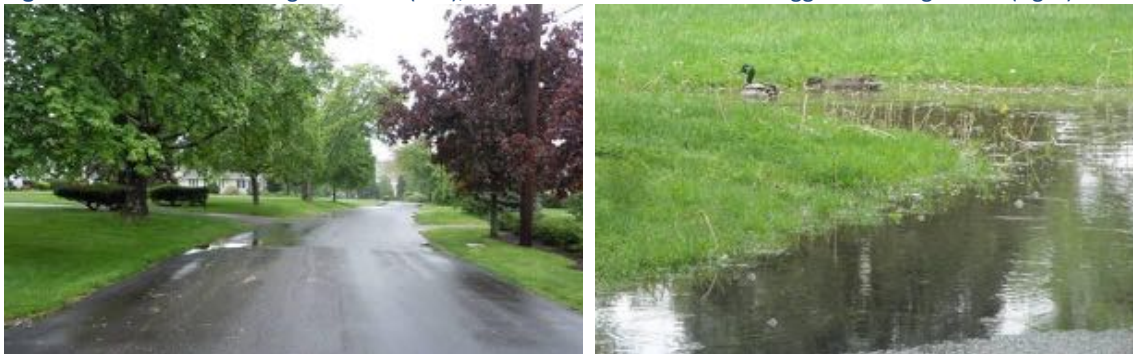
Figure 3.50. Calves Hill Neighborhood (left); Area of Midfarm Road with clogged leaching basins (right)

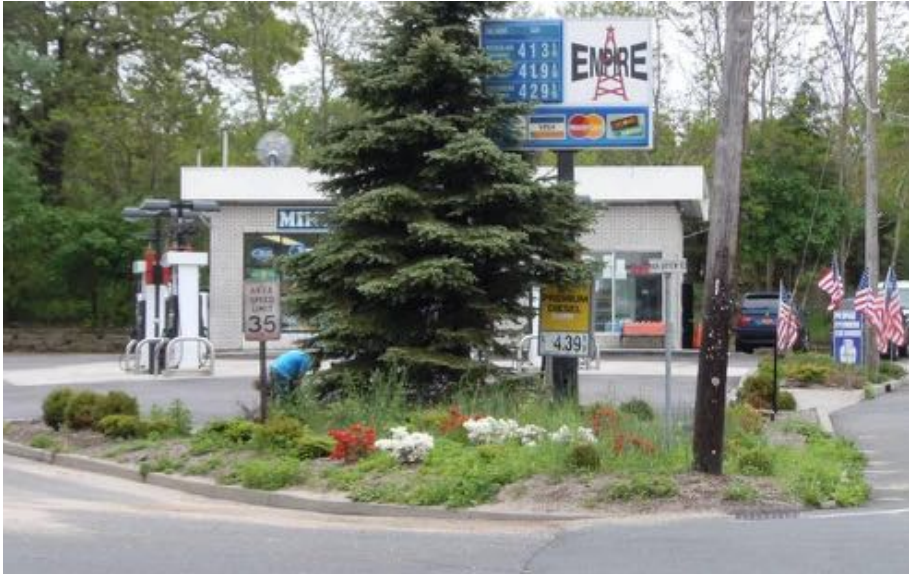
Figure 3.52. Uncovered and sloped vehicle fueling area at Empire Mini-Mart Gas station

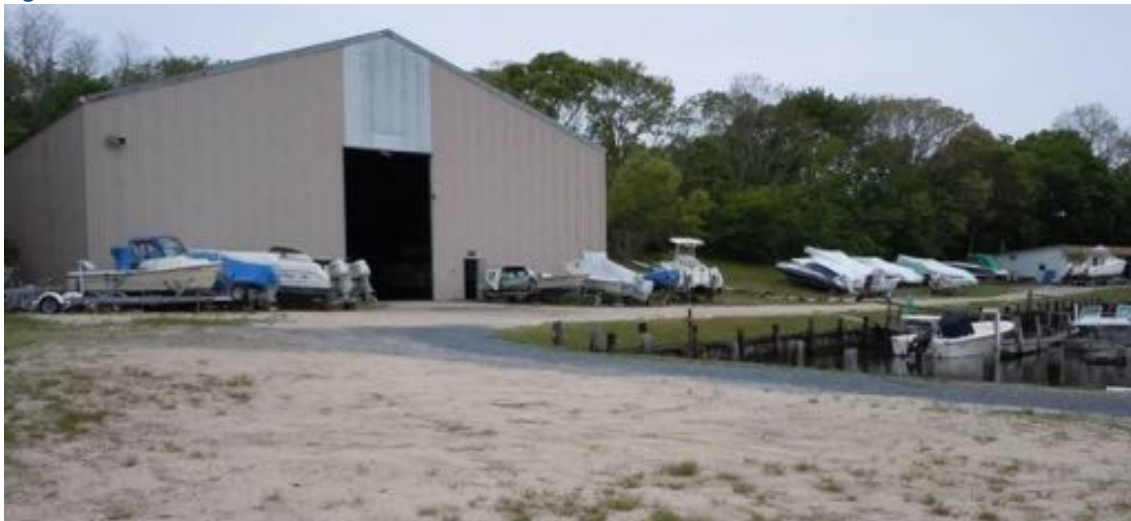
Figure 3.53. Boat maintenance barn at Southold Marina

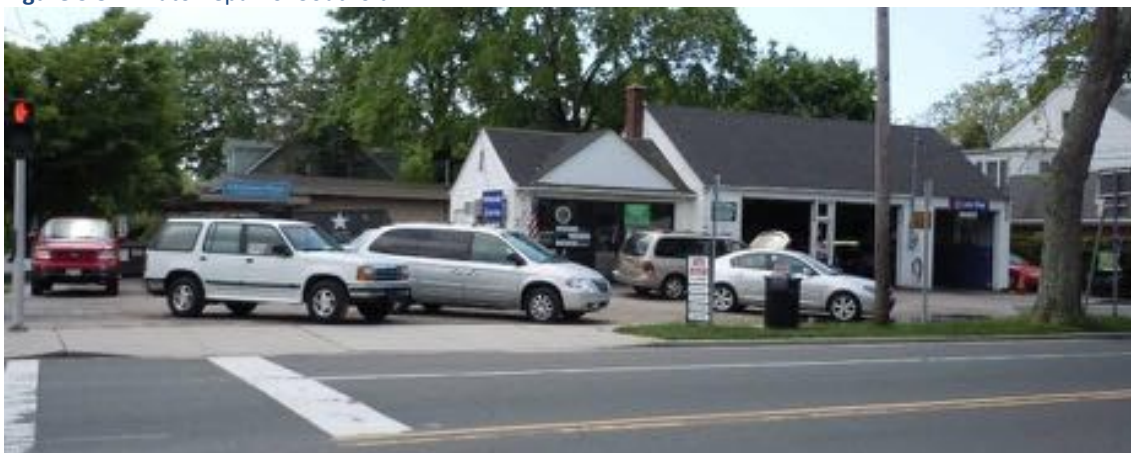
Auto Repair of Southold was identified as a potential hotspot because of vehicle maintenance activities that occur at the site. Stormwater infrastructure was not visible on site; runoff likely contributes to storm drains located on Main Road/ NY Route 25. Pollutants from the site were determined to be minimal as maintenance activities appear to occur in the garage.

Figure 3.54. Auto Repair of Southold

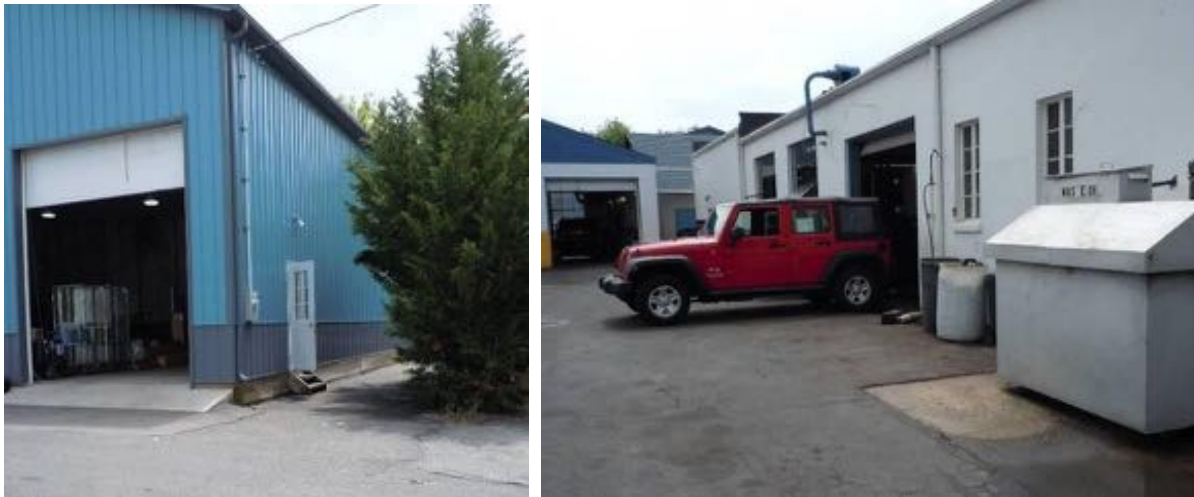
Figure 3.55. Mullen Motors maintenance garage with roof runoff directly connected to impervious area (left); visible staining on pavement and directly connected roof runoff (right).

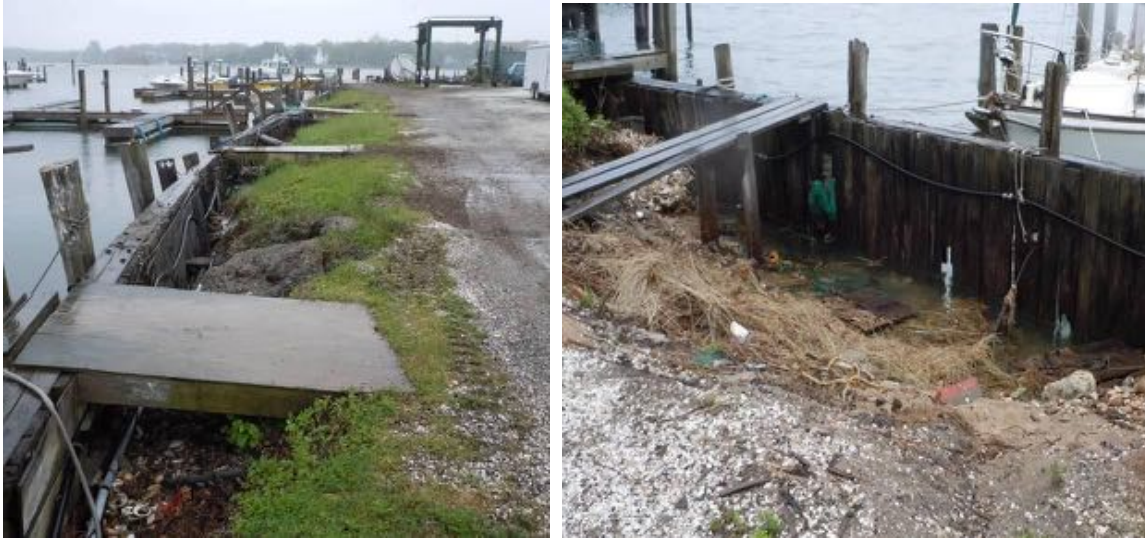
Figure 3.56. Goldsmith Marina potential contribution of sediment along failing bulkhead

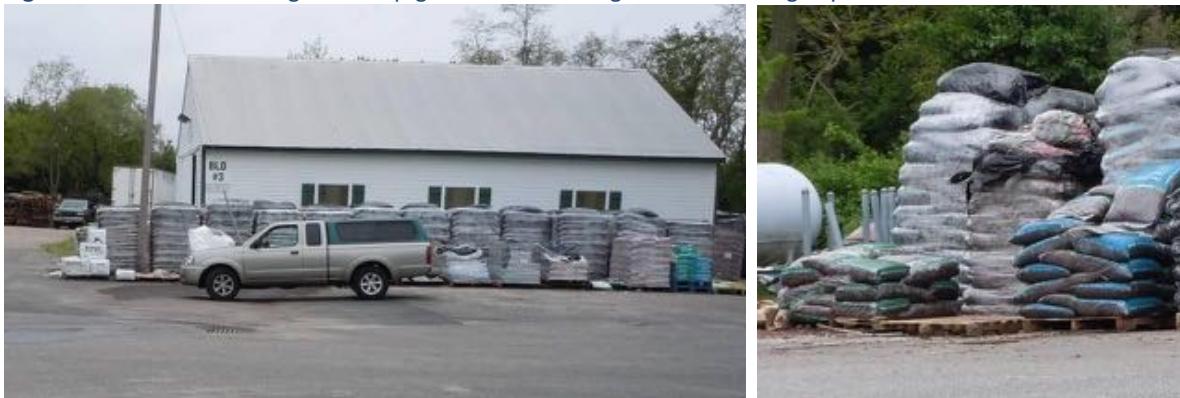
Figure 3.58. Material storage areas up-gradient of leaching catchbasin at Agway

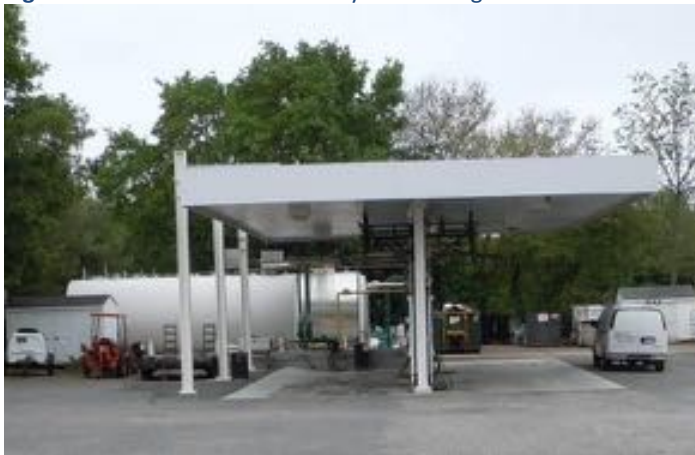
Figure 3.59. Covered fuel delivery truck filling area at Burt's Reliable

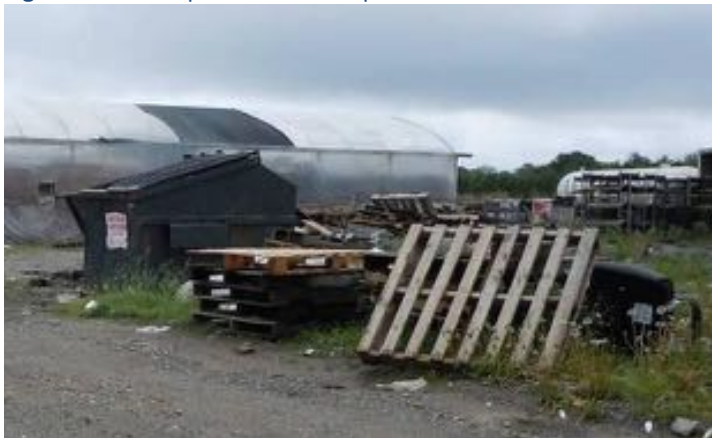
Figure 3.60. Catapano Farms dumpster area
