Town of Southold Subwatersheds Management Plan

June 2013

Horsley Witten Group, Inc.

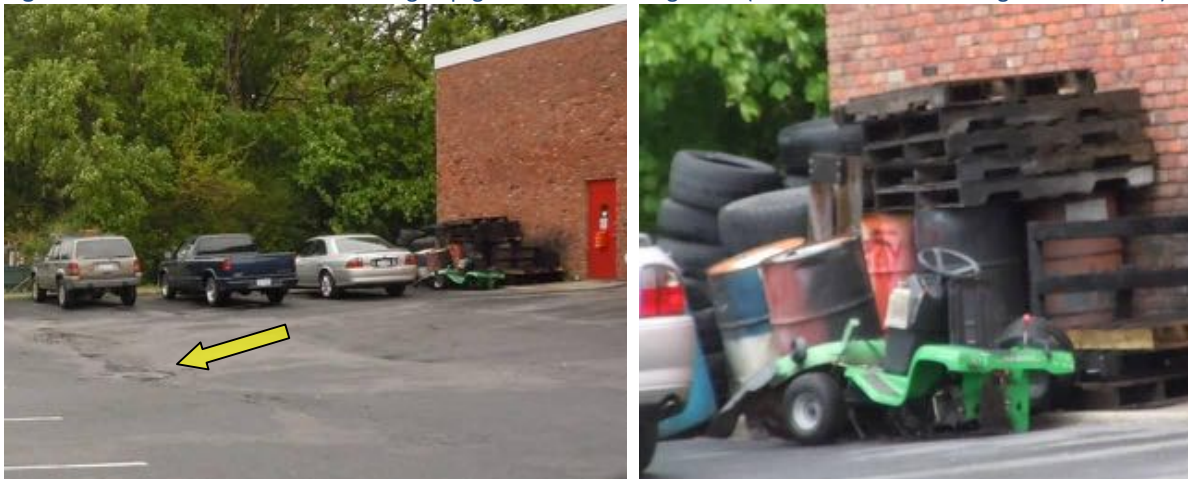
Figure 3.61. Uncovered material storage up-gradient of leaching basin (arrow indicated leaching basin location)

The parking area behind the building is characterized as a medium-level potential hotspot based on observations of hydrocarbon-derived pollutants and debris resulting from uncovered storage that includes equipment, tires, and liquid storage drums up-gradient of leaching catchbasins.
