Upper Mills Dam – Peconic River

Feasibility Study Report: Alternatives for Fish Passage

February 28, 2011

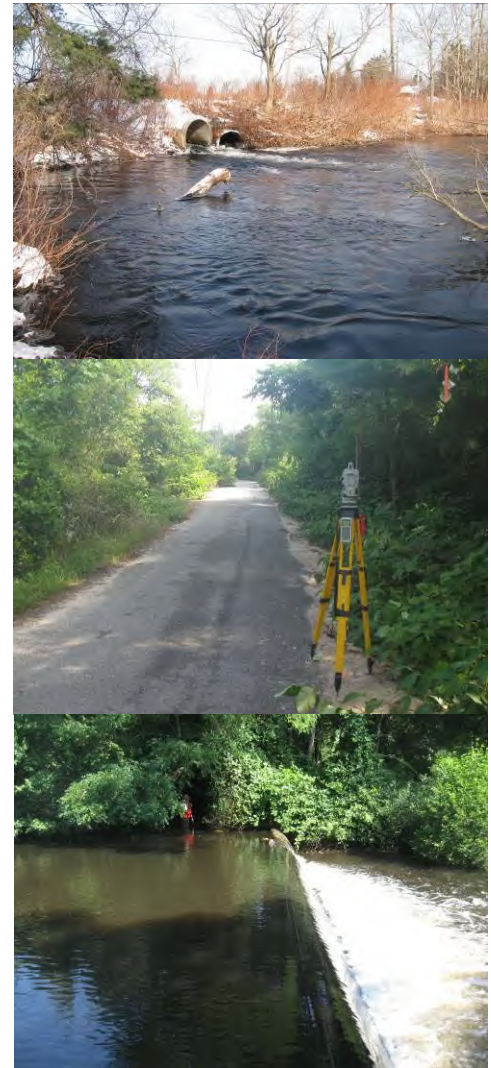
Figure 2. (Top) Looking upstream at the Upper Mills Dam and the downstream outlets of the two culverts; (middle) looking north along the paved road on top of the dam; (bottom) looking north at the USGS gaging weir downstream from the dam.

The USGS maintains a concrete weir 250 ft downstream of the dam in order to measure the stage and discharge of the Peconic River (Figures 2 and 3). This gaging station (#01304500) has been active since 1942. The structural height of the weir is approximately 2.5 ft and its length is 52 ft. A concrete apron on the downstream end is 0.5 ft tall and 6 ft wide. The weir is a fish passage barrier through much of the year but may pass some fish during higher water flows when the drop in water elevation over the weir is decreased (B. Young, pers. comm.). In addition to providing passage around Upper Mills Dam, alternatives for passage over the weir are analyzed below.

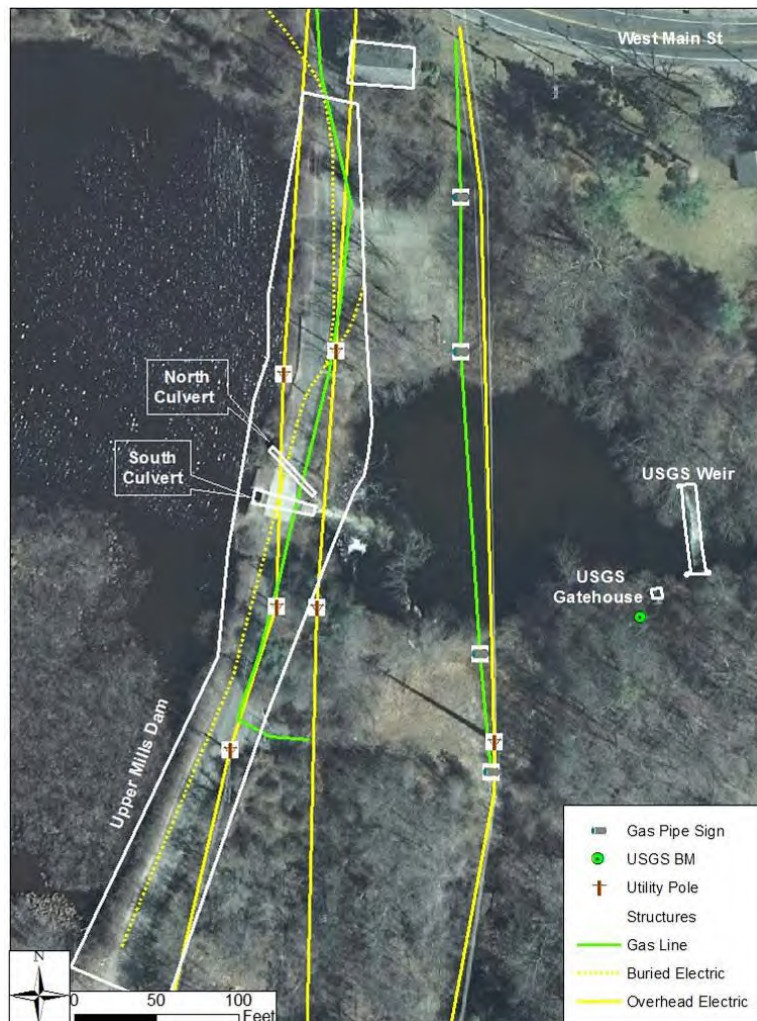
Figure 5. Utilities, structures, and other site features near the Upper Mills Dam.

As mentioned above, the road on top of Upper Mills Dam primarily serves the LIPA substation to the south of the dam. High voltage utility lines lie under the road and overhead carrying electricity to and from this substation (Figure 5). The road has been designed to withstand the use of heavy utility vehicles while protecting the utility lines beneath. The utility lines are within conduits buried between the bottom of the road and the top of the culverts. Additional overhead utility lines are above the road and above the river downstream. A gas line lies beneath the river between the dam and the weir as well and is identified by yellow signs and a mowed strip of vegetation.

These utilities present challenges for the completion of fish passage alternatives involving the construction of new culverts through the dam and any excavation or construction between the dam and the USGS weir. The overhead utility lines are generally high enough not to be impacted by construction vehicles. Care will need to be taken, however, to ensure the utilities under the road are not damaged during any construction relating to the fishway alternatives involving a new culvert. The emergency culvert replacement in 2005 provides a template for what to expect during any future construction. A conversation with representatives at Dunn Engineering, who designed and oversaw the construction in 2005, provided valuable information regarding the utilities. During that culvert replacement, the heavy, reinforced concrete slab on top of the culvert was saw-cut and removed. The utilities were located within one or two conduits directly below this concrete slab and only inches above the culvert. The conduits were kept in place during construction to maintain continuous flow of electricity. The old culvert was pulled out and the new one was slipped underneath the conduits. Fill was then placed around the culvert and the conduits and a concrete slab placed on top. A similar sequence is likely to occur for any construction relating to the fishway alternatives involving a new culvert. Assistance from the utility company would be desirable, as was provided during the emergency culvert replacement.

The gas line underneath the Peconic River between the Upper Mills Dam and the USGS weir is clearly marked on both shores by yellow gas signs. While attempts have been made to obtain information from National Grid, the depth of the line is unknown at this time. Although the line is likely buried well below the channel bed, the elevation will need to be determined before any excavation commences and before construction vehicles drive over the pipe location.

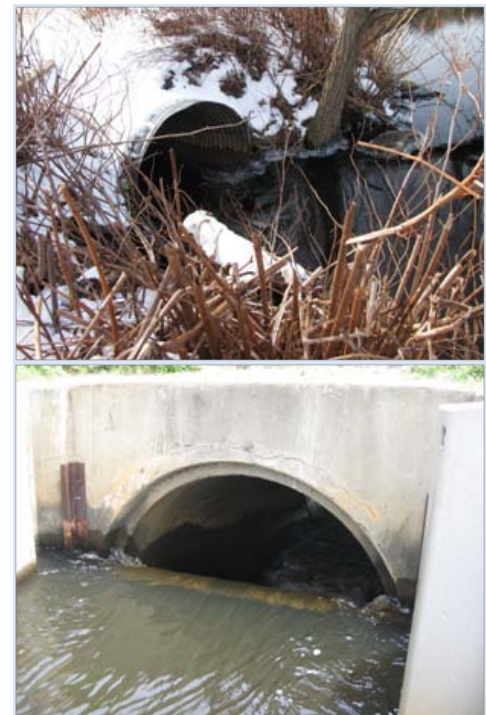
Figure 9. (Top) Looking downstream at the north culvert; (bottom) looking downstream at the south culvert with stop logs in place.

In HEC-RAS, two parallel reaches were modeled to simulate the split flow between the two existing culverts. The north culvert is a 4-ft corrugated metal pipe slightly compressed into an elliptical shape (Figure 9). Both ends of the culvert project from the road embankment without wingwalls that typically help prevent erosion and reduce entrance and exit energy losses. Vegetation is growing at the inlet of this culvert, however, and erosion does not appear to be impacting the integrity of the dam or culvert. The slope of this culvert is 0.119 (ft/ft). The south culvert is a 6-ft diameter concrete pipe that was installed in 2005 (Figure 9). Stop logs are used at the upstream end of the south culvert

to keep the reservoir levels at the desired elevation. As mentioned in the hydrology section above, however, it is unknown if these stop logs are actively managed to regulate flows. The structure appears to be in a stable working condition. The slope of this culvert is 0.053 (ft/ft). Average flow velocities along the length of the culvert, and specifically at the entrance and outlet, indicate conditions are difficult for most fish to negotiate during passage. Flow velocities, as determined with the HEC-RAS model are greater than 3 feet per second (ft/s) in the north culvert and 5 ft/s in the south culvert (Table 3)

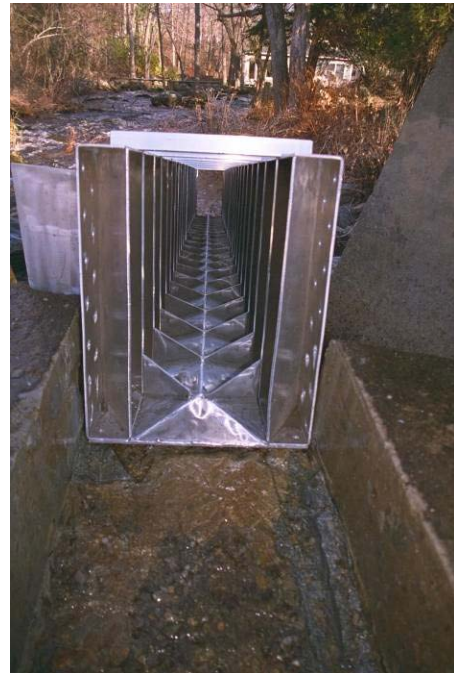
Figure 10. Looking downstream at an Alaskan steep pass fish ladder (photo from NOAA photo library).

The first alternative developed for analysis was the installation of an Alaskan steep pass fish ladder within the existing north culvert. This option was proposed initially as an intended low cost retrofit to an existing structure to accomplish passage. Alaskan steep pass ladders are prefabricated structures with metal pieces extending into the flow of water; these sections of metal disrupt the flow and provide refuge and resting areas behind (Figure 10). The primary benefit of this alternative at this site is that the road surface can remain undisturbed and none of the utilities are exposed or disturbed during construction. The prefabricated fish ladder can be delivered on site, slid into the north culvert, and installed with no surface disruption.

Placing a fish ladder that is rectangular in cross section inside of a circular culvert does present challenges. Assuming the ladder is placed in the center of the culvert, water will flow through the ladder as well as in the space between the ladder

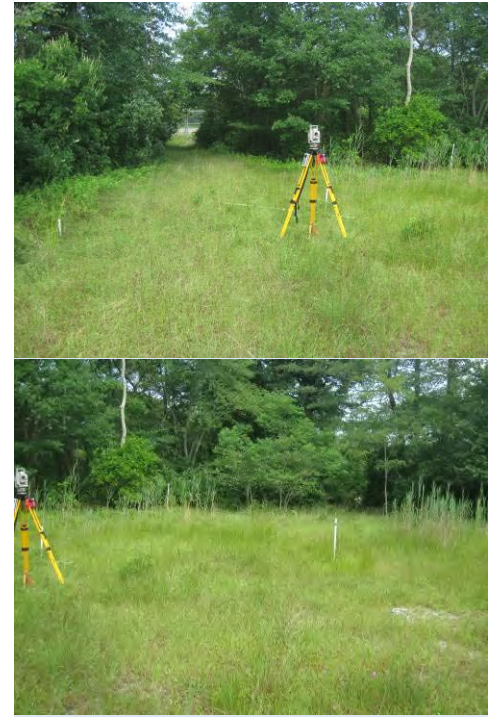
Figure 11. (Top) Dirt access road looking towards dam; (bottom) open field looking towards proposed fishway.

pool (Table 9). Access is also easy at this location: a gate maintained by LIPA provides access along a dirt road to an open field adjacent to the relic channel (Figure 11). The road can be used for access and the field can be used for staging. Although some vegetation will need to be removed to complete construction, much of the existing vegetation and canopy will remain to provide cover and shade.
