Suffolk County Department of Health Services

Peconic Estuary Conceptual Habitat Restoration Design Planning Services

Interim Meeting (*Peconic Estuary Habitat Restoration Conceptual Design Planning Services*)

Iron Point: Summary of Contracted Work and Technical Approach

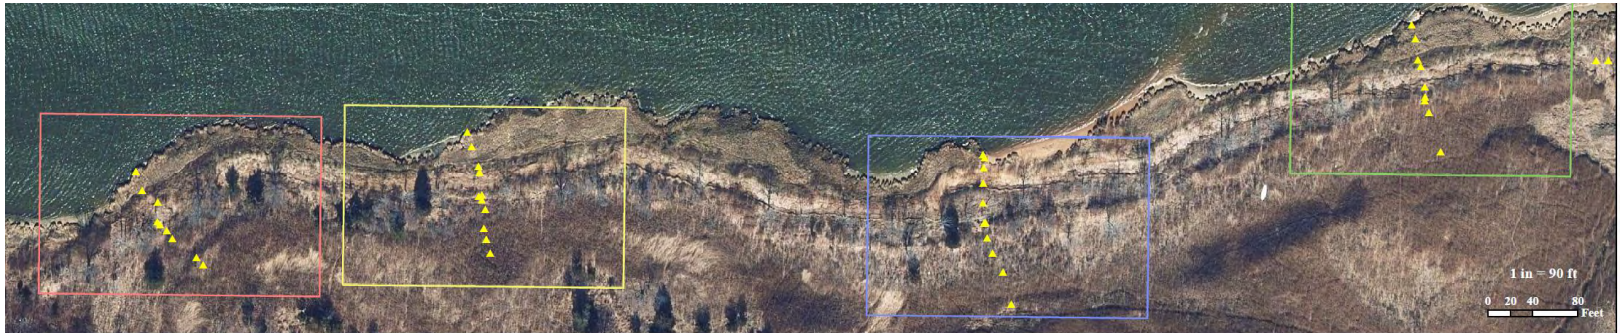
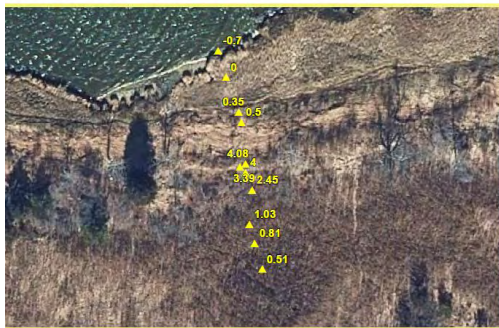
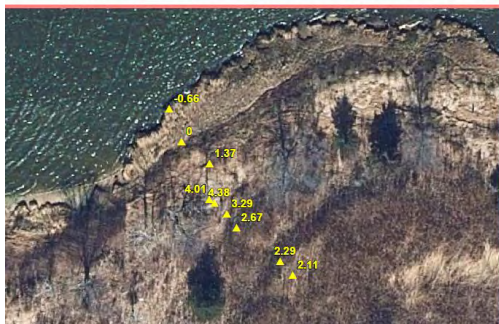
Existing Conditions: Berm and Channel Profiles

- NOTES:**
1. 2016 orthoimage from NYS GIS Clearinghouse (gis.ny.gov).
 2. Elevations referenced to Landward Boundary of Intertidal Marsh = 0.
 3. Elevation data collected December 21, 2018.
 4. Elevation data measured in feet.

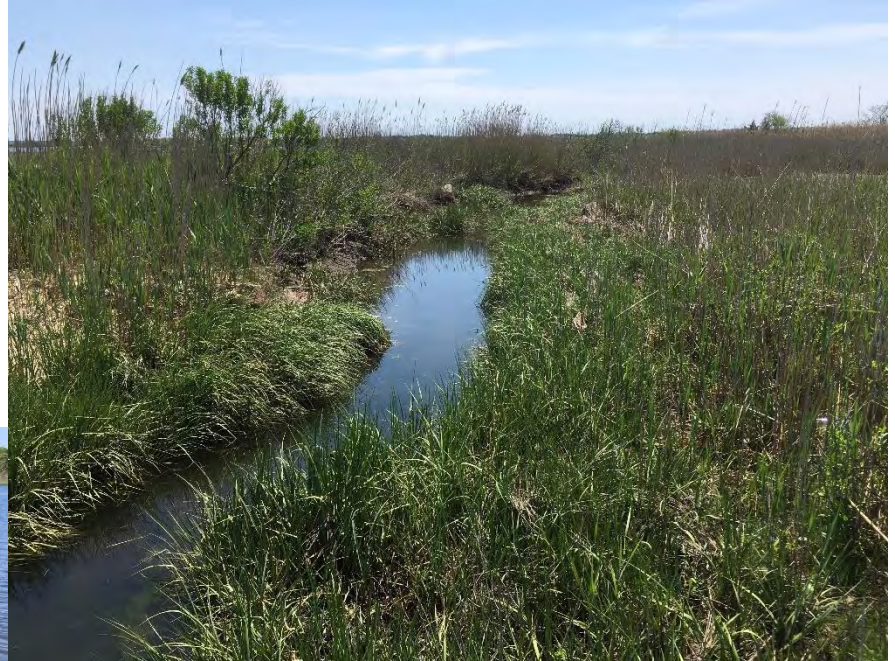
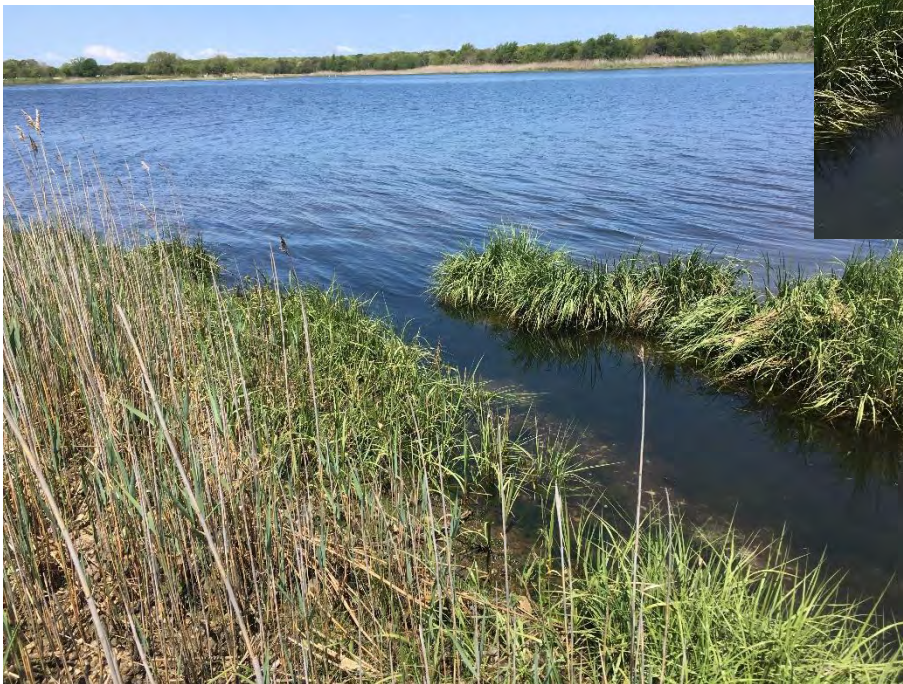
Ditch Outfall to Peconic River:
Looking Upstream (top)
Looking Downstream (bottom)

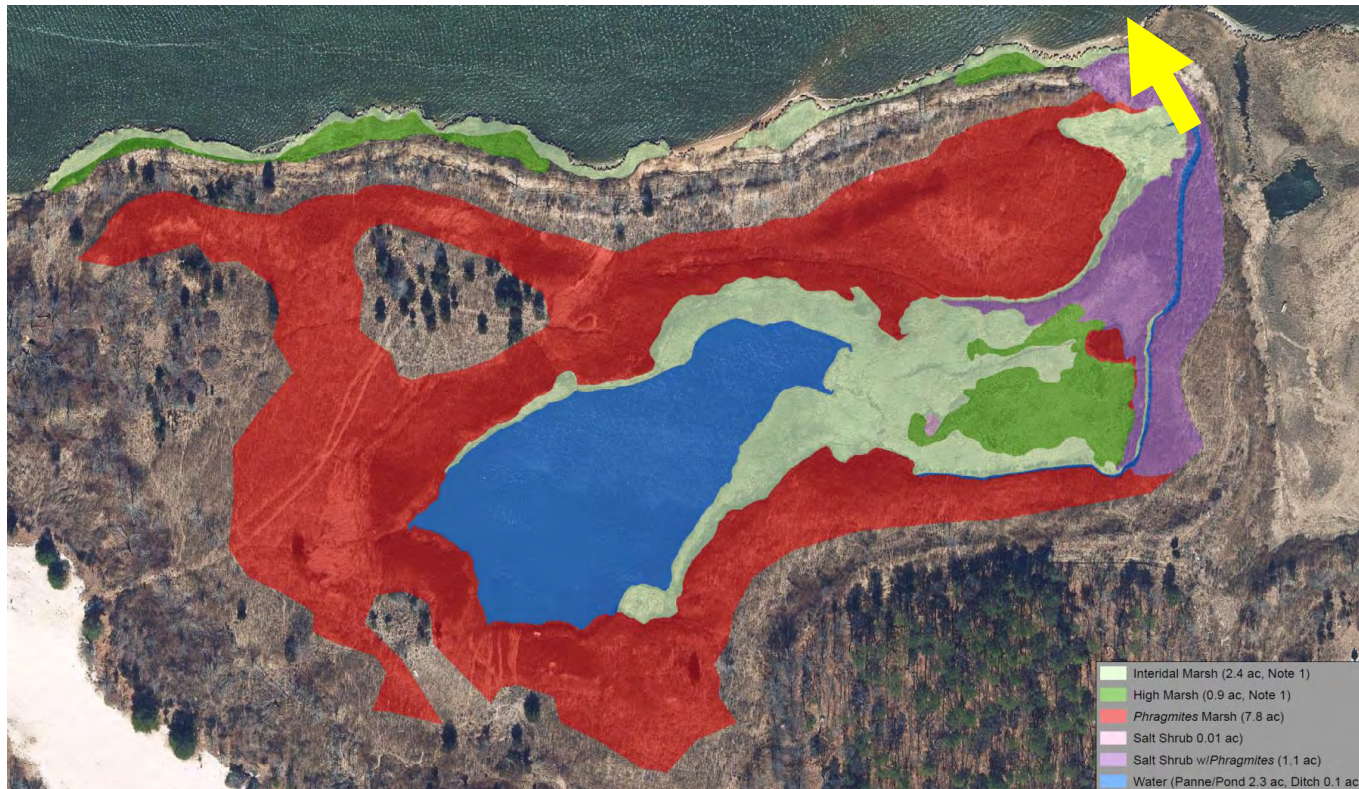
1. Construction of 2-3 new “cuts” within earthen berm
 - *Drawback: Tidal Prism Capture*
 - ‘Fixed’ Tidal Prism Volume of Iron Point marsh is divided between multiple channels. The reduced water volume through each channel, may result in insufficient volume/velocity to flush sediments from channel mouth, resulting in sedimentation of the channel mouth.

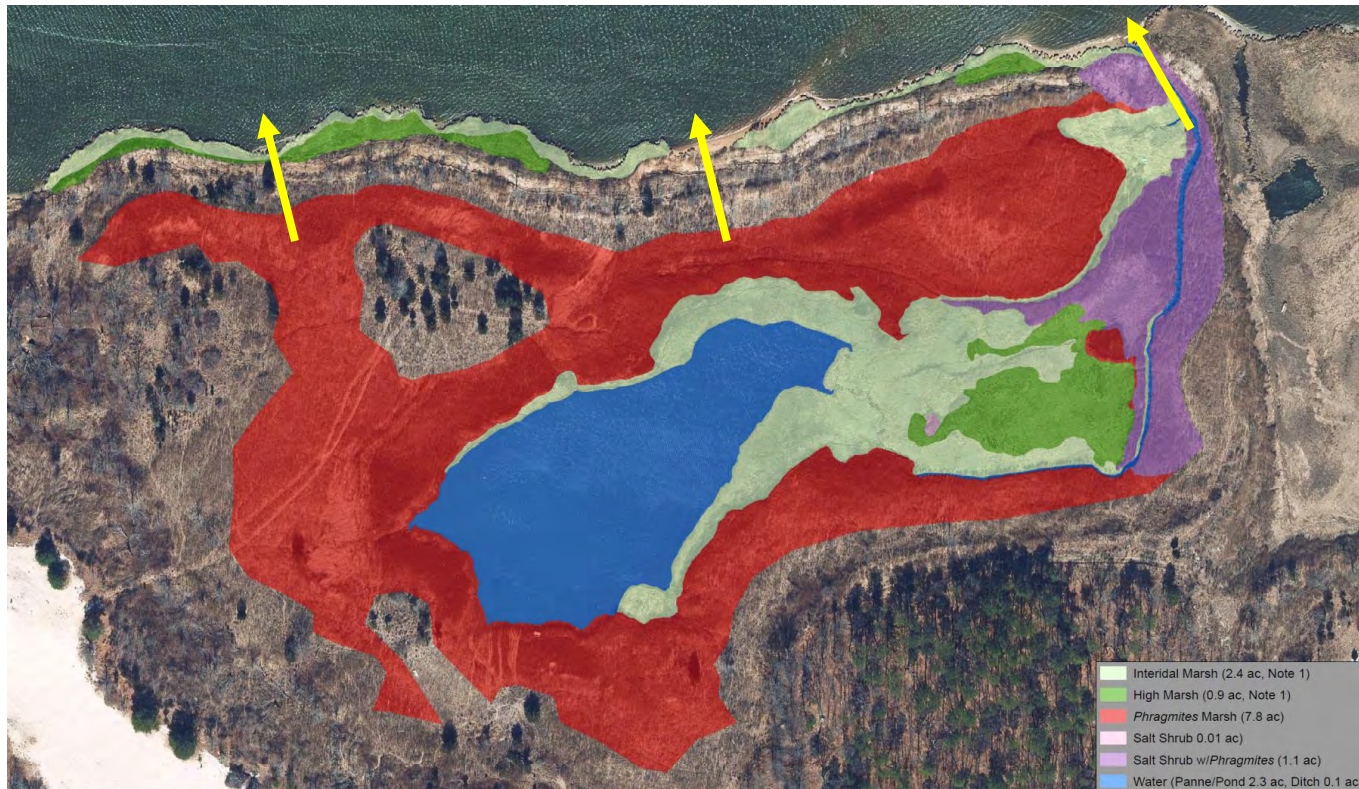
1. Construction of 2-3 new “cuts” within earthen berm
 - *Drawback: Tidal Prism Capture*
 - ‘Fixed’ Tidal Prism Volume of Iron Point marsh is divided between multiple channels. The reduced water volume through each channel, may result in insufficient volume/velocity to flush sediments from channel mouth, resulting in sedimentation of the channel mouth.

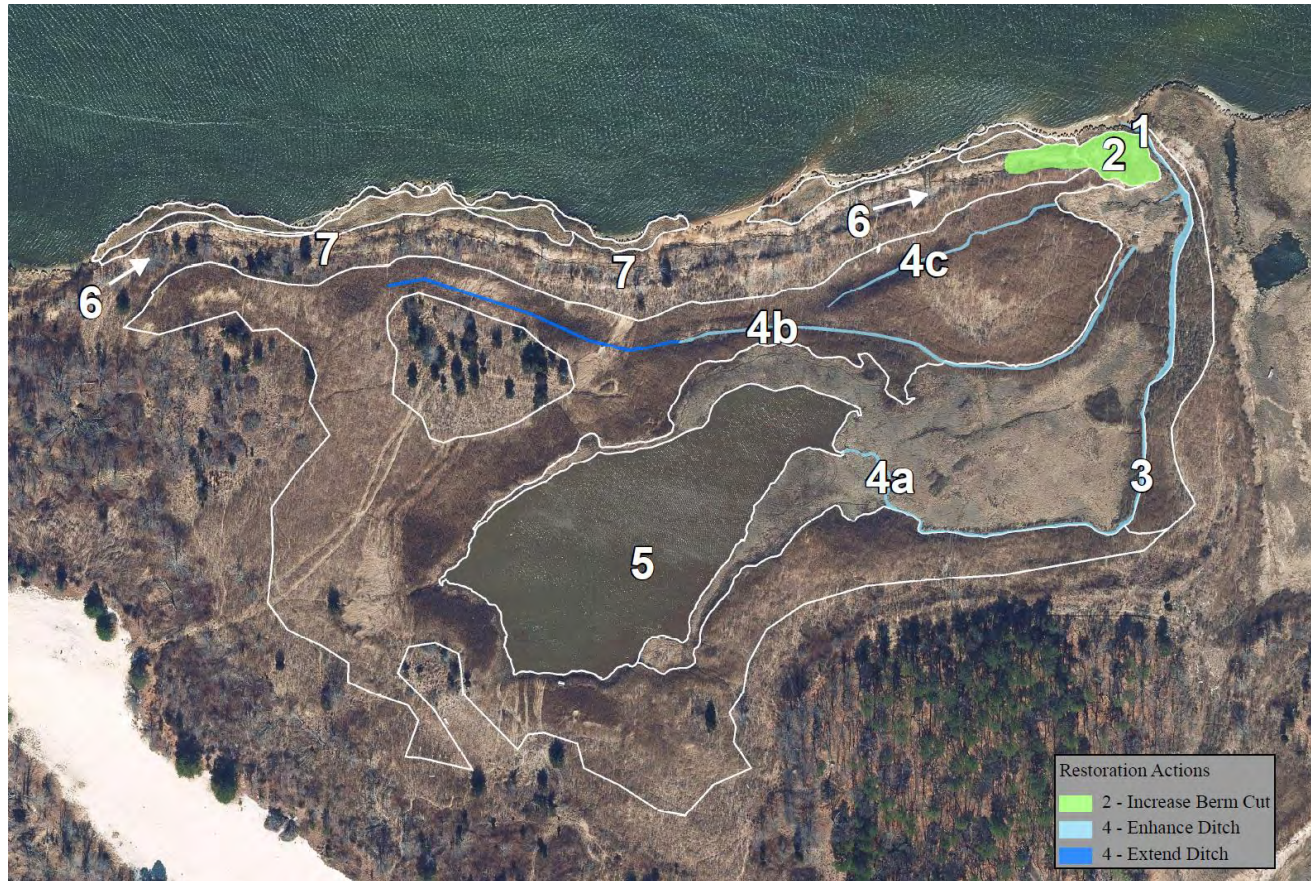
Iron Point: Schematic Plan for Marsh Restoration Actions

1. Increase Channel Mouth Width by 300%
2. Increase Size of Berm Cut
3. Provide Consistent Ditch Slope from Panne to River
4. Provide More Extensive Creek Network
 - 4a. New Channel between Panne and southern Ditch
 - 4b. Enlarge northern Ditch
 - 4c. Provide new Tributary Channel
5. Maintain Portion of Panne as Marsh Pond
6. Construction Access
7. Option: Partial Berm Cuts Stabilized with Bio-Engineering

3. RECOMMENDED ALTERNATIVE: Expand existing berm cut and Create more extensive channel network by enlarging existing ditches and adding new channels.
- Efficient means of increasing tidal flow into the marsh (in terms of excavation quantity)
 - Utilize existing flow paths in marsh; site new creek tributaries within *Phragmites* as much as feasible
 - Channel dimensions shall be based on reference marshes, technical manuals
 - *Drawback: Greater Disturbance in Existing Native Marsh Areas*

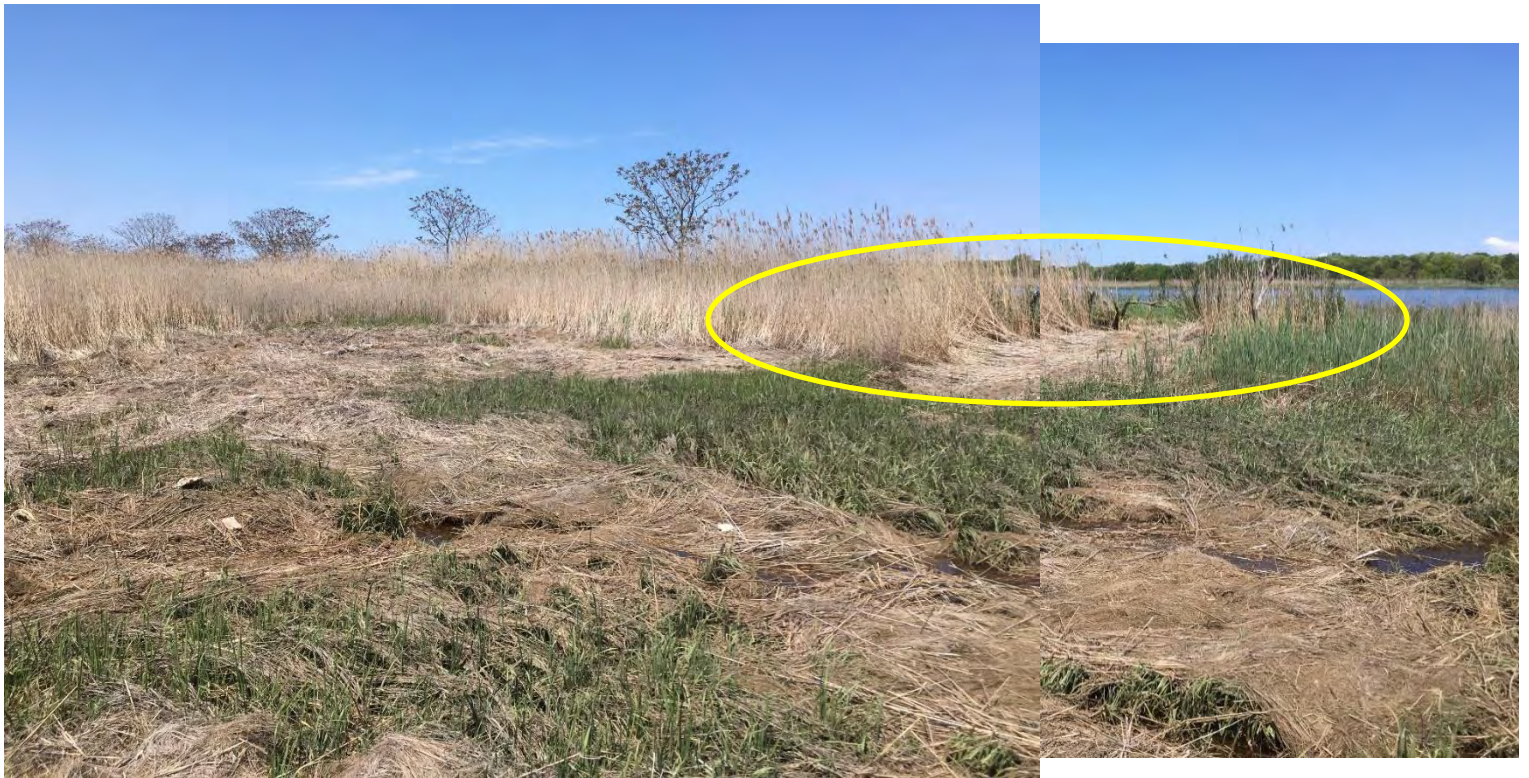
- Convert upland berm to salt shrub/high marsh. Excavate 80 feet of upland berm to salt shrub/high marsh elevation.
- Convert 5200 square feet of salt shrub habitat to intertidal marsh by excavation and re-planting.

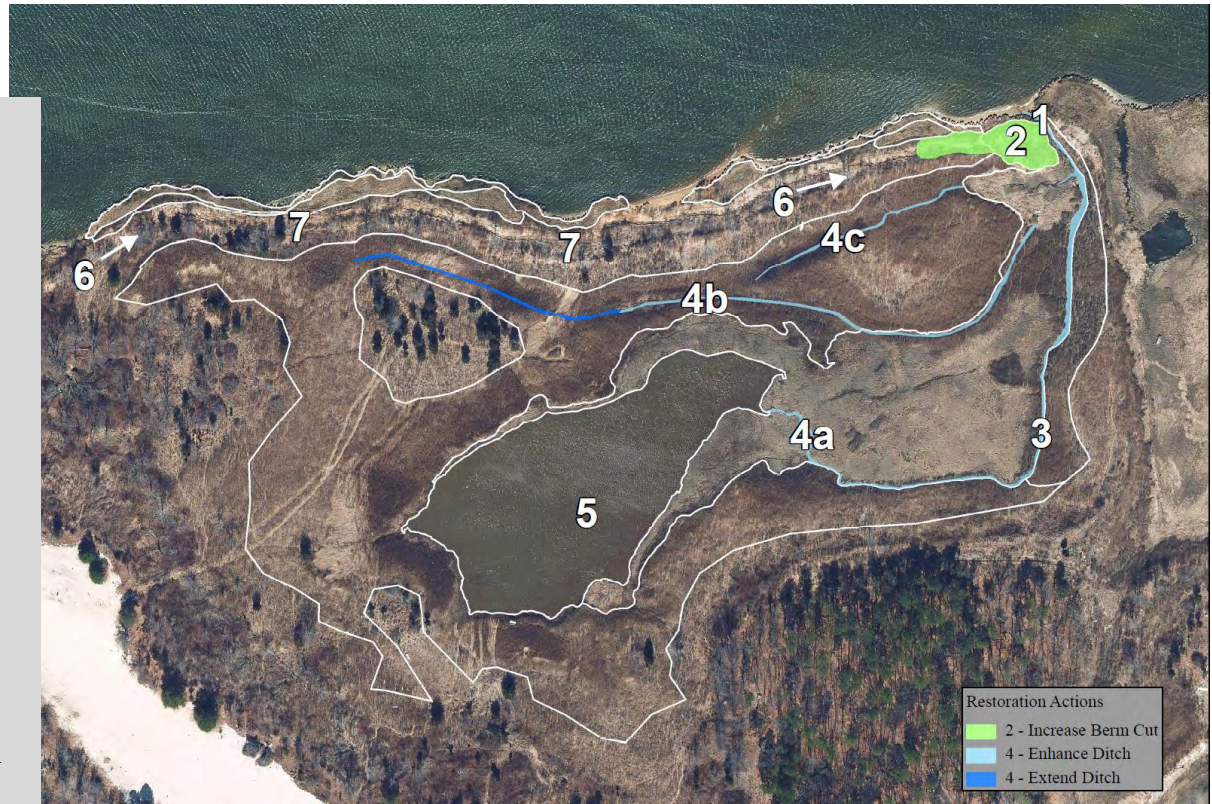
- Channel network layout (i.e. density and length based on reference wetlands and technical manuals).
- For example, channels recommended within 100 feet of marsh locations (NYC Parks, 2016).
- Construct channel between panne and southern ditch
- Restore/enlarge/extend northern ditch
- Provide new tributary channel into *Phragmites* depression.
- Re-plant disturbed areas and new channel banks with *Spartina alterniflora*

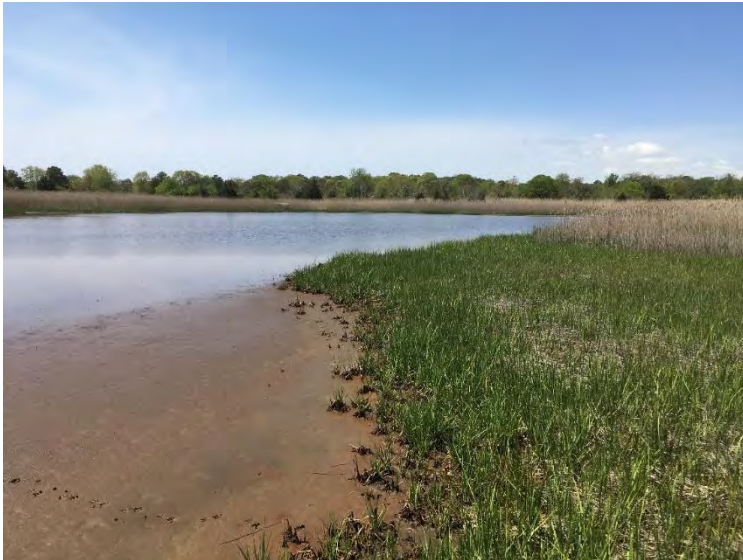
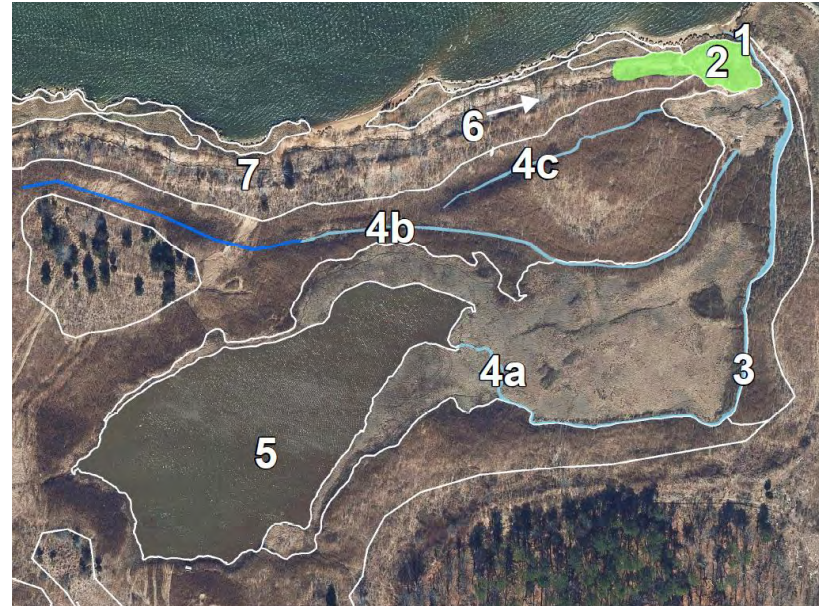
- The recommended channel (4a) does not extend into lowest elevation of panne to maintain pond/panne habitat.

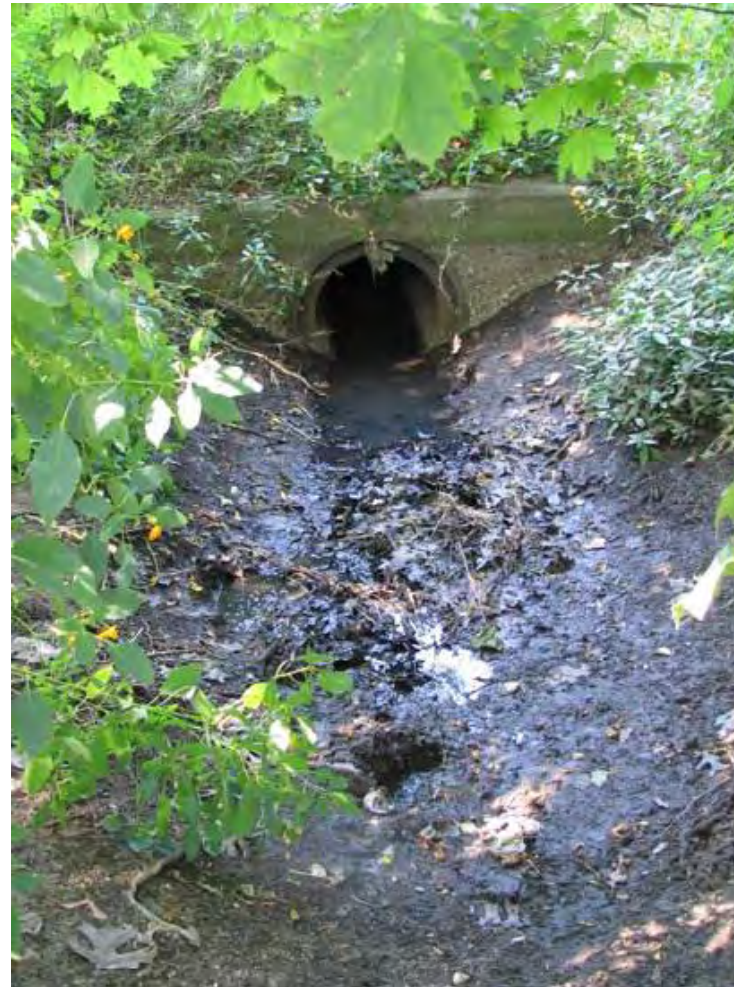
Main Road Stormwater Outfall Culvert:

Existing 24” reinforced concrete
pipe outfall and headwall

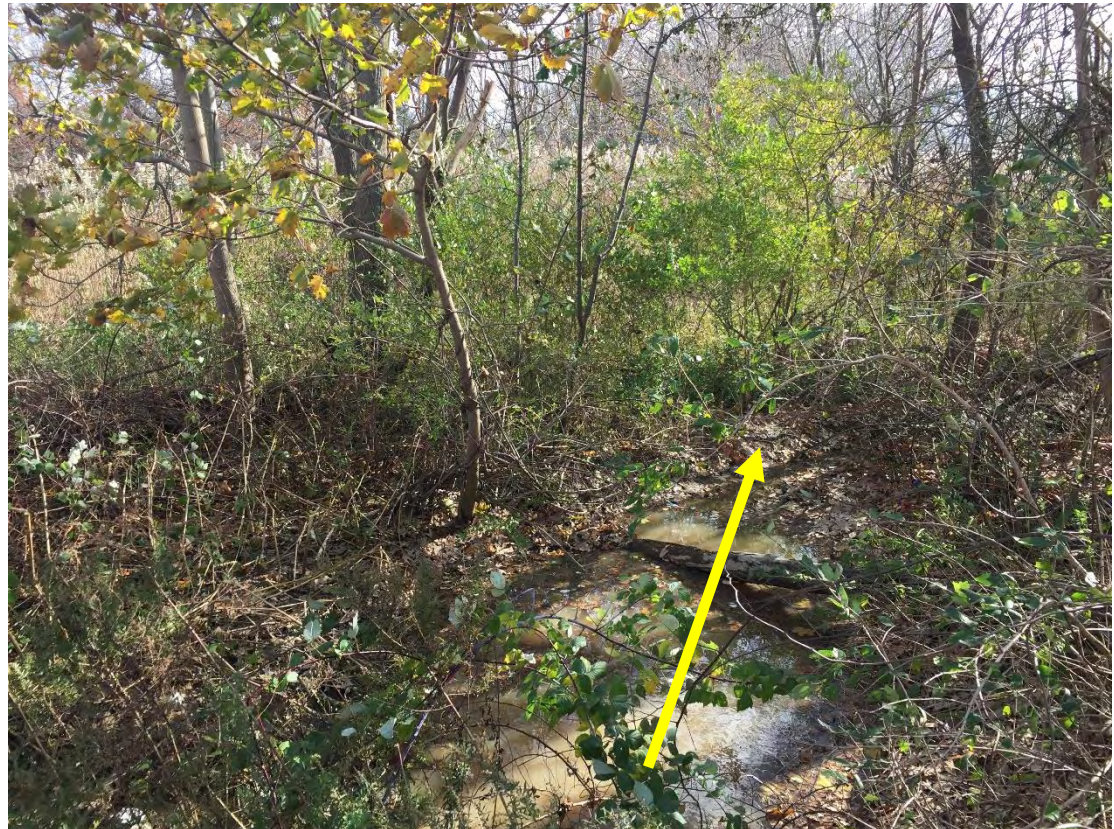
Flow path to wetlands
from outfall.

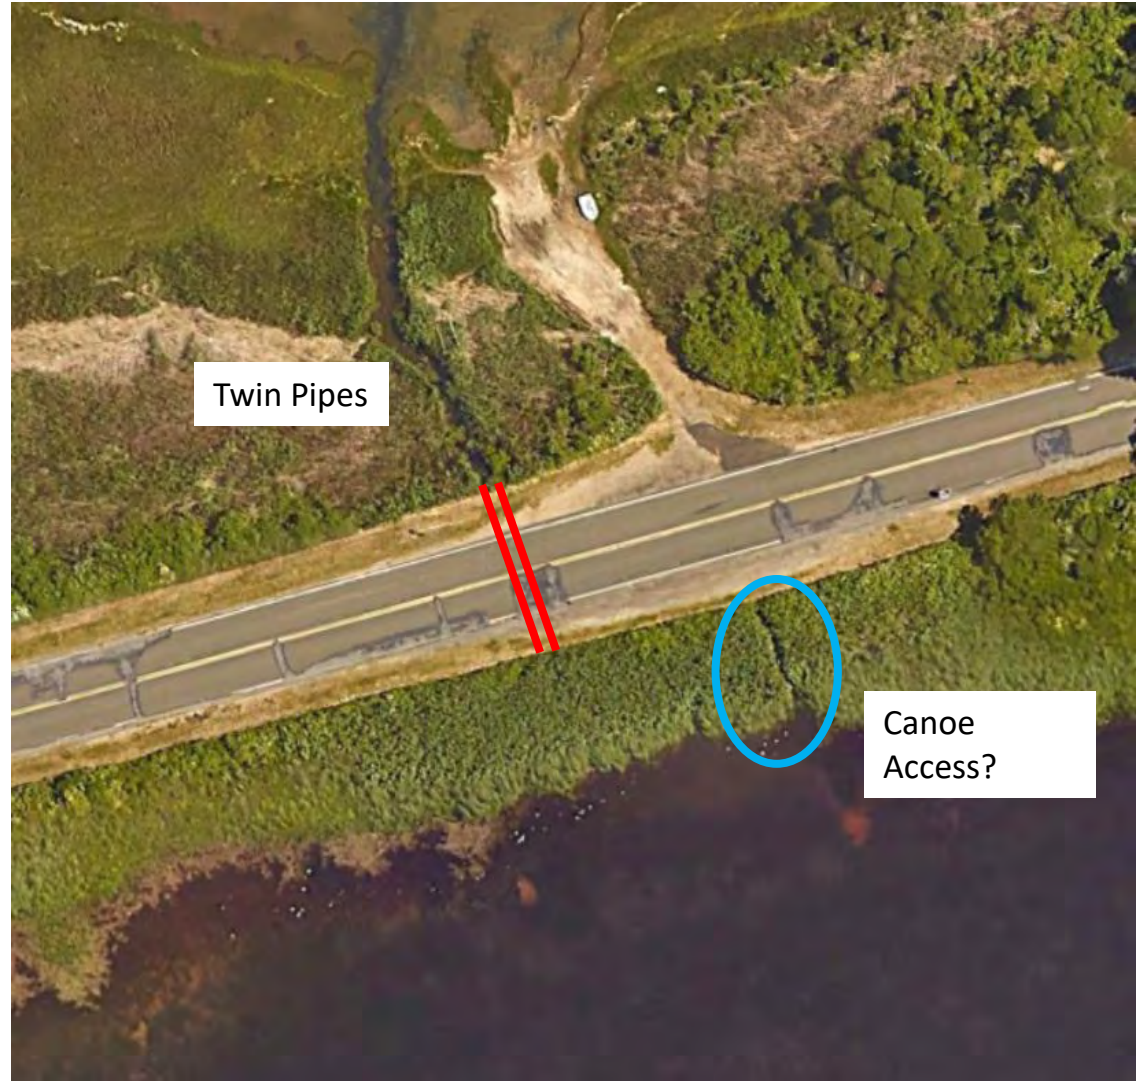
- 2, 12-inch pipes

- Fish passage barrier
 - Perched during certain flows
 - Undersized with no roughness
 - Velocity barrier during most tides/flows
 - Depth barrier – usually only a couple inches of water, which is not enough for herring – needs to be >1.5 times the body height (~3 inches)

- Goal: improve organism passage **while maintaining Pond elevation to prevent intrusion from tides**
 - Herring, American eel
- Replace culverts with single larger box culvert with natural substrate
- Construct riffle so that riffle crest is at desired elevation to keep tides out, but also not flood the road
- 7-8 riffle-pool sequences to make up 3.5 feet of elevation over ~110 feet of channel length
- Each riffle ~0.5ft high, 15ft long
- Proposed slope ~3%
- Move canoe access to fill area
- Mitigation location for fill to be identified, if required by NYSDEC/Town of East Hampton

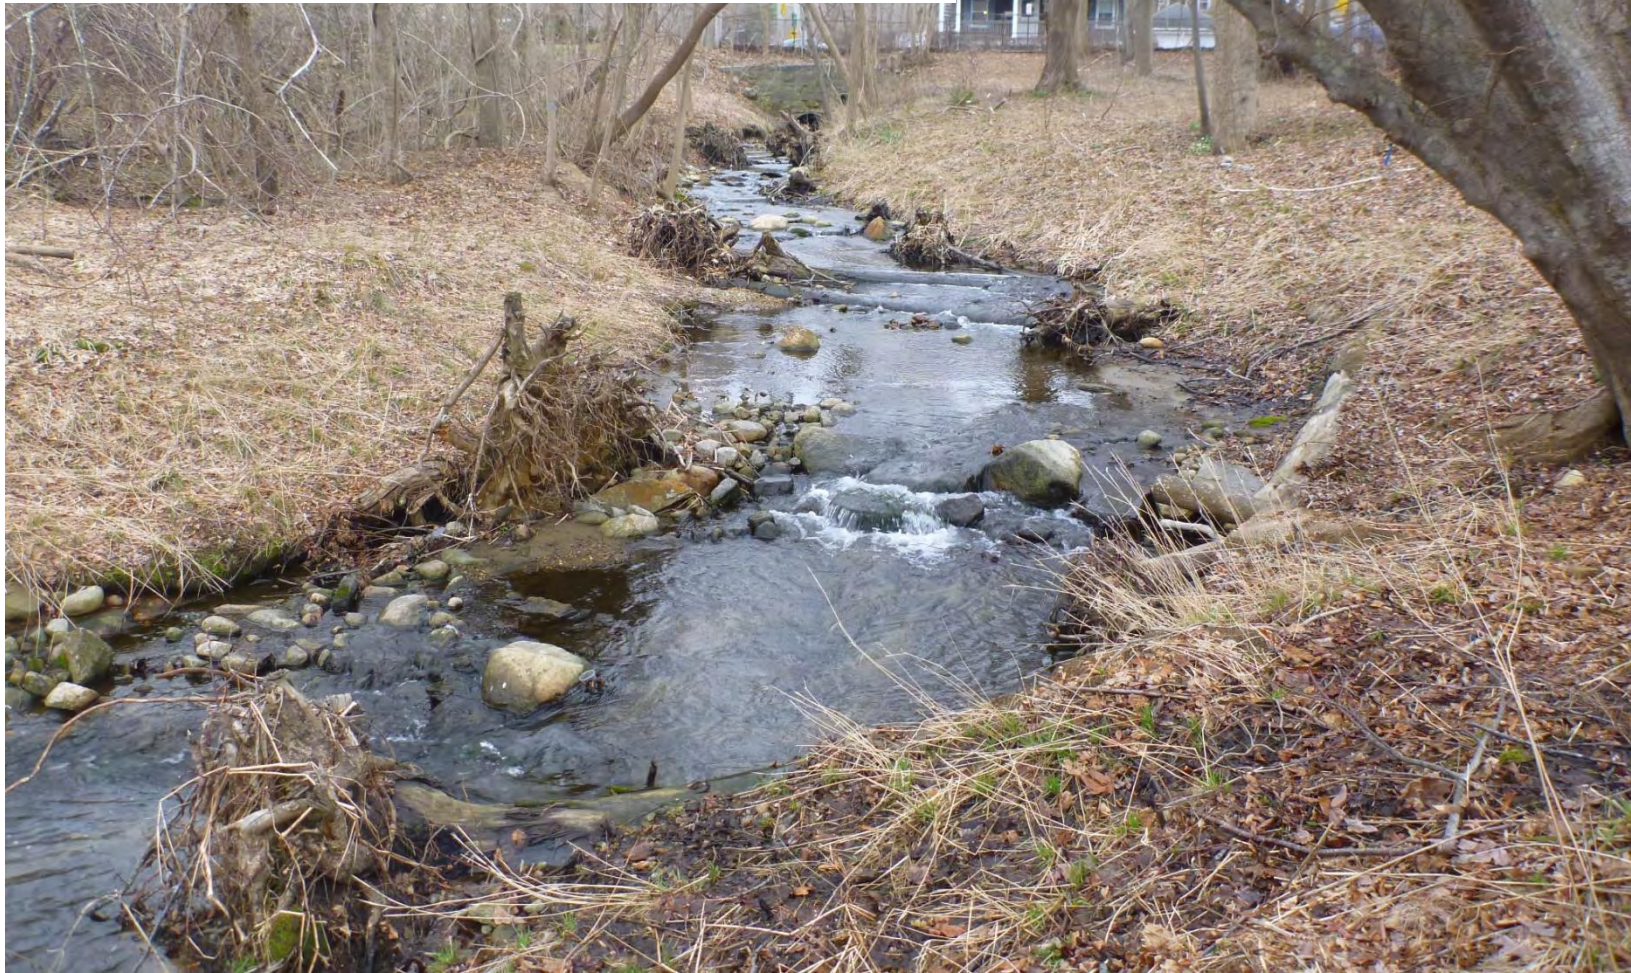
Sawmill Dam Removal, Plymouth, MA
Riffle-Pool Design; ~3% slope

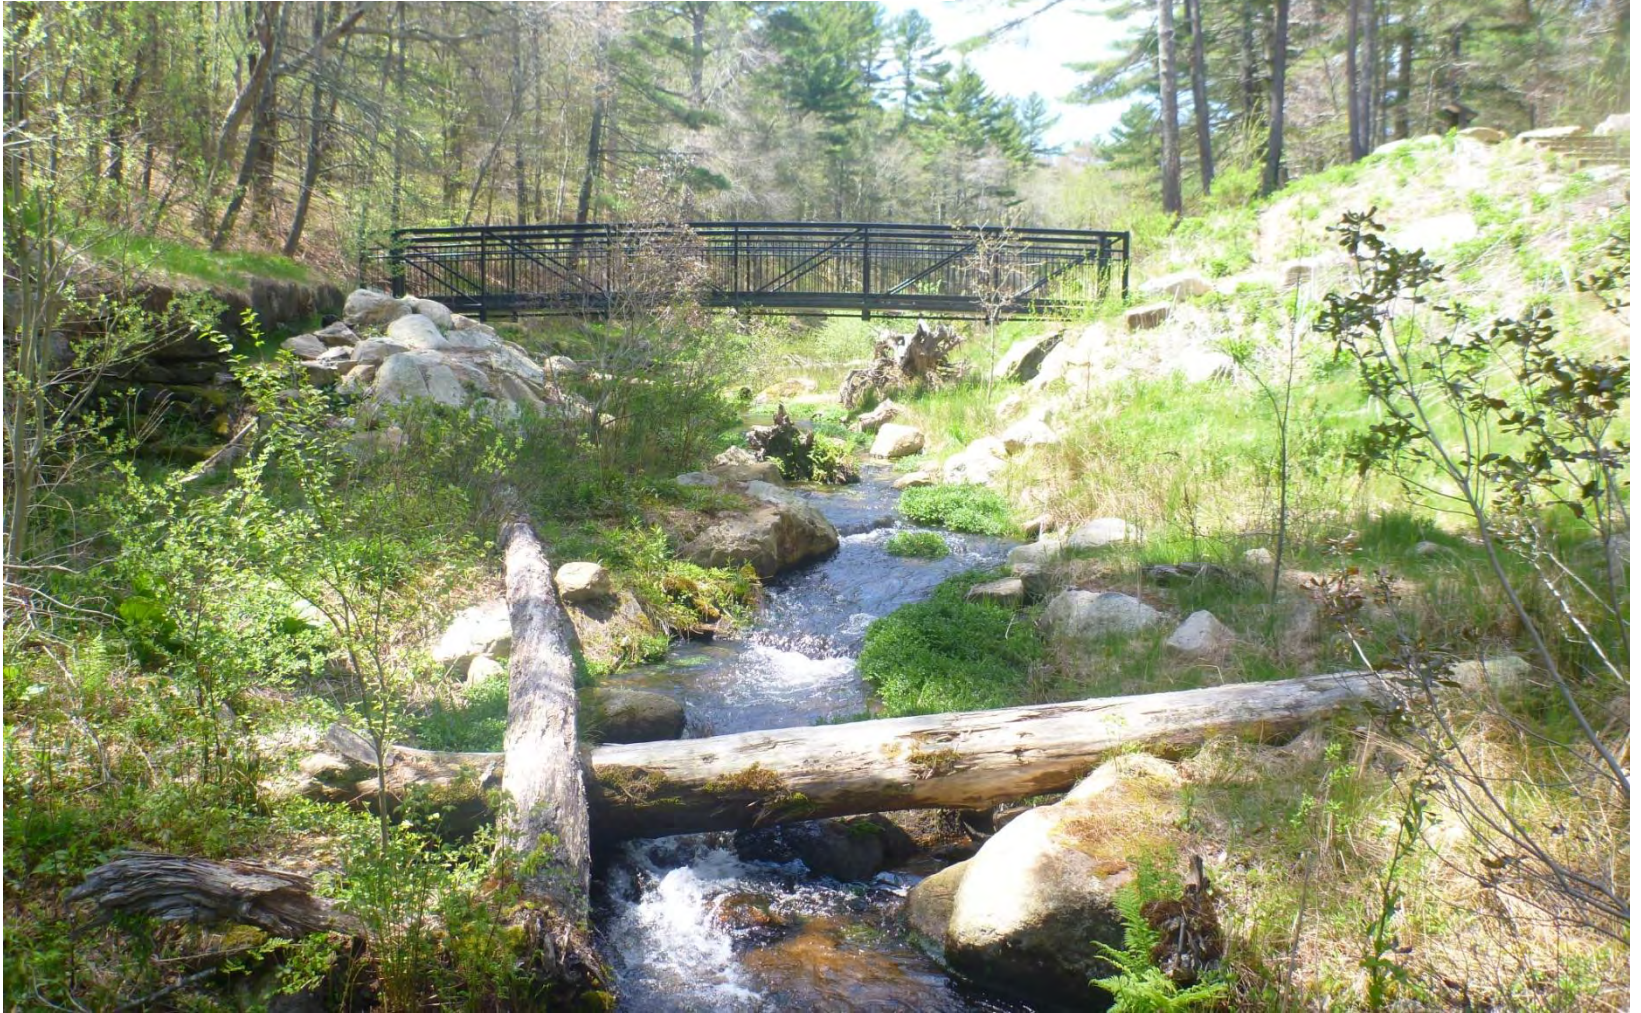
Eel River Culvert Replacement, Plymouth, MA
Natural bottom box culvert with habitat

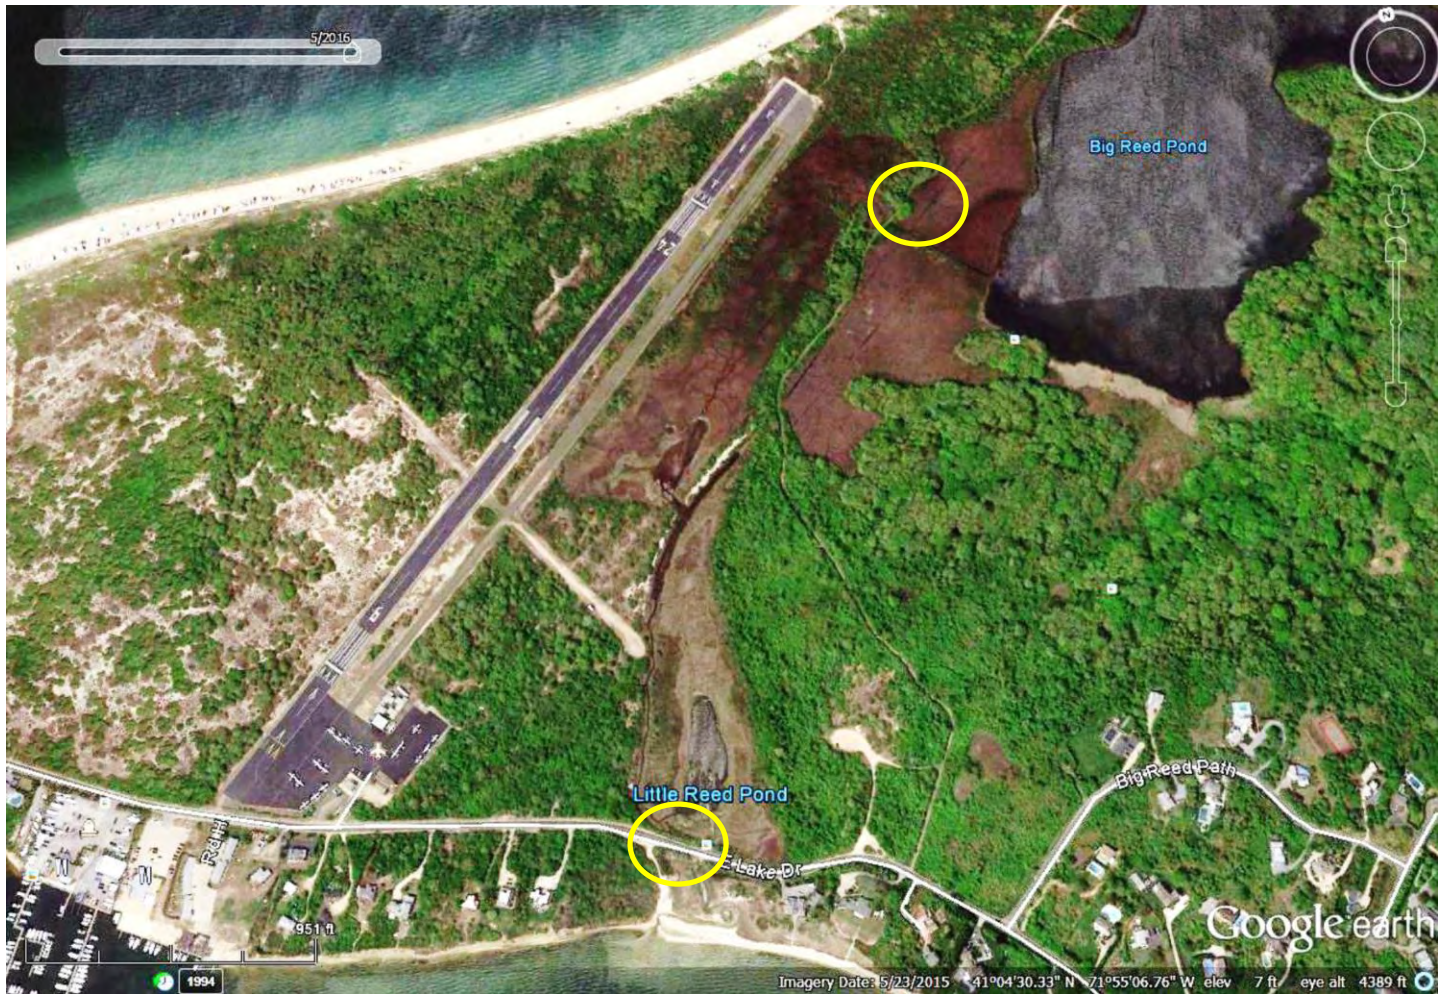
Little Reed Pond

- 3-ft pipe is not a fish passage barrier
- Continuous flow
- Sufficient depth
