Suffolk County Department of Health Services

Peconic Estuary Conceptual Habitat Restoration Design Planning Services

Peconic Estuary Habitat Restoration Conceptual Design Planning Services

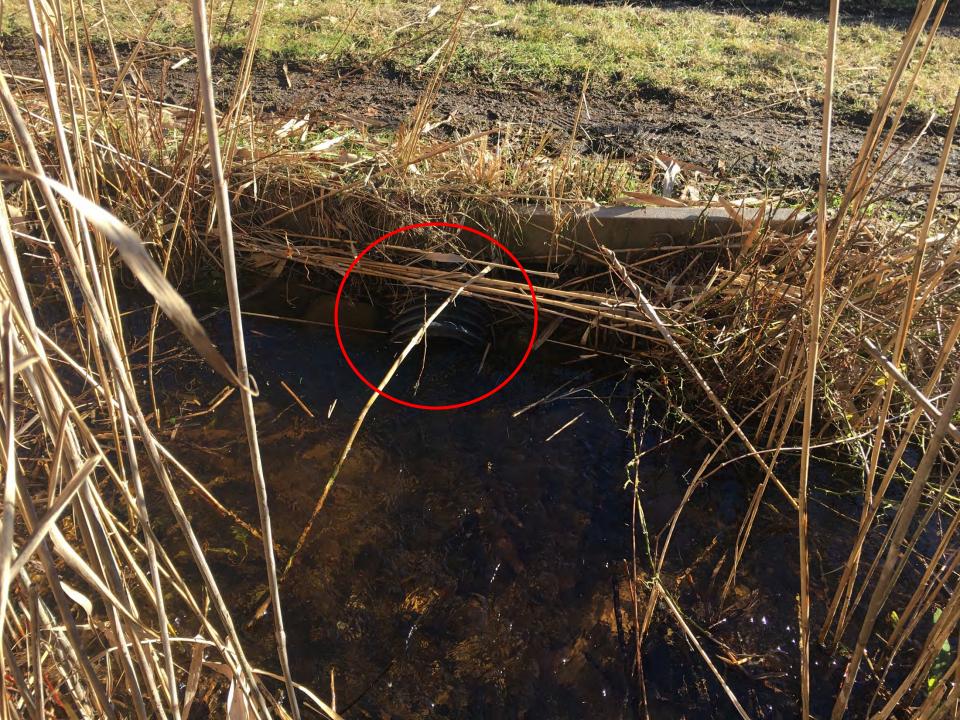
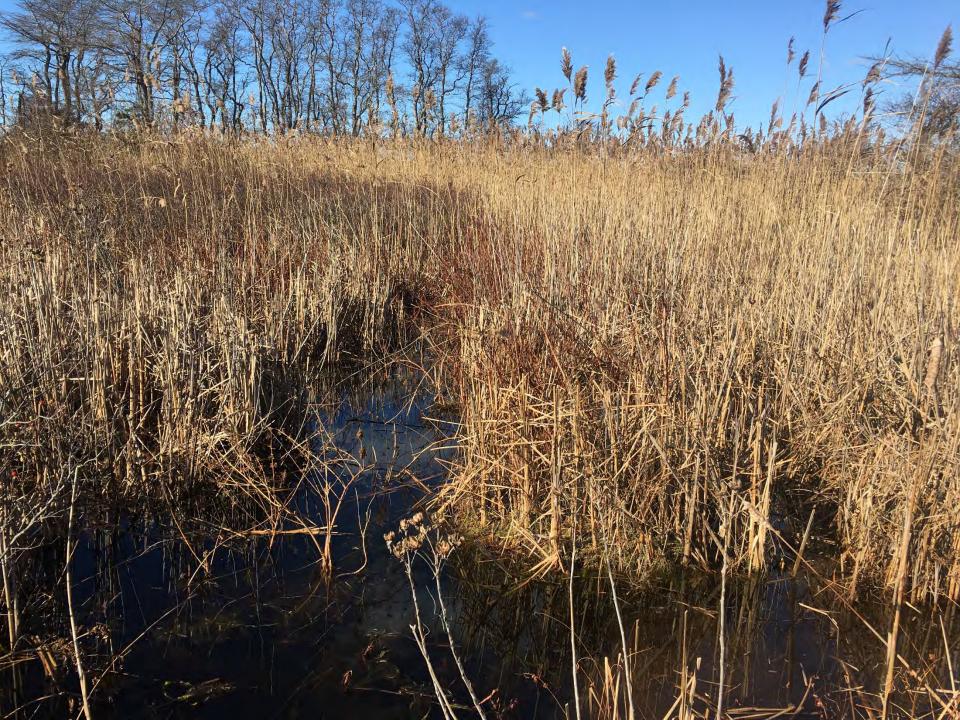
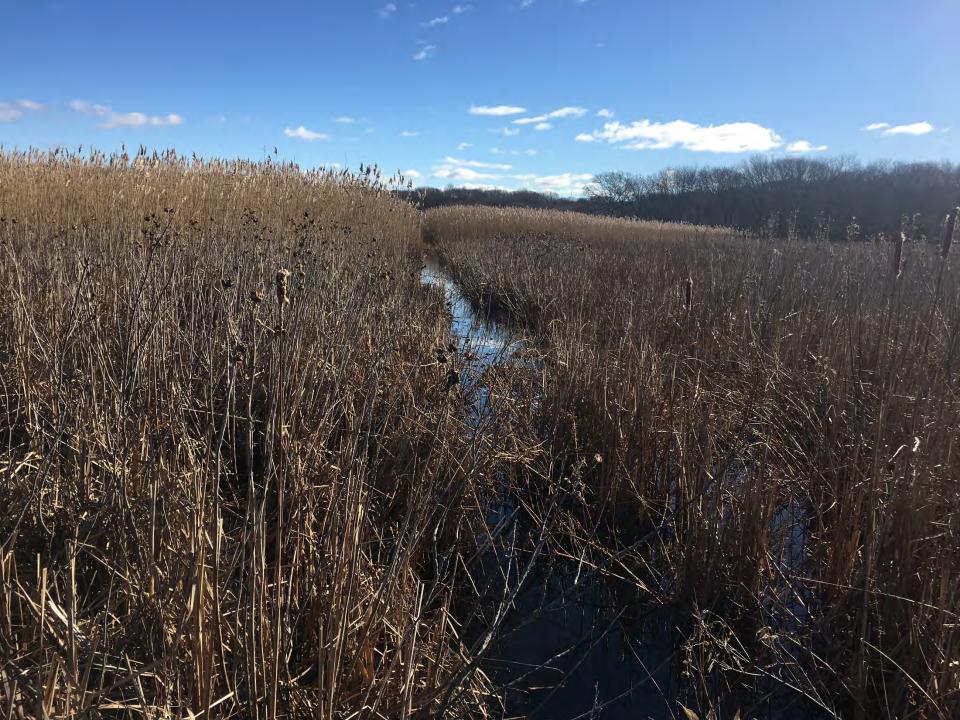
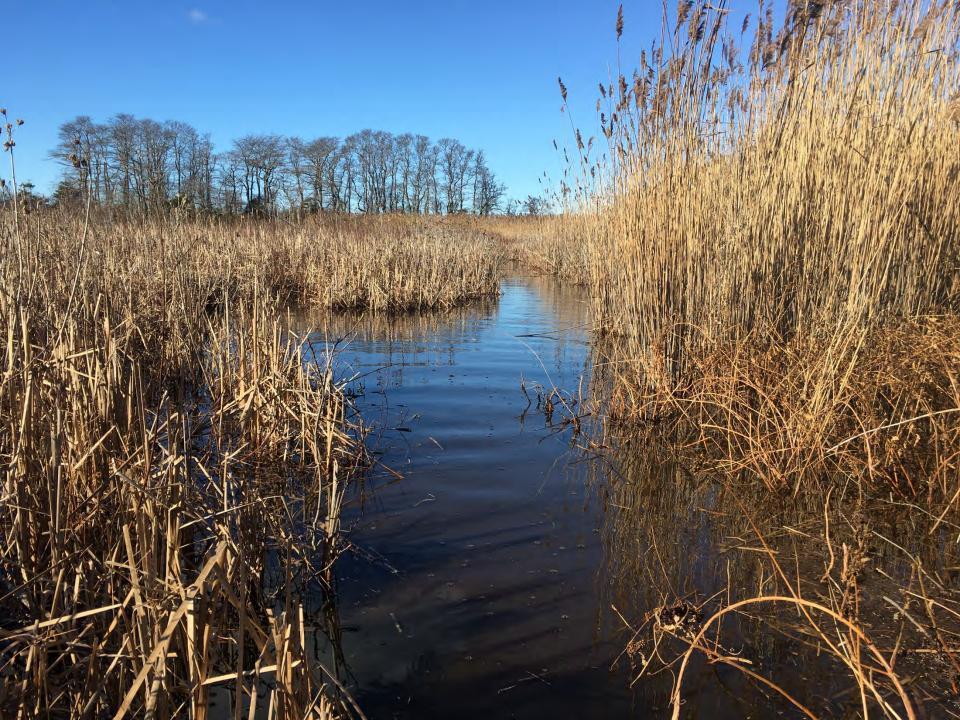
Peconic Estuary Program Conceptual Restoration Design Big Reed Pond Culvert Replacement - Proposed Conditions

Proposed 2' diameter arched corrugated metal culvert, 15' long. Maintain existing pipe elevation of approximately 1.8'

Proposed limit of excavation for culvert replacement. Area is approximately 9'x15' (135 sf). Excavation would extend approximately 2' below existing grade.

Existing 1' corrugated HDPE pipe, 15' long

1. Approximately 1' of fill would be placed above proposed culvert

2. Proposed invert elevations of new culvert shall match existing culvert

3. Proposed grade of park road after construction equivalent to existing road grade (El. 3.5)

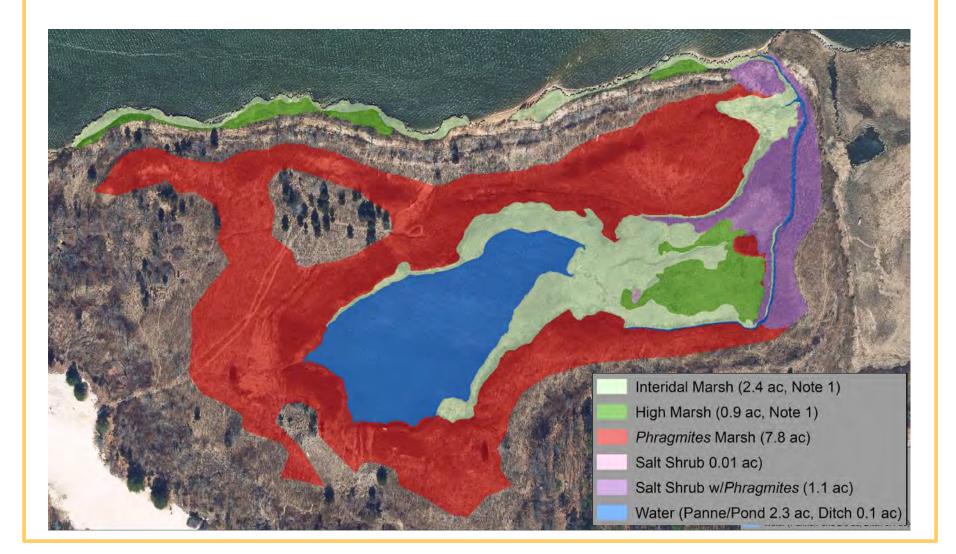
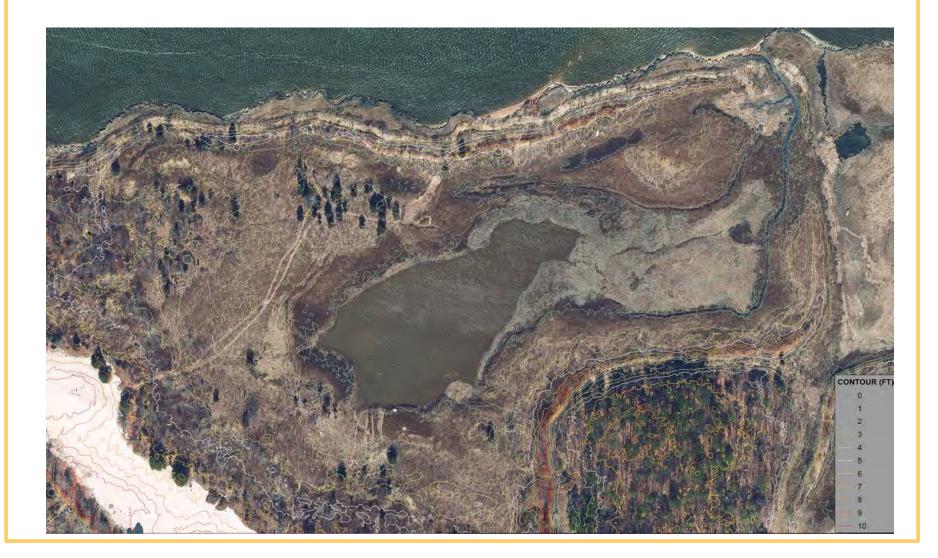
Peconic River Shoreline

Earthen Berm (to left)

Dimension: ~2.5 to 6.0 ft above Tidal Wetlands

~50 ft wide

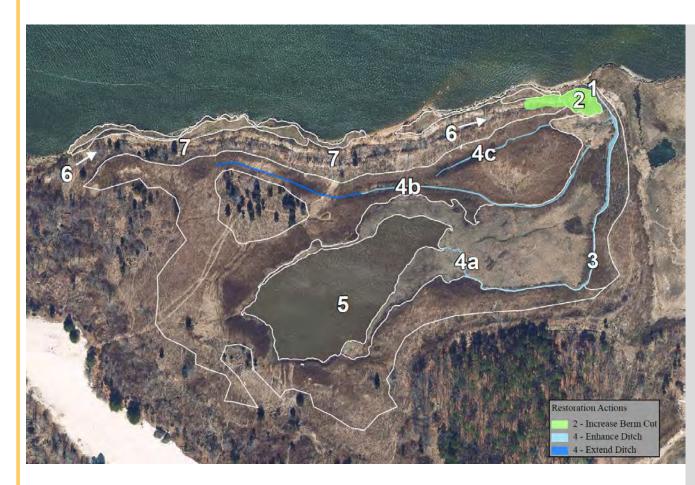
Iron Point: Initial Schematic Plan for Marsh Restoration Actions

1. Increase Channel Mouth Width by 300% 2. Increase Size of Berm Cut 3. Provide Consistent Ditch Slope from Panne to River 4. Provide More Extensive Creek Network 4a. New Channel between Panne and southern Ditch 4b. Enlarge northern Ditch 4c. Provide new Tributary Channel 5. Maintain Portion of Panne as Marsh Pond 6. Construction Access 7. Option: Partial Berm Cuts Stabilized with Bio-Engineering

Iron Point: Discussion Points from Schematic Plan Meeting

- Interior Marshes are "perched" relative to marshes to east and river shoreline. Restricted existing opening may be preventing "marsh drowning" seen elsewhere. Perimeter ditches may be conveying groundwater flow from uplands to river with positive effects on marsh salinity.
 Outcome: Consider constructing limited berm cut and channel on west side with perimeter forming ditches. Using existing ditches are reference system
- 2. Initial Schematic enlarged existing cut and created more extensive channel network. Drawback is *greater Disturbance in Existing Native Marsh Areas*. Outcome: Advantageous to concentrate disturbance in *Phragmites* areas.
- 3. Town of Southampton indicated that the ecological conditions have improved since acquisition of the property in 2001 and concerned about disturbance in higher quality areas of marsh.

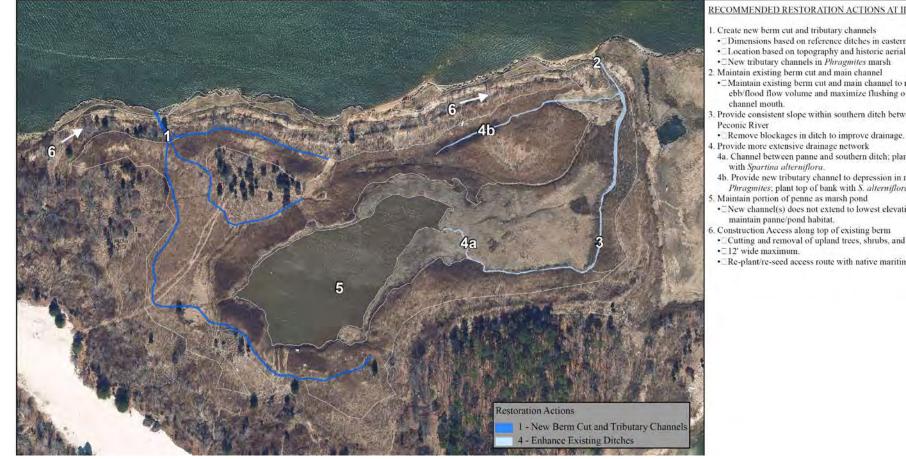
Iron Point: Revised Schematic Plan for Marsh Restoration Actions

- Dimensions based on reference ditches in eastern marsh
- · Location based on topography and historic aerial imagery
- Maintain existing berm cut and main channel to maximize ebb/flood flow volume and maximize flushing of sediment from
- 3. Provide consistent slope within southern ditch between panne and
- 4a. Channel between panne and southern ditch; plant top of bank
- 4b. Provide new tributary channel to depression in northeastern Phragmites; plant top of bank with S. alterniflora.
- . New channel(s) does not extend to lowest elevation of panne to
- · Cutting and removal of upland trees, shrubs, and vines
- · Re-plant/re-seed access route with native maritime plants.

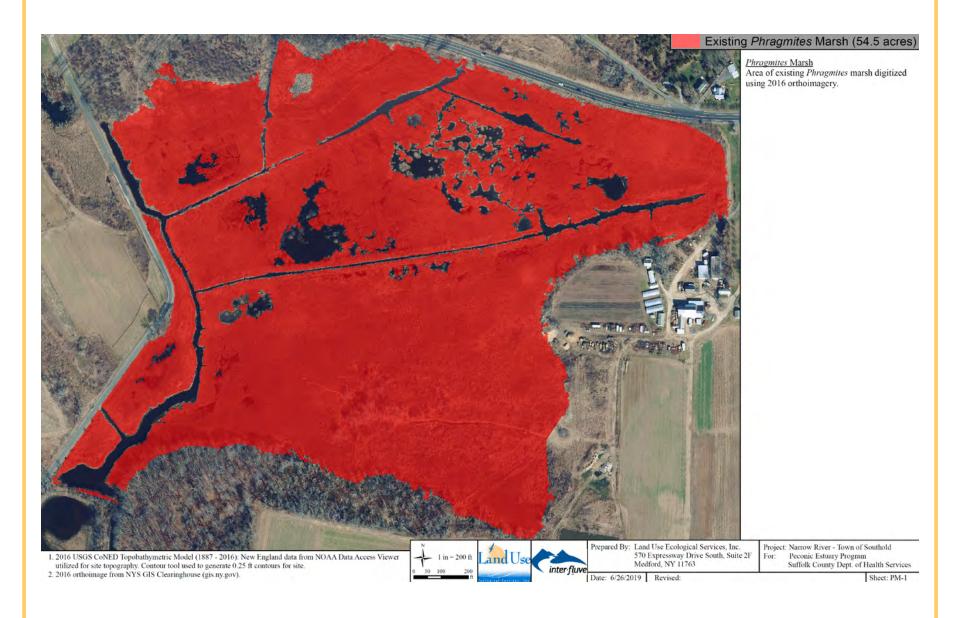
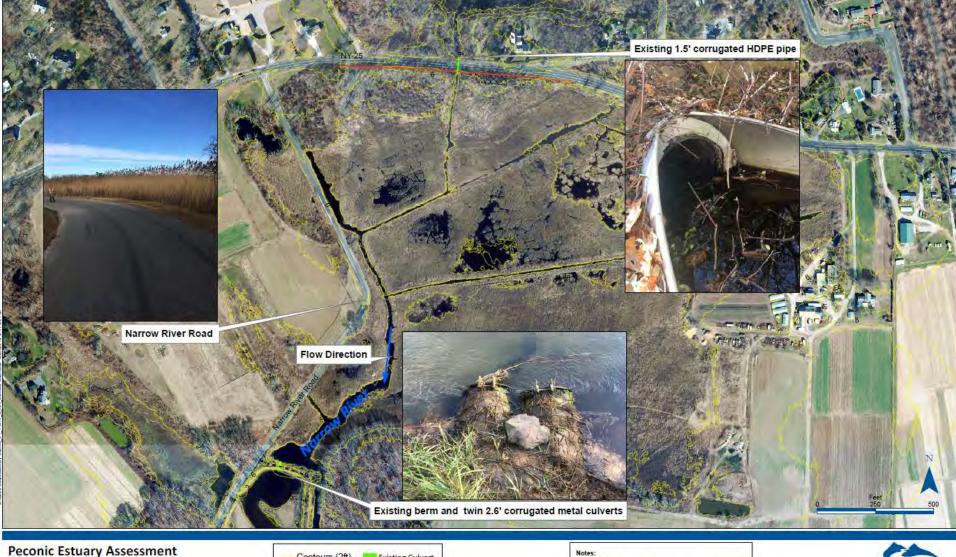
Peconic Estuary Assessment Narrow River Culvert Replacements Sheet 2 - Existing Conditions and Site Photos Narrow River, Orient, NY, Suffolk County (NY) SCTM#: 300-7-1-3

Datum	Orient Harbor NAVD88 (ft)	Cornell Cooperative Extension (ft)
Mean Spring High Water (MSHW)	1.63	
Mean Higher High Water (MHHW)	1.44	
Mean High Water (MHW)	1.12	0.6
Mean Tide Level (MTL)	-0.14	
Mean Low Water (MLW)	-1.4	-1.1
Mean Lower Low Water (MLLW)	-1.6

Narrow River Road elevation at lowest point: 0.8ft

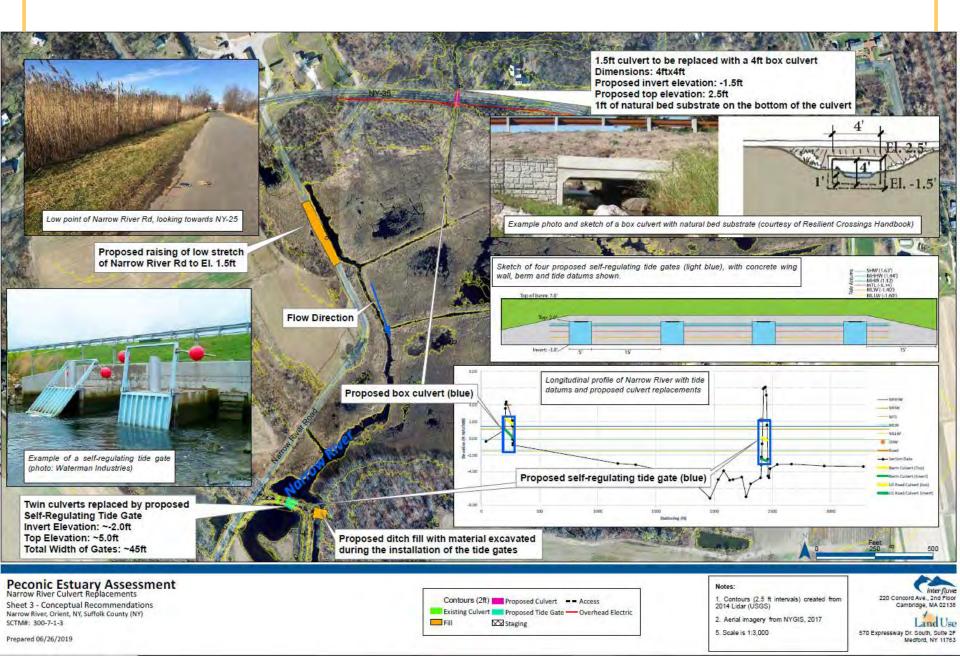
Double Culvert at Earthen Berm – 1.6 feet in diameter with flap gates

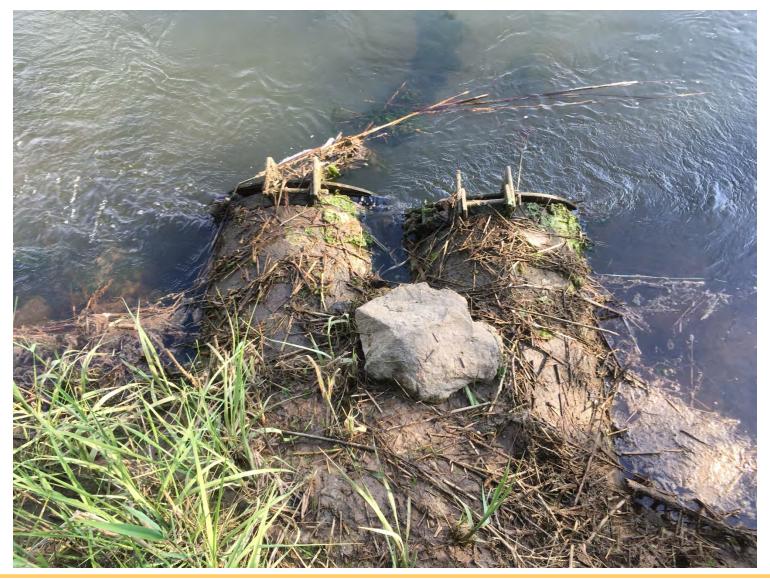
Double Culvert at Earthen Berm – 1.6 feet in diameter with flap gates

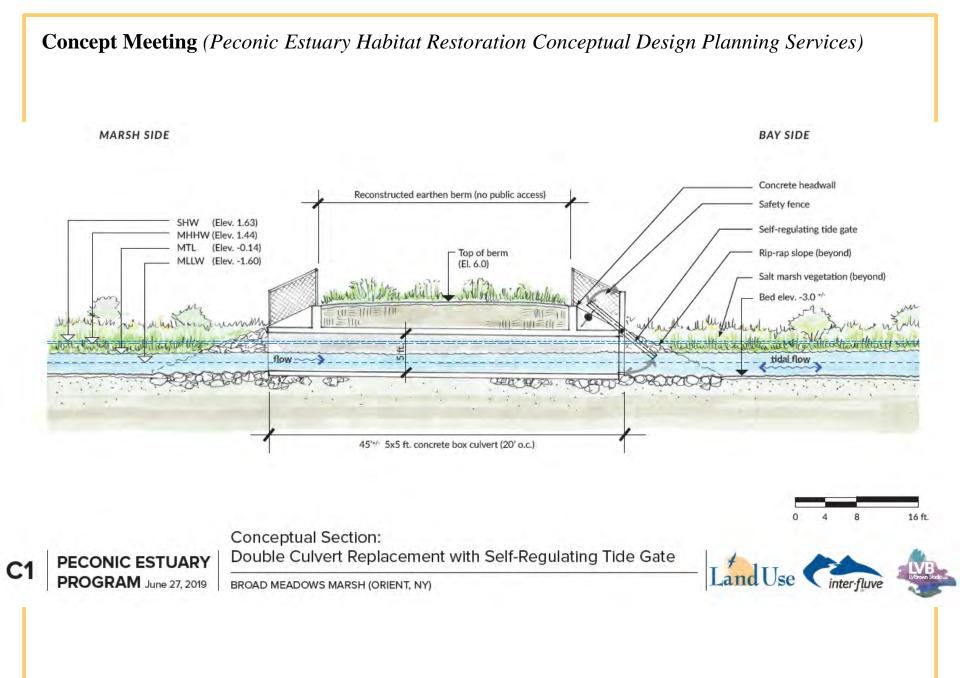
Concept Meeting (*Peconic Estuary Habitat Restoration Conceptual Design Planning Services*) **Narrow River** *Proposed self regulating tide gates: 4, 5x5-ft gates with associated box culverts* Sketch of four proposed self-regulating tide gates (light blue), with concrete wing SHW (1.63') wall, berm and tide datums shown. MHHW (1,44') Tide data MHW (1.12) MTL (-0.14) MLW (-1.40') Top of berm: 7.0' MLLW (-1.60') Top: 20 Invert: -3.0'/ 15' 5' 15'

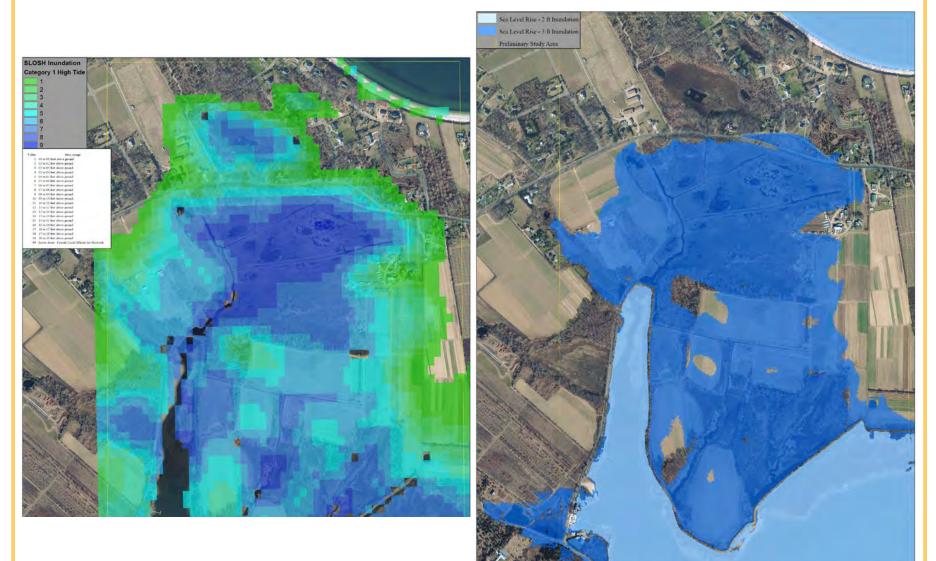
The coastal flooding hazards are greatly increased during storm events (left) or under future sea level rise projections (right).

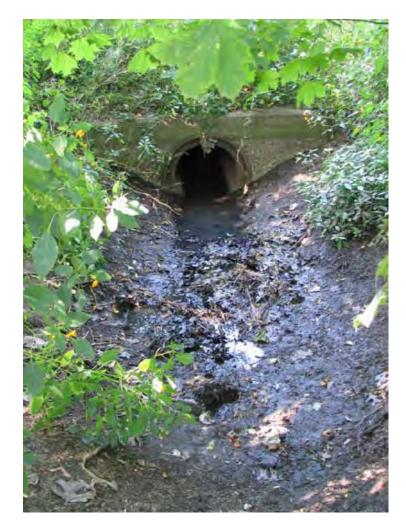
Existing 24" reinforced concrete pipe outfall and headwall

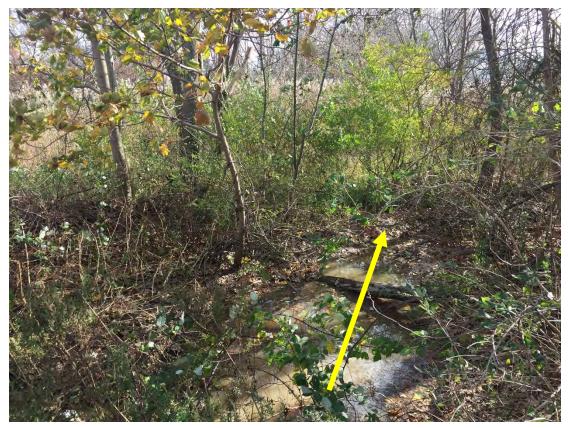
Flow path to wetlands from outfall.
