Accabonac Harbor Subwatershed Management Plan

June 2013

Horsley Witten Group, Inc. 90 Route 6A, Sandwich, MA 02563 508.833.6600 www.horsleywitten.com

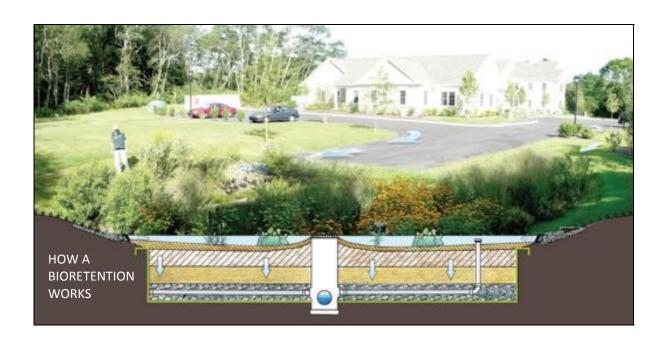
AB-R16. Shipyard Lane Boat Launch — Pavement

Figure 3.23. Existing conditions at Shipyard Road (AB-16) in photo on left; proposed concept on right

removal and bioretention facility
