# Dering Harbor Subwatershed Management Plan

June 2013

### Horsley Witten Group, Inc.

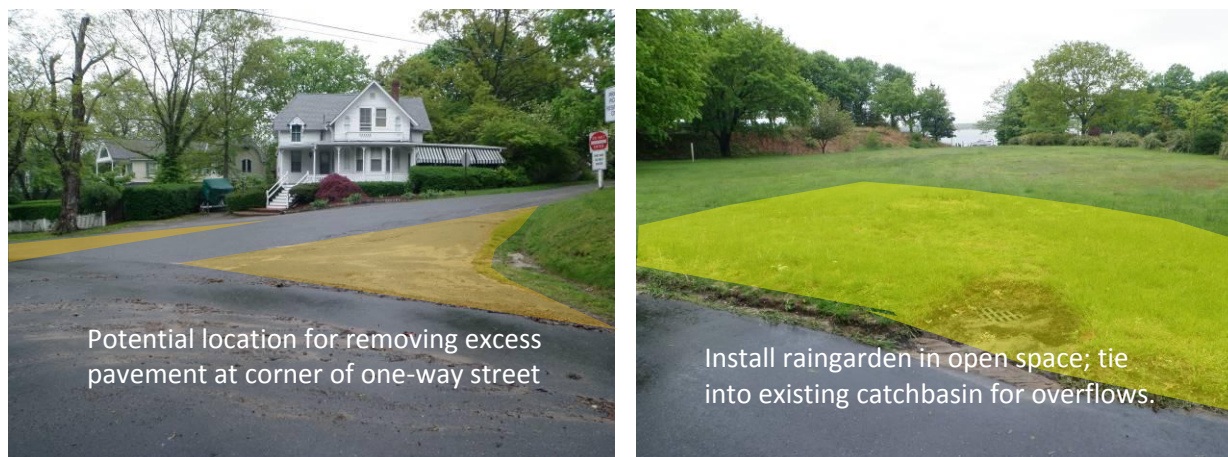
Two main roads in a residential portion of *The Heights* drain to a catchbasin in an open space area on Bay Street. The catchbasin was clogged/filled to rim with sediment, so it is unknown if it is a leaching catchbasin or if it is tied into an existing drainage network. Spring Garden and Wesley Roads are each one-way and have excessively wide pavement areas where they merge with Bay Street. We propose **pavement reduction** at each of the road connections and the installation of a **raingarden** in the open space area (Figure 3-2). The raingarden can overflow into the existing catchbasin. Permeable paver blocks can be used for the driveway extension. This location provides significant opportunities to engage the community, educate the public, enhance aesthetics, and provide for traffic-calming devices.

**Figure 3-2.** Area for pavement reduction and potential rain garden in The Heights.

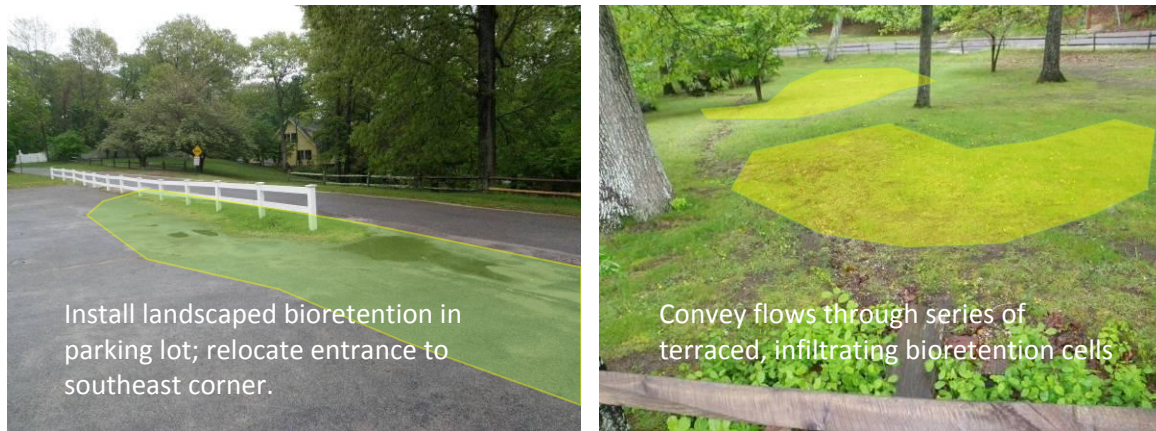
This site is a large church parking lot in the hamlet of Shelter Island Heights. There is currently no stormwater management in place, and sheet flow from the parking lot drains southward across Spring Garden Road into an existing catchbasin which appears to outlet into the park. An eroded flow path

from the outlet structure is visible through the park. The soils here are conducive to infiltration (see Soils Map in Appendix A). The concept at this site is to formalize the parking lot with a landscaped **bioretention island**, **stripe parking stalls**, and provide **clear demarcation of the drive aisles and entrances**. The current entrance along Spring Garden Road will be relocated to the southeastern corner of the lot. Overflow from the bioretention will be piped to **terraced bioretention cells** in the park with **leaching chambers** to enhance infiltration in the lower cells (Figure 3-3). **Benches and educational signage** could be incorporated into the design to promote spiritual meditation and stormwater awareness.

**Figure 3-3.** Proposed series of infiltrating bioretention cells in parking lot and adjacent park

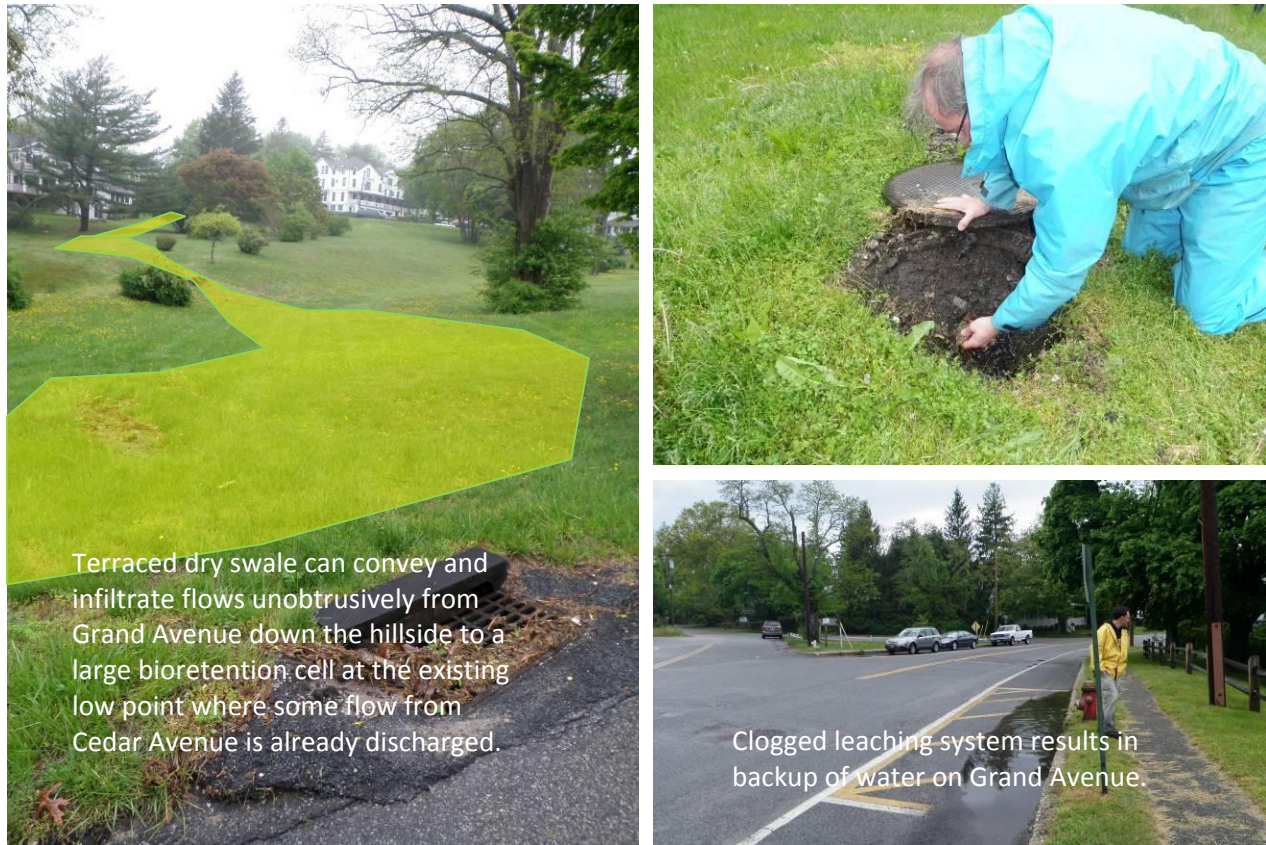
There is a large open space/park area extending downhill between the commercial area on Grand Avenue and the waterfront along N. Ferry Road and Cedar Avenue that could potentially be used to improve stormwater management. This land is owned by the Peconic Land Trust and managed by SIHPOC. Currently, there is a leaching catch basin in a grass area across the street from the Chequit Inn on Grand Avenue that, upon inspection, was completely clogged by organic debris and sediment (Figure 3-4). In addition, oils, leachate from dumpsters, nutrients, and other pollutants generated in the commercial area of Grand Avenue are likely being carried by stormwater to this point; therefore, providing a vegetated filter prior to infiltration is a preferred management approach. At the bottom of the hill, there is an existing catchbasin that conveys runoff from Cedar Avenue into an existing depression in the park. The soils here are conducive to infiltration (HSG A soils; see Soils Map in Appendix A). The total drainage area to this site needs to be further investigated, but it appears that there is enough space here to manage at least the 11 acres (3 acres impervious) initially estimated. The concept is to **modify the existing catchbasin** on Grand Avenue to convey road runoff to a **vegetated swale**, which then transitions down the slope via a **stepped dry swale** system to allow for infiltration. This swale can convey excess flows to a larger **infiltrating bioretention** excavated at the bottom of the hill in the existing depression. Additional bioretention cells can be included in the design, if necessary. The open space area in the park is an important community asset; therefore, the retrofit goal should be to minimize the footprint of a proposed facility, while taking advantage of the infiltration capacity of the soils and existing drainage features. This would be an effective area for public education signage.

**Figure 3-4.** Opportunity to clean and infiltrate stormwater in an existing park.

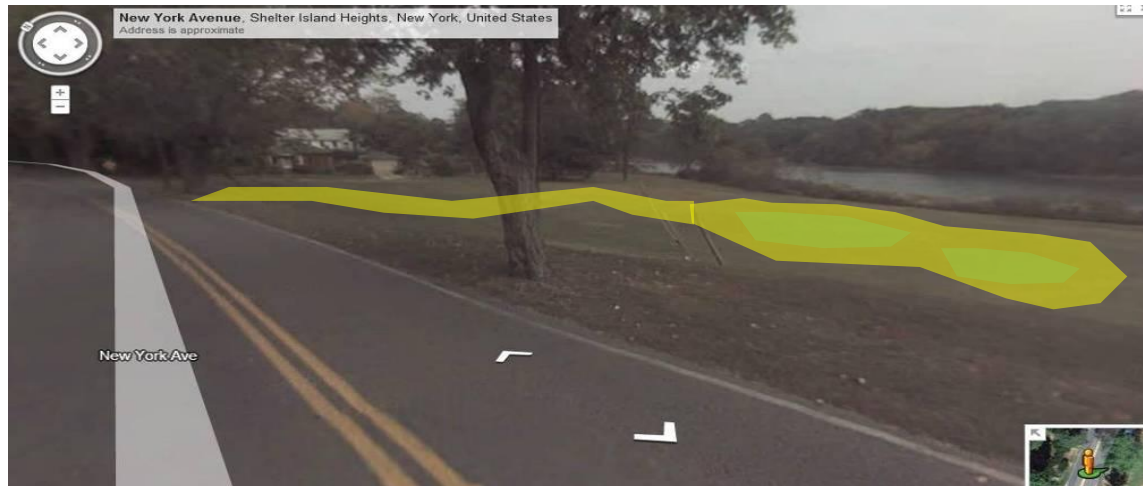
Two undeveloped residential waterfront lots (ball fields) off New York Avenue owned by SIHPOC offer potential for managing stormwater from the road and upgradient homes and the golf course. Residents upgradient from this site experience flooding during storm events, and recently, large recharge basins were installed upgradient of New York Avenue. The concept is to modify the existing catchbasin on the road to convey flows from the road and any runoff not captured by the upgradient rechargers to a **constructed wetland** via **grass channels** on both sides of the open field. This retrofit would also provide enhanced **buffer protection** for Chase Creek and be could be maintained as a public park, with walking/bike paths that weave through the area and benches/signage to educate park users about the watershed issues. Additional runoff volume reduction in this drainage area could be achieved with infiltration swales along the eastern edge of the golf course where the soils have high infiltration rates (HSG A soils; see Appendix A).

**Figure 3-7.** Location of potential constructed wetland off New York Ave (Source: Google Maps)

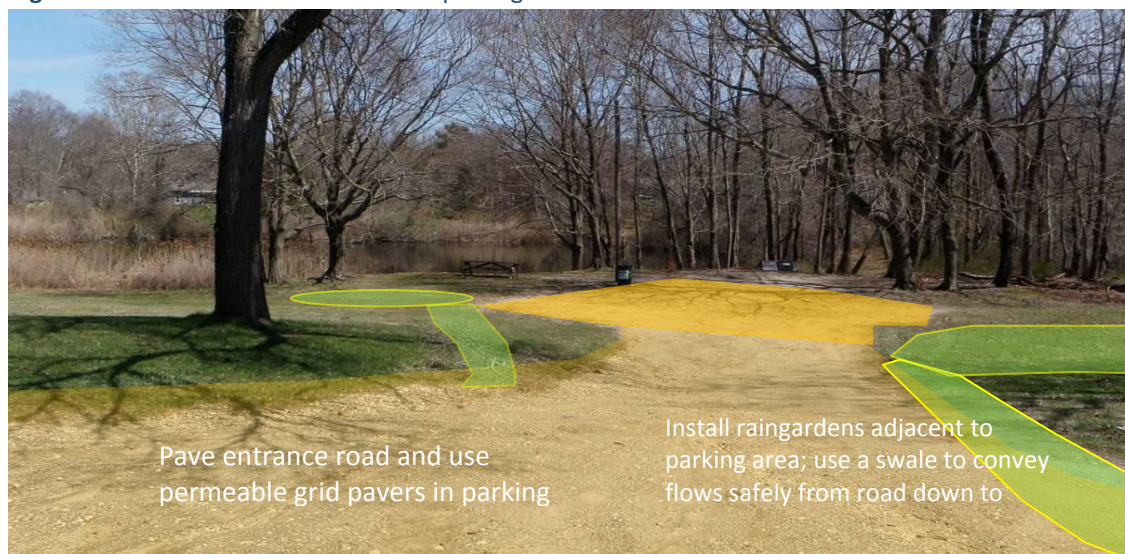
This site is located at a public park in the headwaters of Chase Creek and offers a great opportunity to demonstrate simple stormwater practices that can also be done on individual residential lots. The parking lot is for access to a well, and is owned by the Town, but the SIHPOC has an easement here for access/maintenance. The concept here is to install a **raingarden** adjacent to existing dirt road entrance and parking area. A **swale** may be necessary to convey flow from the existing road to the raingarden (Figure 3-8), and drainage structures could be installed along the street to help collect runoff at several locations rather than all at one point to reduce erosion potential. We recommend paving the entrance, but resurfacing the parking area with **pervious paver blocks** (e.g., concrete grid grass pavers) to provide recharge and prevent erosion. If pervious paver blocks are not feasible, the parking area should be graded to direct sheet flow to adjacent raingardens for treatment. **Educational signage** would be installed to highlight the connection between the wetlands of Chase Creek, Dering Harbor and Peconic Estuary water quality issues, and the stormwater practices demonstrated on site. These stormwater demonstration projects could be coupled with larger community participation activities related to wetland invasive species management, trail maintenance, etc.

**Figure 3-8.** Ice Pond Park entrance and parking area.

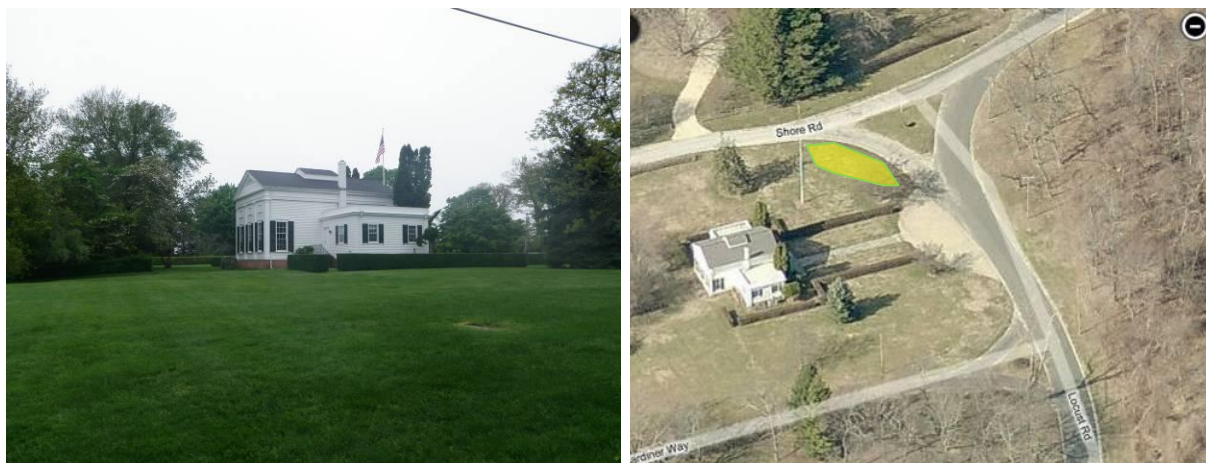
There is no stormwater infrastructure at the Village Hall. Most of the area is turf grass that appears to have been recently replaced with sod. Rooftop and a small gravel parking area are the only impervious areas. Roof runoff is discharged to the lawn. For a demonstration project, consider converting a small portion of the northeast corner of the property into a **raingarden** to collect flows from the adjacent road (Figure 3-15). In addition, a small asphalt berm (small speed bump) should be used to direct road runoff into the practice.

**Figure 3-15.** High management lawn at Village Hall and proposed location for demonstration raingarden (Bing Maps).

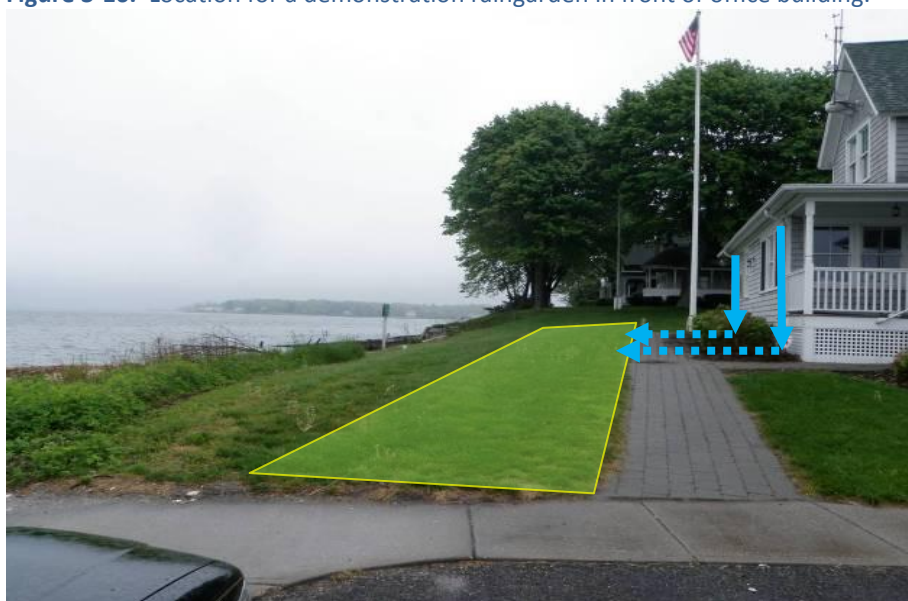
On the watershed boundary, this site offers a highly visible location for public education. There is currently an underground stormwater management system in place at the site that appears to be working well. The concept for this site is to install a **demonstration raingarden** in front of the office building to collect rooftop runoff as shown in Figure 3-16. Currently, the roof drains to the road, where shingle particles were observed at the PVC pipe outfall. **Educational signage** could be placed here for both visitors and residents, describing the water quality issues in the watershed and what individuals can do to help.

**Figure 3-16.** Location for a demonstration raingarden in front of office building.

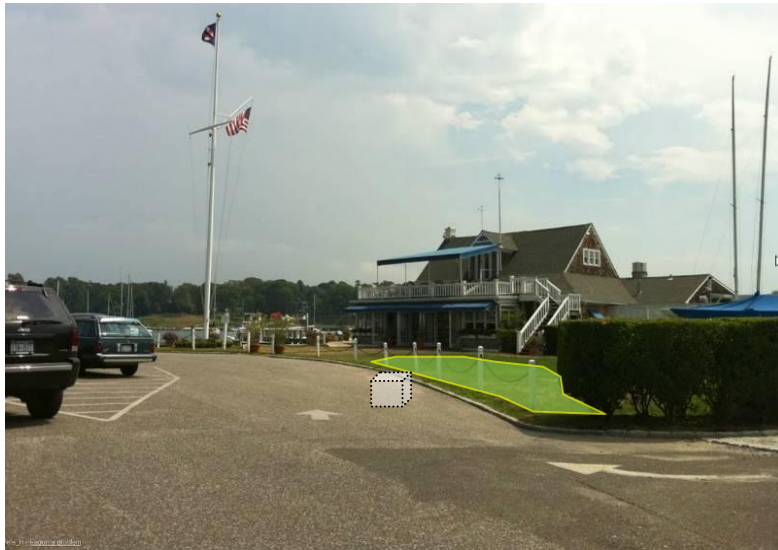
There is currently no stormwater management at the Shelter Island Yacht Club. A portion of the parking lot drains to an existing leaching catchbasin adjacent to the grass area in front of the clubhouse. For demonstration purposes, and to provide for increased water quality treatment, a **raingarden** could be installed that ties overflow back into the existing catchbasin (Figure 3-19).

**Figure 3-19.** Location for retrofit at Yacht Club

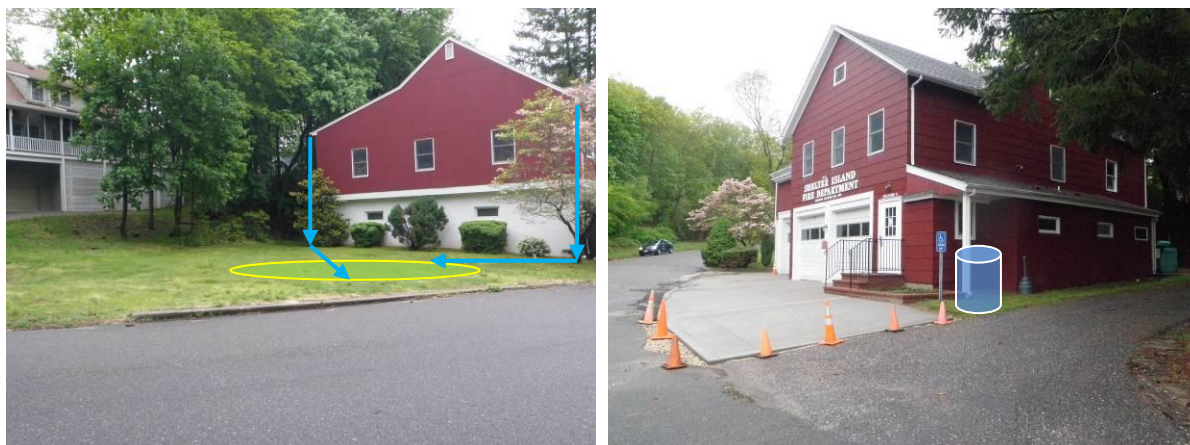
The Shelter Island Fire Station is located at the intersection of Prospect Ave and Grand Avenue. Currently, roof runoff discharges to the grassed area adjacent to the building and the impervious parking area and roadway. For demonstration purposes and to provide for volume reduction, disconnect rooftop runoff from the fire station in a **raingarden** and/or **rain barrel** at existing downspouts on either side of the building (Figure 3-20). The fire station would make a great location for school kids to participate in the construction and planting of a raingarden, and is also a good location to host a community rain barrel distribution event.

**Figure 3-20.** Downspout disconnection at fire station

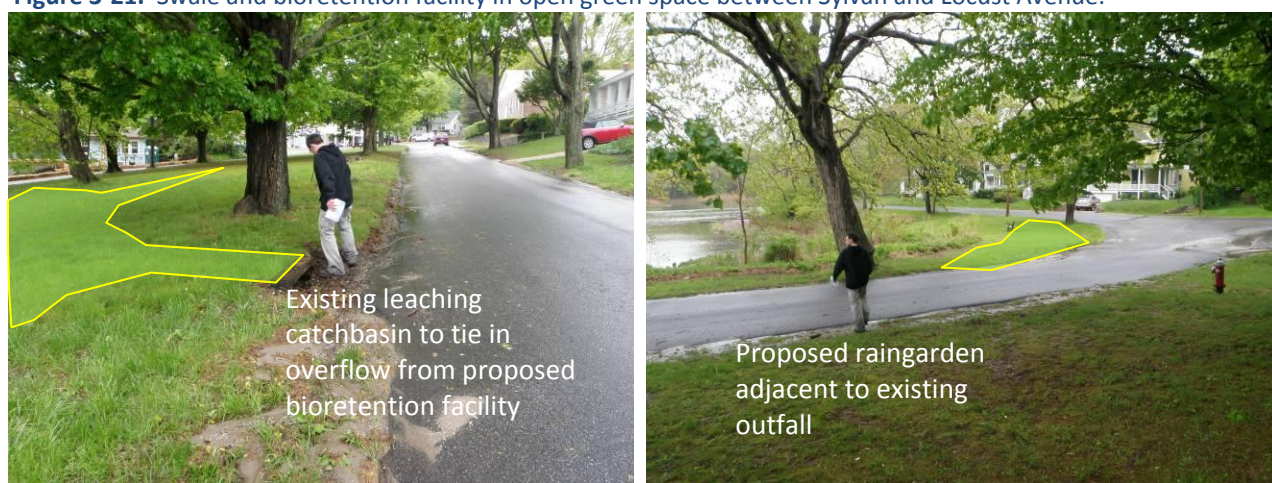
The green space between Auburn and Sylvan Avenue (owned by SIHPOC) provides a great opportunity to capture and treat runoff from a residential area prior to infiltration. There are at least three existing catchbasins along the road in this area; one of which is a recently installed leaching catchbasin. While the existing leaching catchbasins seem to be working well, they provide little nutrient removal compared to vegetated practices. The concept proposed here is to divert flows via paved flumes from the top of the open space into a **shallow dry swale** (planted with grass to allow for pedestrian crossing and mowing) and then into a **large infiltrating bioretention facility**. The overflow from large storm events can be directed into the existing leaching catchbasin. Confirmation of the size of the contributing drainage area, the location of trees, and the location of catchbasins will determine the final footprint of the facility. Plantings will need to be shade tolerant as there is a high percentage of canopy cover at this location. Additionally, a smaller raingarden can be placed at the bottom of the hill in the grassed area upstream of the outfall. **Educational signage** and a **pet waste station** may be ideal for this location.

**Figure 3-21.** Swale and bioretention facility in open green space between Sylvan and Locust Avenue.

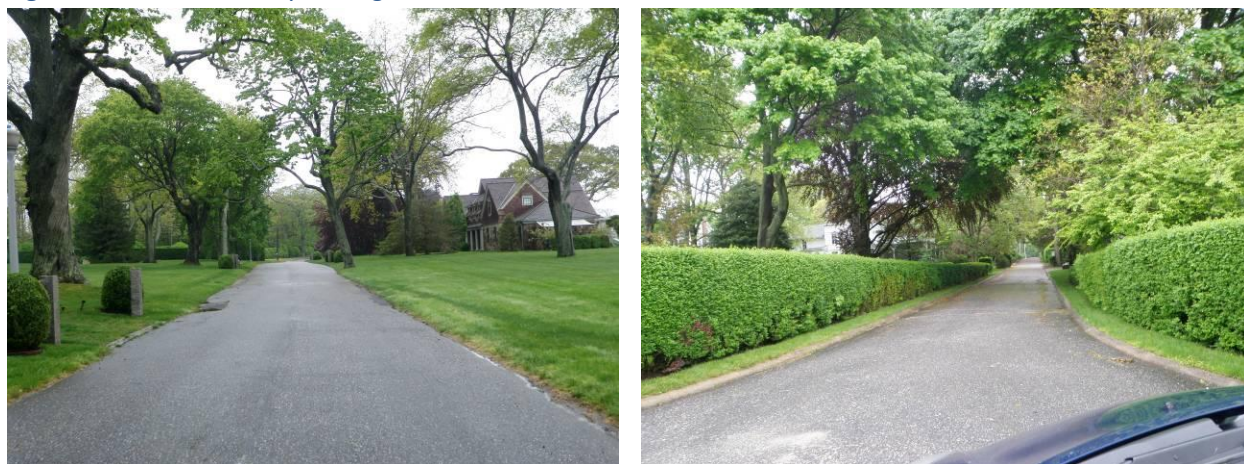
The Gardiner Way residential area is located in the Village of Dering Harbor between Locust Road and Shore Road and south of the Dering Harbor Village Hall. This area consists of approximately 7 single-family homes located on both sides of the road, sixty or more years of age, on lots that range in size from 1/2 to greater than 1 acre. Gardiner Way is a narrow, paved, open-section road that drains to the west towards Shore Road; no stormwater practices were observed. There are no sidewalks present, and the road surface shows signs of deterioration. The overall size of the area is approximately 18 acres, of which 60% is forested. Lot cover typically consists of less than 50% impervious cover, with extensive turf grass. Very few driveways are impervious (~10%). No permanent irrigation was observed, and the majority of the lawns appear to have high to medium maintenance requirements. The neighborhood was clean at the time of observation without visible pet waste, trash, or dumping. Evidence of buffer encroachment was observed with managed lawn abutting the bulkhead at the western portion of the road adjacent Shore Road and Dering Harbor. Opportunities for pollution prevention within the neighborhood include education of waterfront homeowners on proper buffer management and landscaping practices.

**Figure 3.22.** Gardiner Way looking east and west

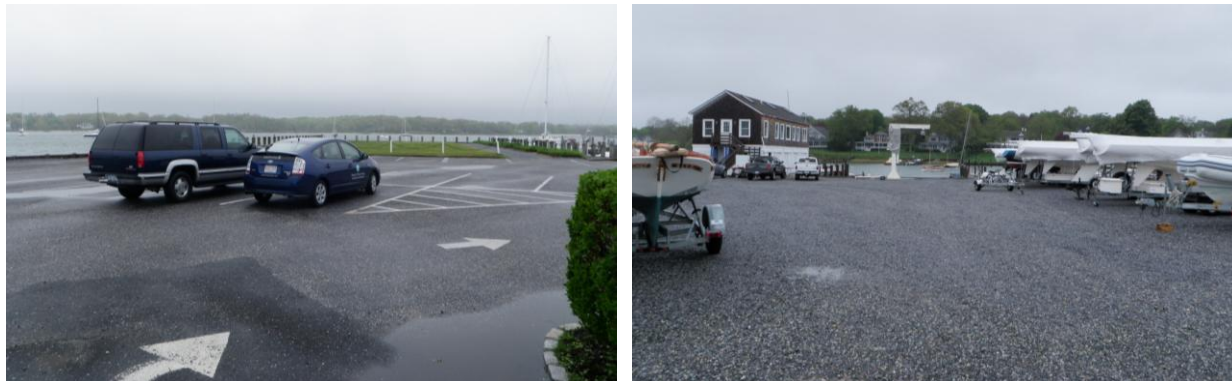
The Shelter Island Yacht Club has a restaurant and bar and is also used for boat storage and docking. The main parking lot is paved, while the overflow parking lot and boat storage area are gravel. Two leaching catchbasins are onsite; one at the edge of the parking lot adjacent to the club and the other in the gravel parking/boat storage area. No evidence of runoff from the gravel parking area from boat maintenance was observed; runoff is contained in the leaching basin onsite. Retrofit DH-R29 describes recommended stormwater improvements to the site, including a raingarden in the grass area adjacent to the paved parking lot.

**Figure 3.25.** Yacht Club parking lot (left); boat storage area (right)
